Fuel imbalance involving Boeing 767-3JHF, VH-EXZ

Auckland Airport, New Zealand, on 27 July 2019

ATSB Transport Safety Report

AO-2019-053

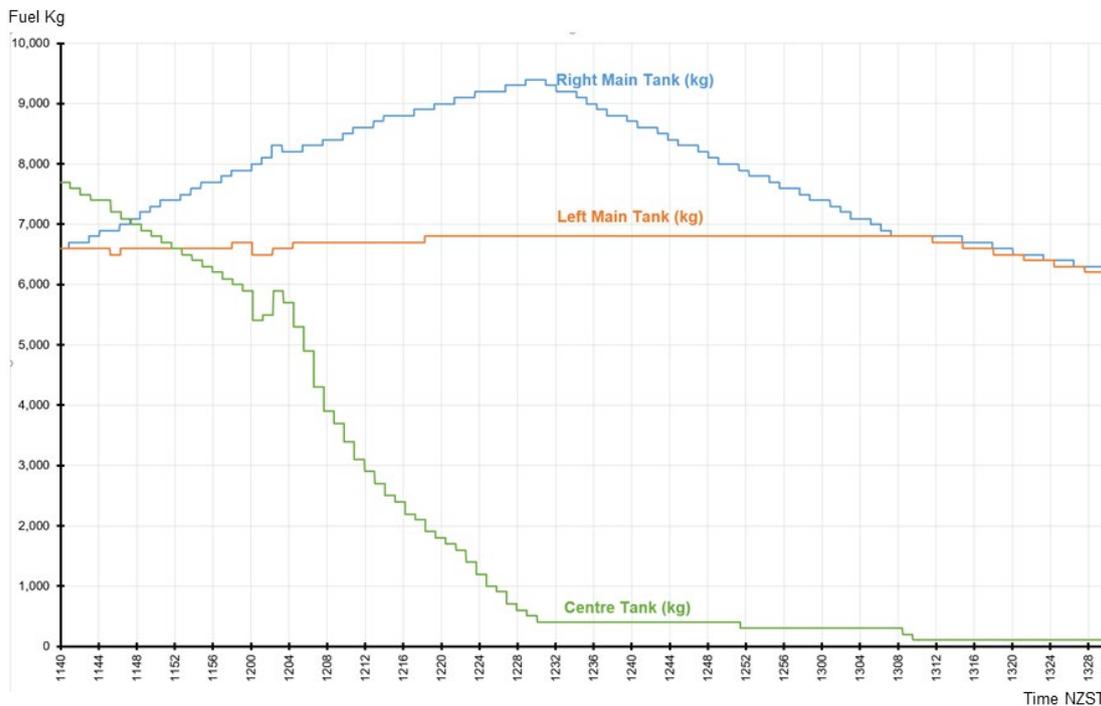
Figure 3: DFDR recorded fuel tank quantities.

Figure 3 is a graphical display of the fuel tank quantities recorded by the digital flight data recorder (DFDR). The time period covered is from completion of engine start, at 1140 to the time at which the centre tank was completely drained of fuel, at about 1330.

The data identified that the imbalance was the result of fuel being fed into the right main tank while the engines were being fed fuel from the centre tank. This abnormal condition commenced around the time of the engines start and continued until the centre tank pumps were switched off. The data also identified that, from post-engine start until landing, the fuel panel switch positions were properly set and in accordance with the normal and supplementary procedures.

The maximum differential of 2.6 t occurred at about 1230. At that time, the centre pump low pressure lights illuminated. In response, the flight crew turned the centre tank pumps off and configured the fuel panel to rebalance the fuel between the left and right tanks. The left and right main fuel tanks returned to a balanced condition at 1308, after which the flight crew returned the fuel panel to a normal configuration. The left and right main fuel tanks remained in balance for the remainder of the flight.
