- Final Report -

AAIS Case N°: AIFN/0001/2020

Severe Turbulence during Cruise

Operator:	Emirates
Make and Model:	Airbus A380-861
Nationality and Registration:	The United Arab Emirates, A6-EEN
Place of Occurrence:	BEIRA FIR
State of Occurrence:	The Republic of Mozambique
Date of Occurrence:	16 January 2020

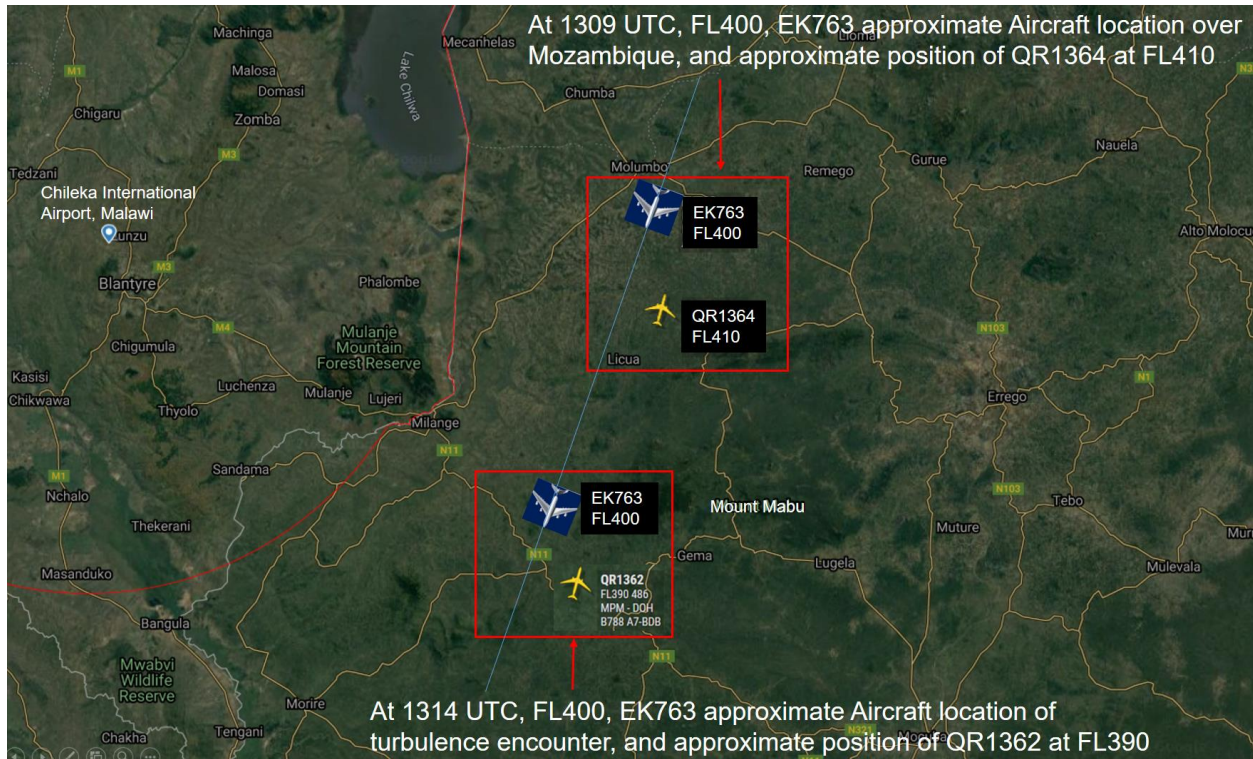
At 1314:24, at FL400, within BEIRA FIR, the Aircraft started to experience moderate to severe turbulence which lasted for about 30 seconds. Figure 1 illustrates the approximate geographical Aircraft location where the turbulence occurred.

Figure 1. EK763 flight path at 1309 UTC and approximate location of Aircraft turbulence encounter at 1314 UTC

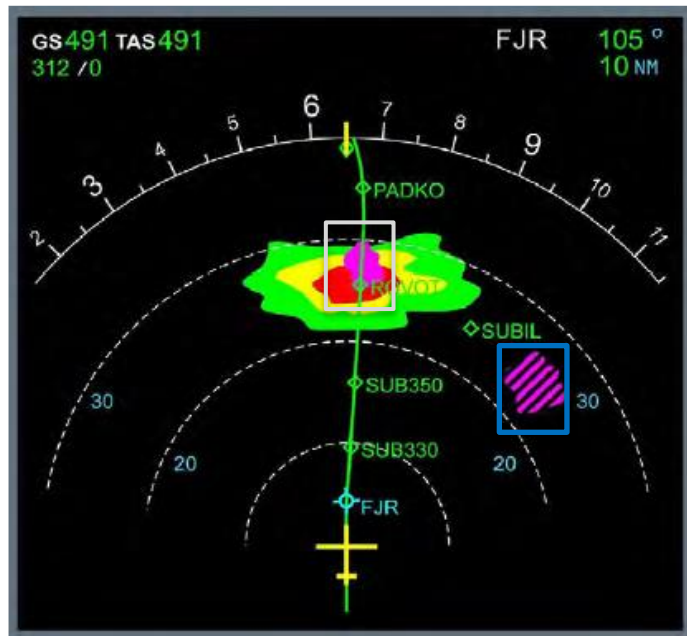
The turbulence detection (TURB) function was based on the Doppler effect² and detected wet turbulence in a volume of space ahead of the Aircraft. This function is based on the movement of precipitation. The TURB detection function scanned ± 60 degrees in azimuth, between 0 and 60,000 ft mean sea level (MSL), and up to 40 NM in front of the Aircraft. The ND displayed the areas of wet turbulence in a magenta color. As noted in figure 3, the magenta within the white box (the white box is used for illustration purpose only) is on-path wet turbulence. The magenta that is hashed within the blue box (the blue box is used for illustration only) is off-path wet turbulence. The VD does not display areas of wet turbulence.

Figure 3. TURB area indication (magenta) on ND
[Source: FCOM A380]

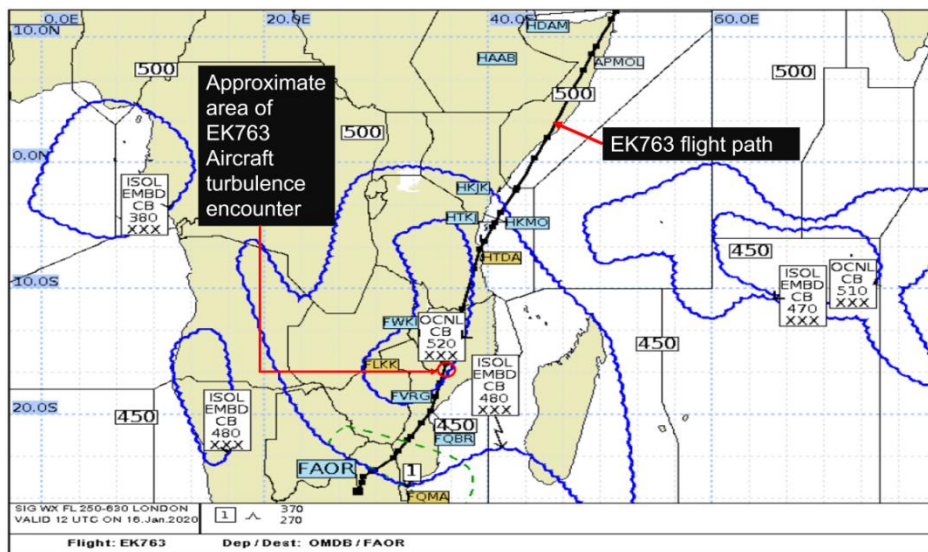
The significant weather (SIGWX) forecast chart from the OFP on 15 January 2020, issued at 0347 UTC, illustrated the weather from 1200 UTC over the central and eastern border of Africa (figure 5). The approximate area of the Aircraft turbulence encounter was indicated by the red circle.

Figure 5. OFP significant weather chart valid 1200 UTC on 16 January 2020 [Source: Operator]

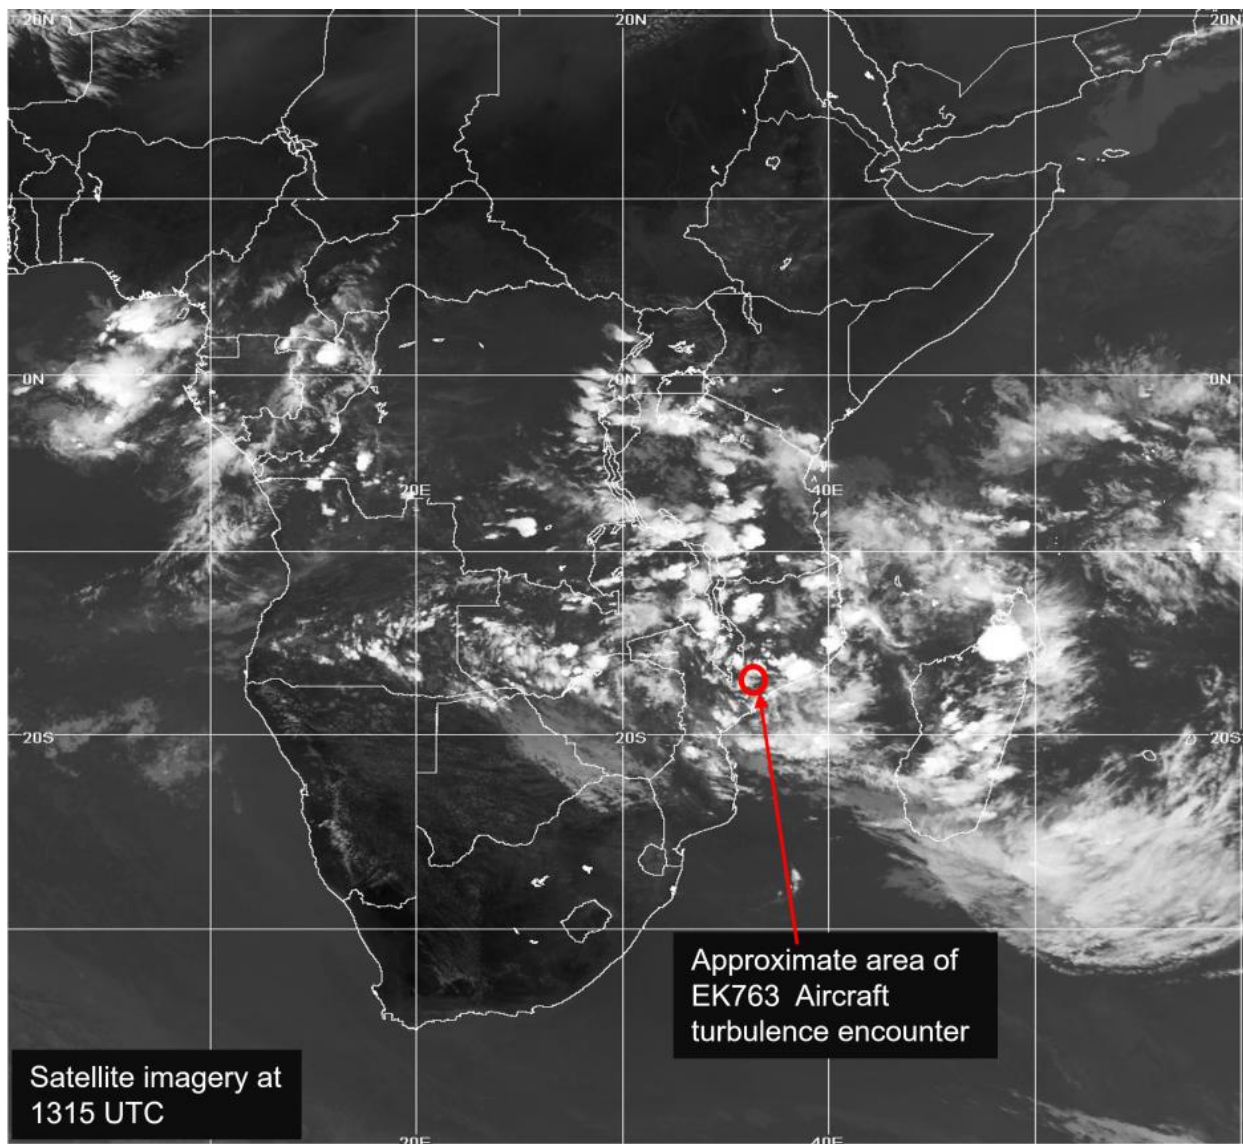
The satellite image, as illustrated in figure 6, was made available to the Investigation by the United Arab Emirates National Centre of Meteorology (NCM) and shows the weather in this area at 1315 UTC on 16 January 2020. The chart shows an area of convection activity with isolated embedded CB up to 48,000 ft and occasional CB up to 52,000 ft. Within this area of convergence, multiple isolated and embedded CBs can be identified. The NCM stated that thunderstorms are typical for this area of East Africa during this time of year because of the Intertropical Convergence Zone (ITCZ) affecting the area. In figure 6, a red circle illustrates the approximate area of the turbulence encounter.

Figure 6. Satellite image at 1315 UTC [Source: UAE NCM]

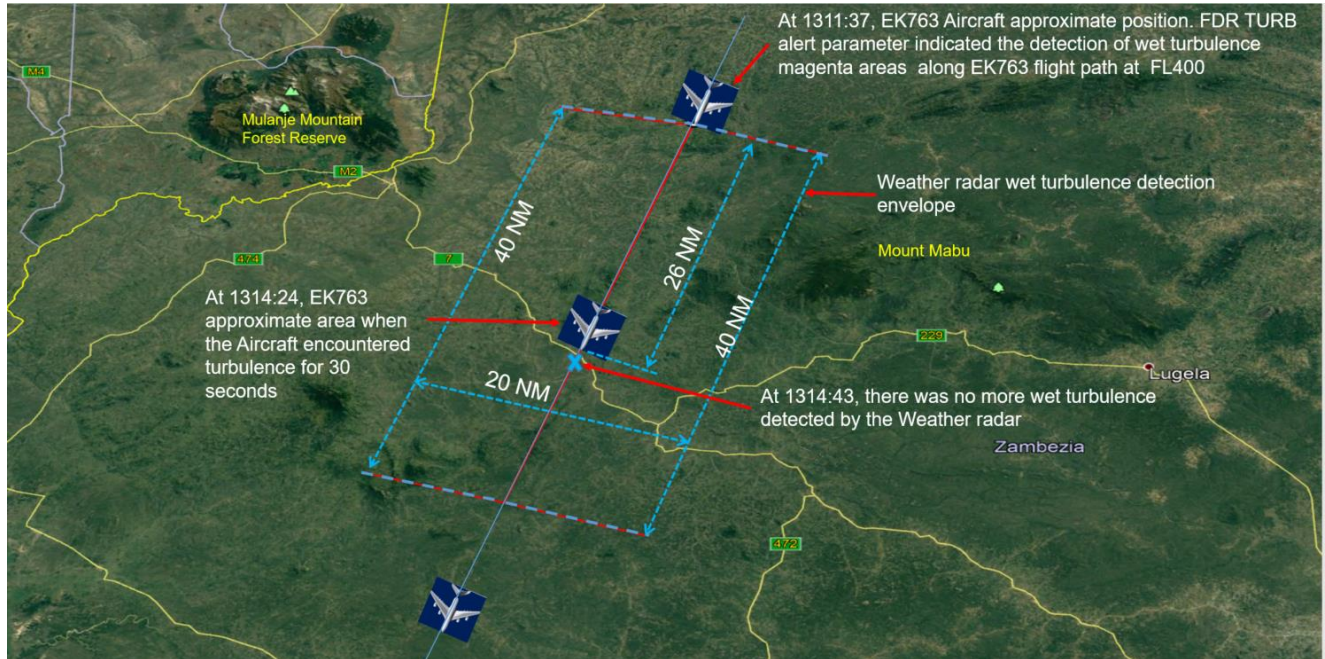
Figure 7. EK763 weather radar wet turbulence detection envelope

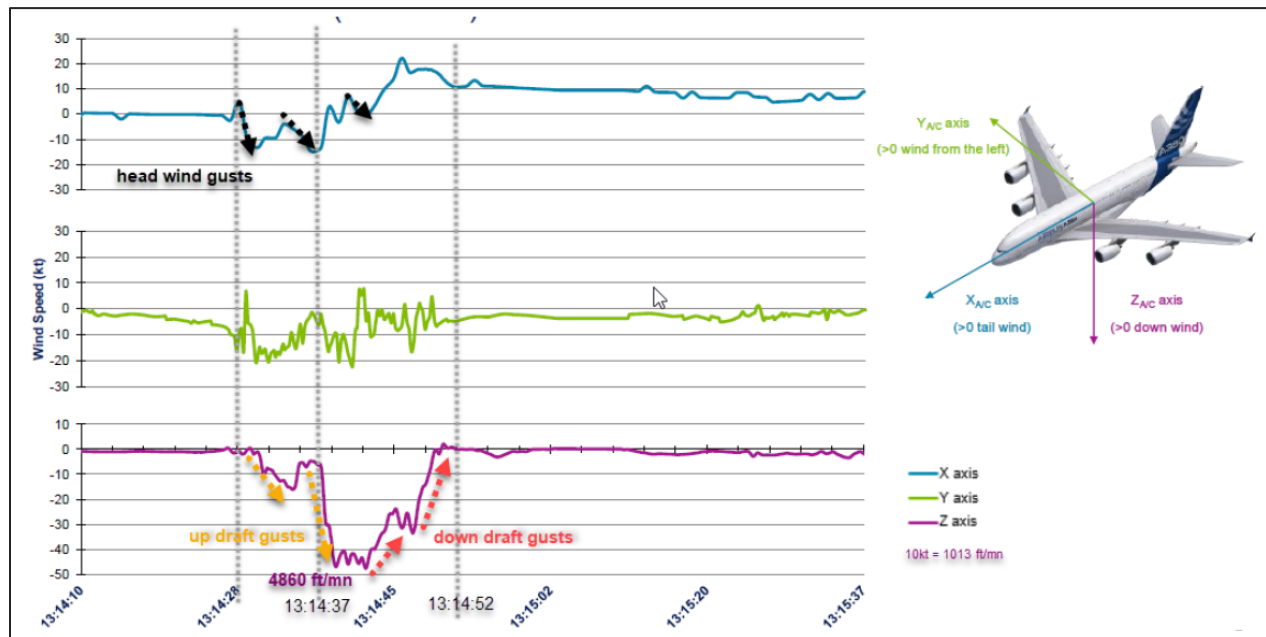
- (f) The onset of the turbulence was caused by an updraft gust of around 4,900 feet per minute combined with a headwind gust of 10 kt. Figure 8 illustrates the winds during the turbulence encounter as reconstructed by the Aircraft manufacturer.

Figure 8. Wind reconstruction plots [Source: Airbus]

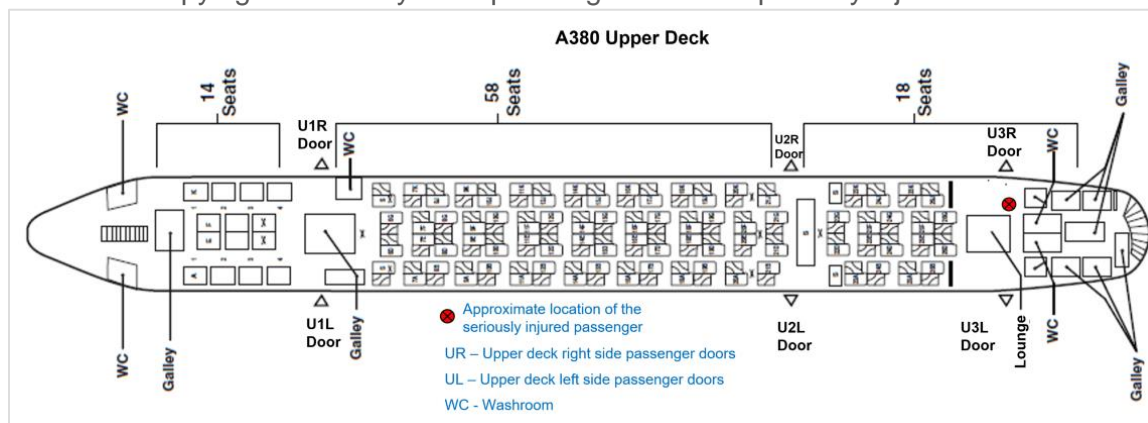
- The passenger, who was seriously injured, was on her way to the lavatory adjacent to the aft cabin upper deck U3R door. As per the cabin crew statements, the passenger fell to the floor, which most likely indicates that she was lifted off her feet. Figure 9 illustrates, with a red circle, where the passenger was located at the time of the turbulence encounter.

Figure 9. A380 Upper deck – location of the seriously injured passenger

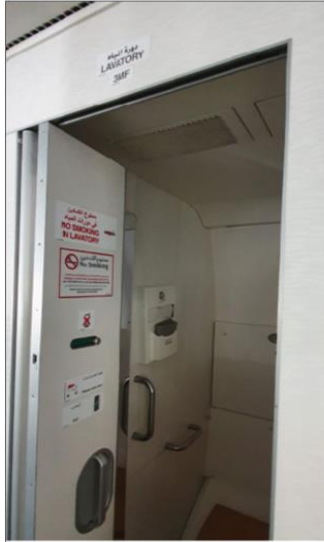
Lavatory with two handholds

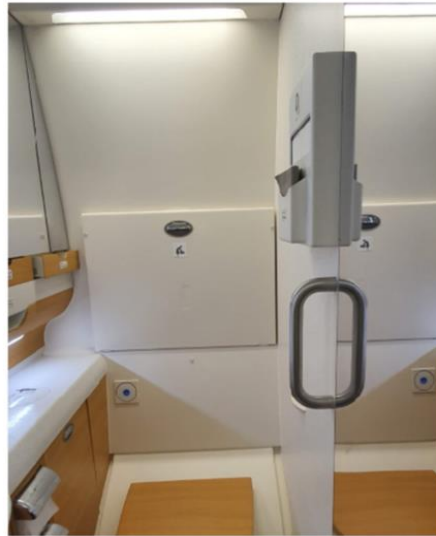
Lavatory with a single handhold

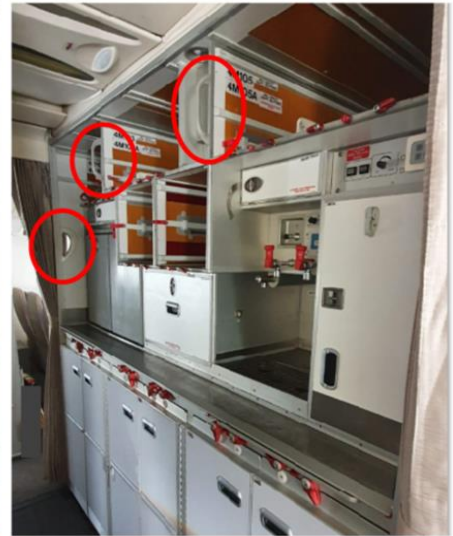
The dry galleys and work stations had no handholds. Most of lounge areas had handhold. The shower had a single handhold adjacent to the shower seat. Each of the nine cabin crew rest bed compartments, which were located in the aft section of the cabin, had a single seat belt which restrained the wearer at the waist. There was no handhold any of the bed compartments. The interior walls were made of fiber glass reinforced plastic.

Typical galley installation with location of handholds

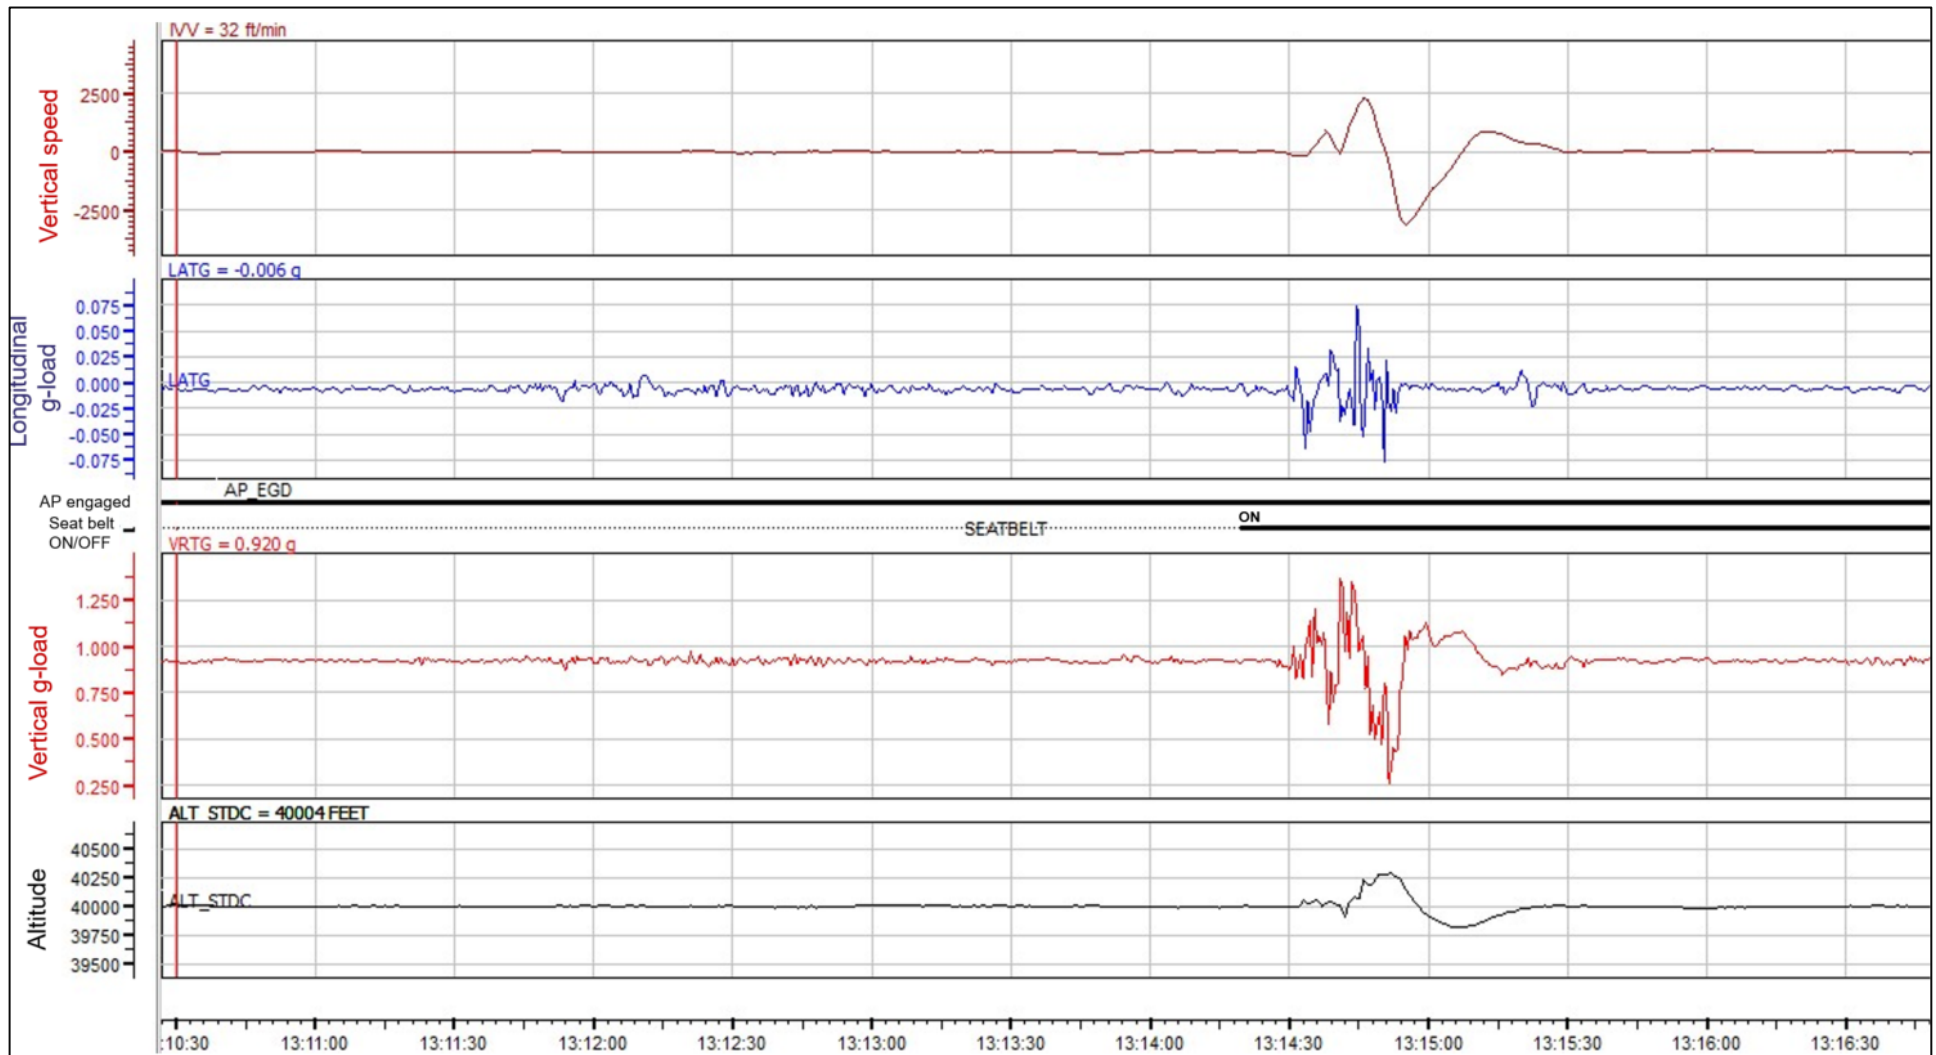
Appendix C – Seat belt sign status and G-loads [Source: Emirates]

Flight data was also retrieved from the Aircraft's QAR. In addition to the flight data, the QAR data was used to determine when the seat belt switch was moved to the ON position prior to the turbulence encounter, as noted in Appendix C to this Report.
