SERIOUS INCIDENT

Aircraft Type and Registration:	Antonov 26B, UR-CQD	
No & Type of Engines:	2 AI-24VT Turboprop engines	
Year of Manufacture:	1980 (Serial no: 10101)	
Date & Time (UTC):	16 July 2020 at 0219 hrs	
Location:	Birmingham Airport	
Type of Flight:	Commercial Air Transport (Cargo)	
Persons on Board:	Crew - 6	Passengers - 3
Injuries:	Crew - None	Passengers - None
Nature of Damage:	None	
Commander's Licence:	Airline Transport Pilot's Licence	
Commander's Age:	44 years	
Commander's Flying Experience:	2,512 hours (of which 624 were on type) Last 90 days - 71 hours Last 28 days - 44 hours	
Information Source:	Aircraft Accident Report Form submitted by the pilot and additional information from the operator and ATC

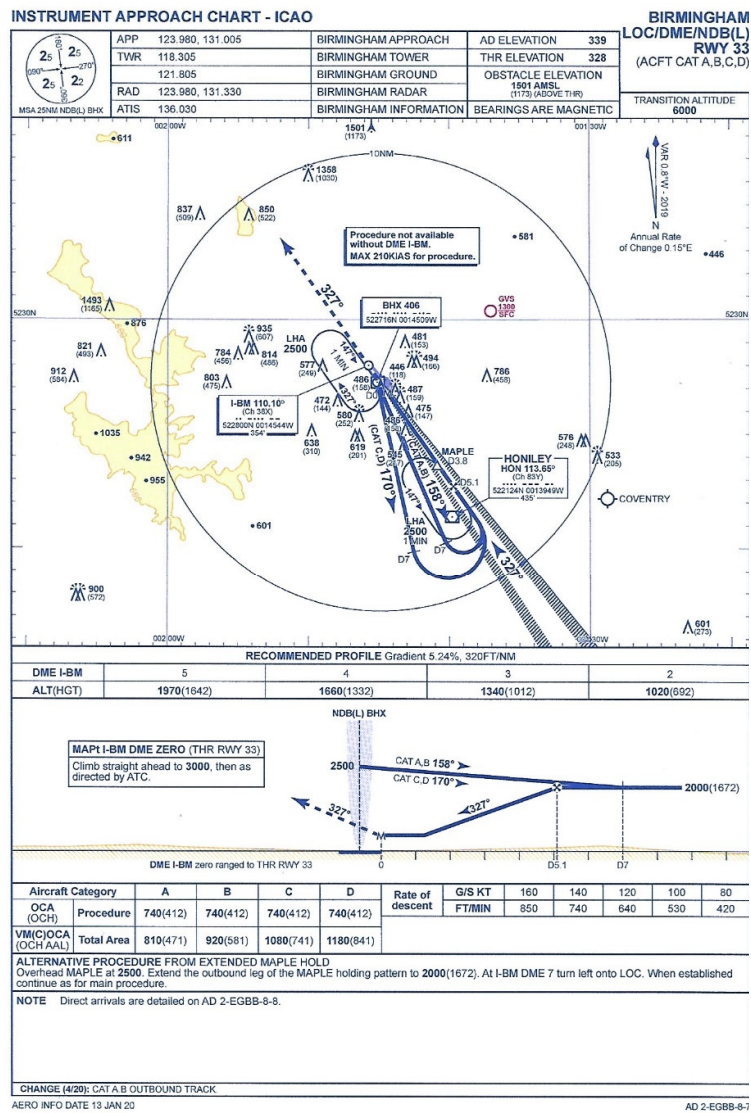
Figure 1
LOC/DME Approach Chart for Runway 33

At 5.5 nm from touchdown the aircraft was at 2,500 ft, 500 ft above the platform altitude for the approach. The aircraft continued to descend but then maintained an altitude of about 2,000 ft, remaining at this altitude beyond the start of the approach descent point, situated 5.1 nm from touchdown. At 3 nm from touchdown the aircraft was still maintaining 2,000 ft, 660 ft above the correct profile altitude. ATC instructed the pilots they were above the correct descent profile and the aircraft began a descent, but a few seconds later ATC instructed the pilots to go around and to climb straight ahead to 3,000 ft, in accordance with the published missed approach procedure. The aircraft then made a left turn before once again maintaining the runway heading. It was re-cleared to climb to 4,000 ft and given radar vectors for a further LOC/DME approach to Runway 33.

The aircraft was cleared to descend with the procedure but started its descent below the 2,000 ft platform altitude when 8 nm from touchdown, 2.9 nm before the correct procedural descent point. At 7 nm the aircraft was descending through 1,600 ft, 400 ft below the correct altitude. ATC passed altitude and range information to the pilots but did not warn the pilots that they were below the correct altitude. The aircraft continued its descent and at 6 nm was at 1,500 ft, 500 ft below the correct altitude. ATC then gave the pilots a terrain warning and instructed them to go around. There was no immediate reply so ATC repeated the instruction with the aircraft now passing 1,400 ft, 600 ft below the correct altitude. The pilots responded that they had the runway in sight and were “*approaching the glideslope*”. ATC informed them there was no glideslope and again instructed the aircraft to go around, which the pilots then acknowledged.
