**SERIOUS INCIDENT**

<b>Aircraft Type and Registration:</b>	Sikorsky S-92A, G-LAWX	
<b>No &amp; Type of Engines:</b>	2 General Electric CO CT7-8A turboshaft engines	
<b>Year of Manufacture:</b>	2004 (Serial no: 920007)	
<b>Date &amp; Time (UTC):</b>	14 October 2019 at 1742 hrs	
<b>Location:</b>	Near Shipston-on-Stour, Warwickshire	
<b>Type of Flight:</b>	Private	
<b>Persons on Board:</b>	Crew - 2	Passengers - 9
<b>Injuries:</b>	Crew - None	Passengers - None
<b>Nature of Damage:</b>	None reported	
<b>Commander's Licence:</b>	Airline Transport Pilot's Licence (Helicopters)	
<b>Commander's Age:</b>	54 years	
<b>Commander's Flying Experience:</b>	6,200 hours (441 of which were on type) Last 90 days - 25 hours (25 hours on type) Last 28 days - 15 hours (15 hours on type)	
<b>Information Source:</b>	AAIB Field Investigation

**Synopsis**

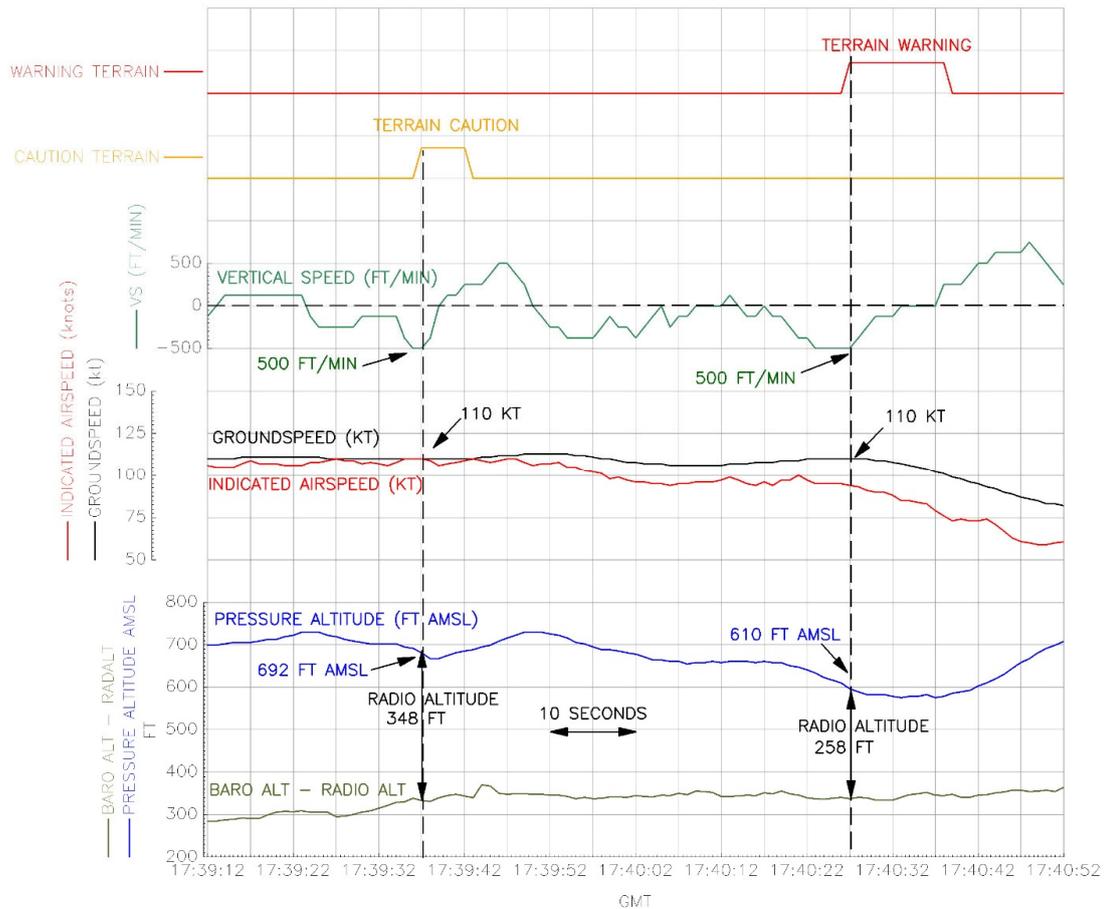
**Figure 10**

The helicopter then began descending again and fifty seconds after the first EGPWS alert, the CVR recorded an EGPWS, “WARNING TERRAIN, WARNING TERRAIN”. The helicopter had descended to an altitude of 610 ft (258 ft agl), at 110 kt groundspeed and with a rate of descent of 500 ft/min. The commander again acknowledged this with “ITS COPIED” and then “VISUAL”. The helicopter then climbed to an altitude of 720 ft (343 ft agl) over 30 seconds and reduced speed (Figure 10). There were no further EGPWS alerts for the remainder of the flight.

G-LAWX incident flight EGPWS parameters

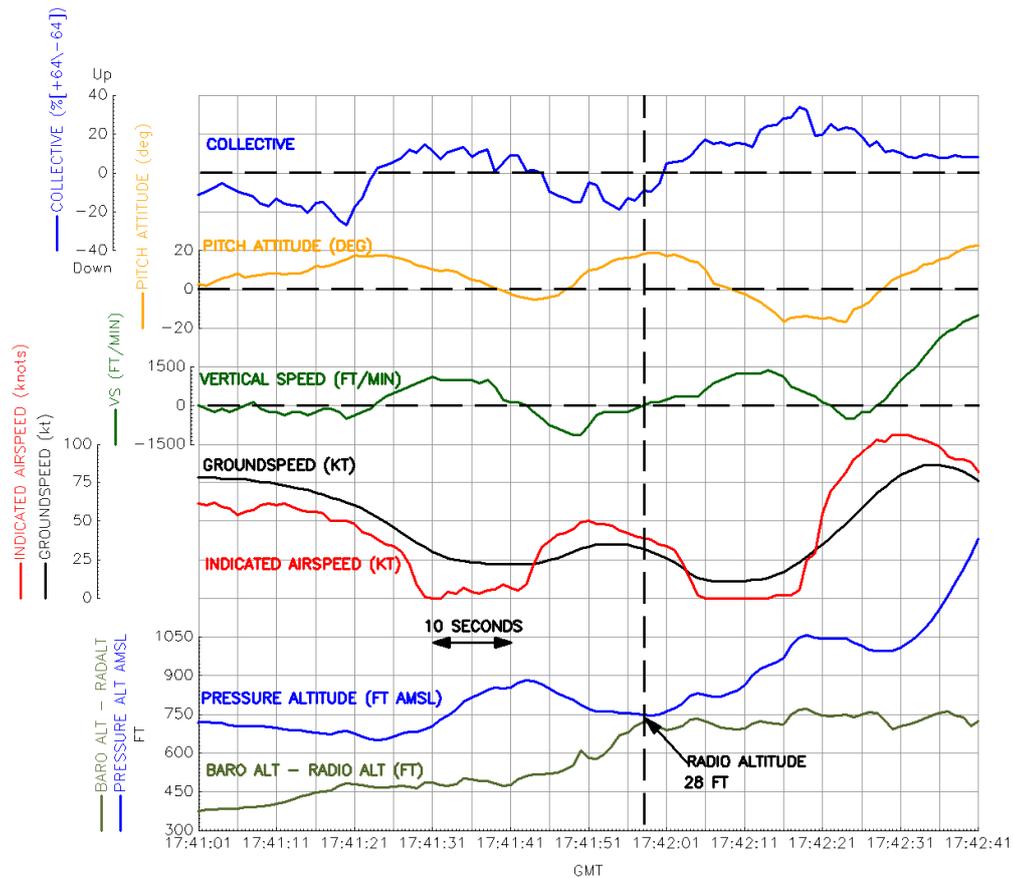
**Figure 12**

As the helicopter flew in a westerly direction, the pilot had right pedal applied throughout, yawing the helicopter gradually onto a more northerly heading. At 1741:21 hrs, the CVR recorded the co-pilot stating, “ONE MILE TO GO”. At 1741:25 hrs, the commander asked, “IS THAT THE HOUSE?” to which the co-pilot replied “LOOKS LIKE IT”. The helicopter had descended gradually to an altitude of 654 ft (186 ft agl) with a groundspeed of 49 kt and indicated airspeed of 35 kt. The helicopter continued to slow and yaw to the right but had started to climb because the commander had raised the pitch attitude to +18° (Figure 12).

G-LAWX FDR data for first approach

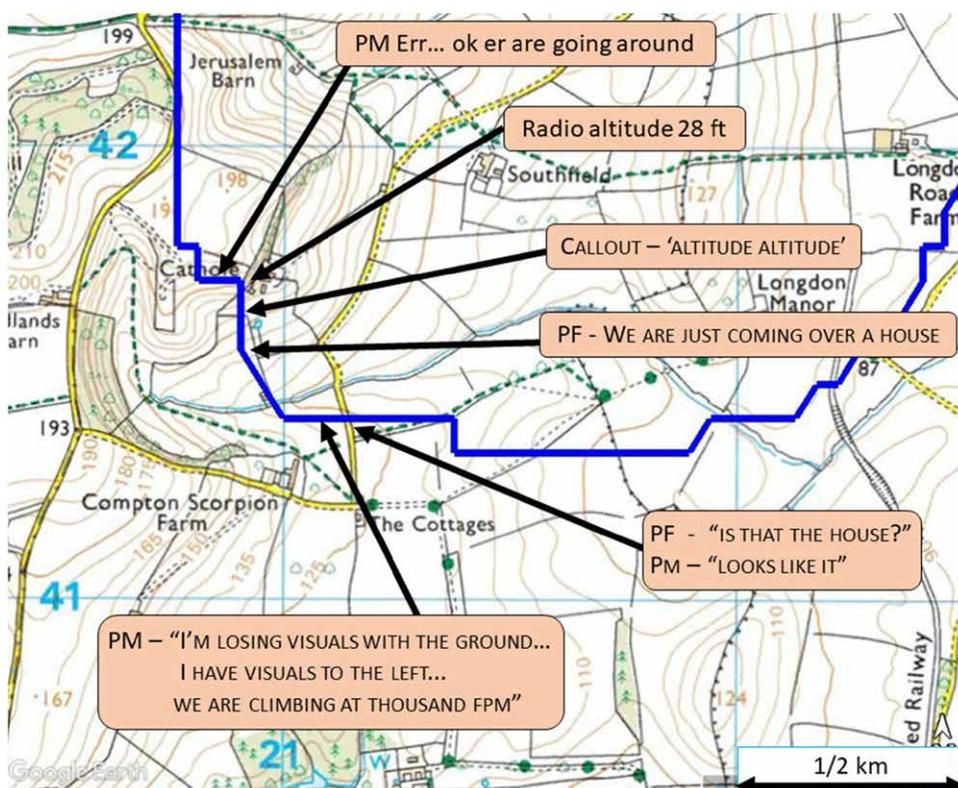
**Figure 13**

The co-pilot called, “I’M LOSING VISUALS WITH THE GROUND...I HAVE VISUALS TO THE LEFT... WE ARE CLIMBING AT THOUSAND FEET PER MINUTE” (Figure 13). The helicopter climbed to 883 ft and then descended, its rate of descent increasing to a maximum of 1,125 ft/min as the groundspeed increased to 35 kt.

At the time of the “ALTITUDE, ALTITUDE” alert, although the helicopter maintained a level altitude of just over 700 ft, the radio altitude decreased through 78 ft agl, having passed through the ‘decision height’ of 150 ft agl approximately a second earlier. The rate of descent reduced and three seconds later, with a groundspeed of 30 kt and a pitch attitude of +18°, the helicopter probably passed over trees beside a house and on the edge of the field when the radio altitude decreased to 28 ft at its closest point to the ground below.

G-LAWX flight path and FDR data (terrain heights are in m)

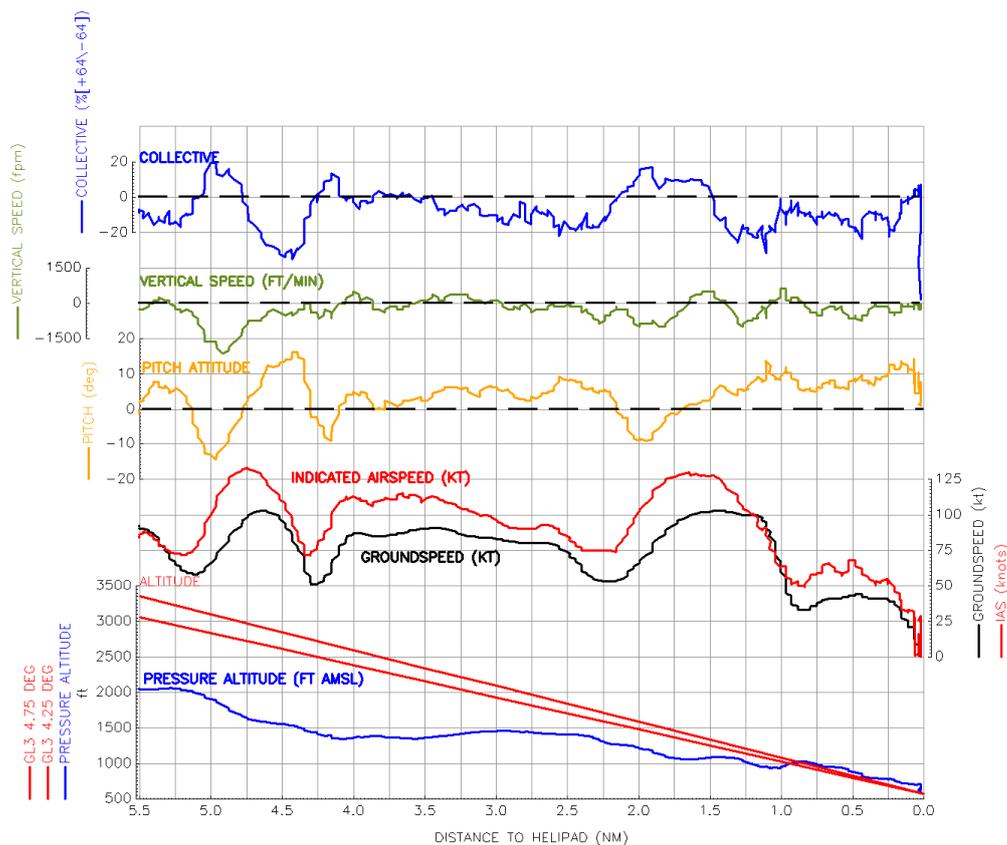
**Figure 14**

The helicopter flew towards the south-west for an approach using the GL3. It turned towards the LS passing the 5 nm point to the south at 1748 hrs and descended from an altitude of approximately 2,000 ft. During the next minute, the helicopter attitude pitched to  $-14^{\circ}$ , up to  $+16^{\circ}$  then back down to  $-10^{\circ}$  pitch before stabilising. This, along with modulation of the collective, caused fluctuations in airspeed from between 72 to 133 kt and a rate of descent up to 1,820 ft/min. During this time the co-pilot called out speed and height information and, when 4.25 nm from the LS, stated "so, ITS FIFTY KNOTS GROUND SPEED AT FIVE HUNDRED FT... I DON'T THINK WE ARE GOING TO GET IN ON THIS," to which the commander replied, "NO WE ARE NOT". The approach continued and the co-pilot continued to call out flight parameters. The flight path varied either side of the direct heading to the GL3 and consistently below the  $4.5^{\circ}$  glide path (Figure 14).

### G-LAWX flight data during GL3 approach

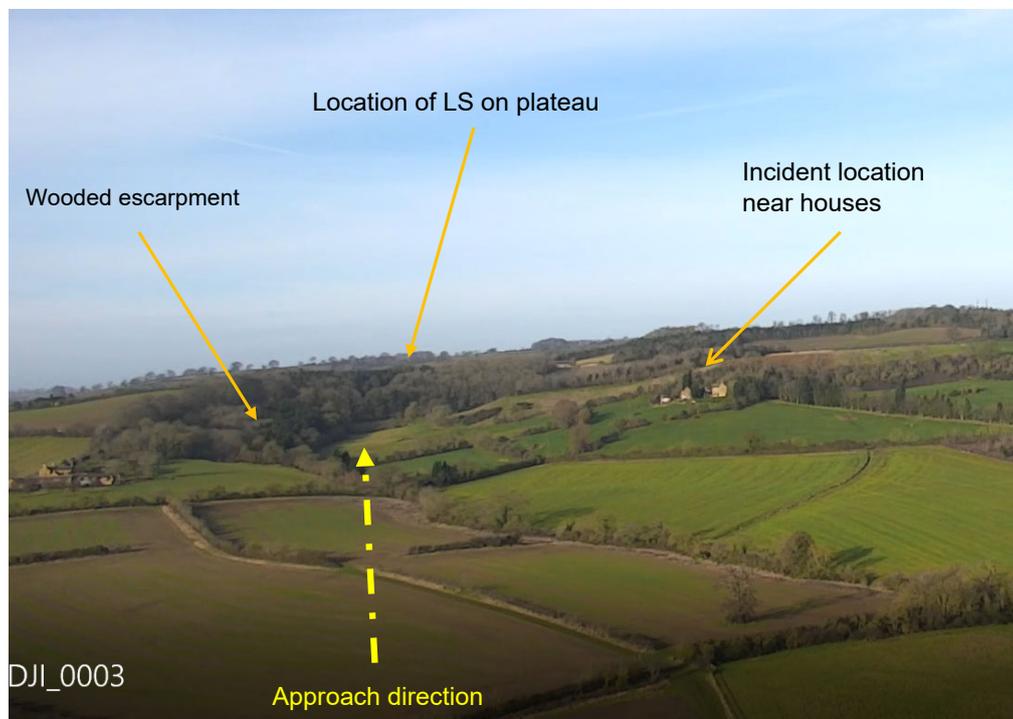
**Figure 15**

Approaching the LS from the east (Figure 15), there is a steep wooded escarpment below a plateau on which the landing site is situated. The helicopter came closest to the ground 1 km east of the LS and 600 ft to the north of the intended westerly approach path, near the top of a hill with an elevation of 650 ft amsl and a gradient of 15 - 20%.

View of the approach to the LS from the east.  
(This image does not show the conditions of reduced light and visibility present at the time of the serious incident.)
