Depressurisation and crew incapacitation Boeing 737-376SF, VH-XMO

19 km north of Narrandera Airport, New South Wales on 15 August 2018

ATSB Transport Safety Report

AO-2018-056

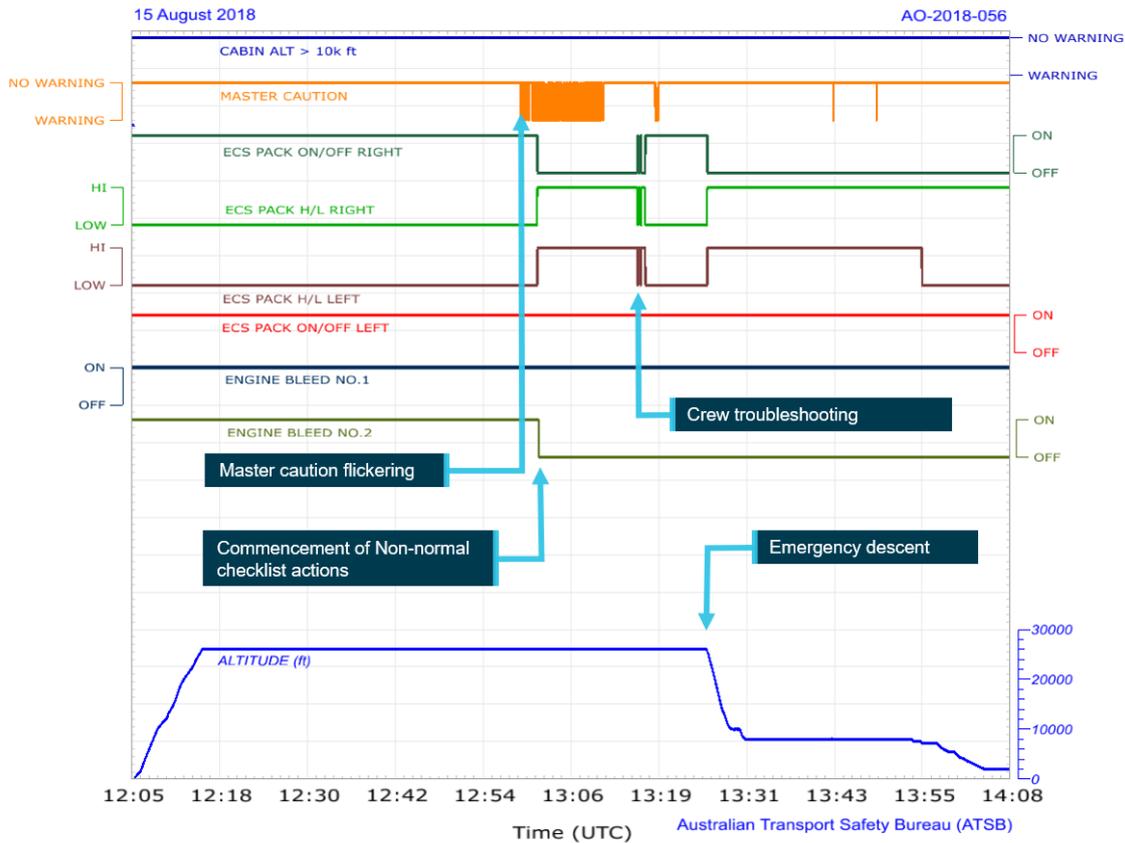
Figure 1: Recorded data from the occurrence flight.

The FDR data showed that, at 1315 UTC, the right air conditioning (ECS) pack was switched ON and OFF multiple times in a short period. The left pack had switched between high- and low-flow modes. The right pack had also switched between high- and low-flow modes. These events correlated with the troubleshooting period conducted by the flight crew and the engineer at Sydney.

The FDR data recorded that, at 1325 UTC, the right air conditioning pack was turned OFF and the signals for the left and right packs had switched to high flow. The aircraft altitude then reduced rapidly signalling the commencement of the emergency descent.

Displayed is the master caution warning status, air conditioning system status and crew troubleshooting actions during the conduct of the flight through to the emergency descent and landing.
Source: ATSB

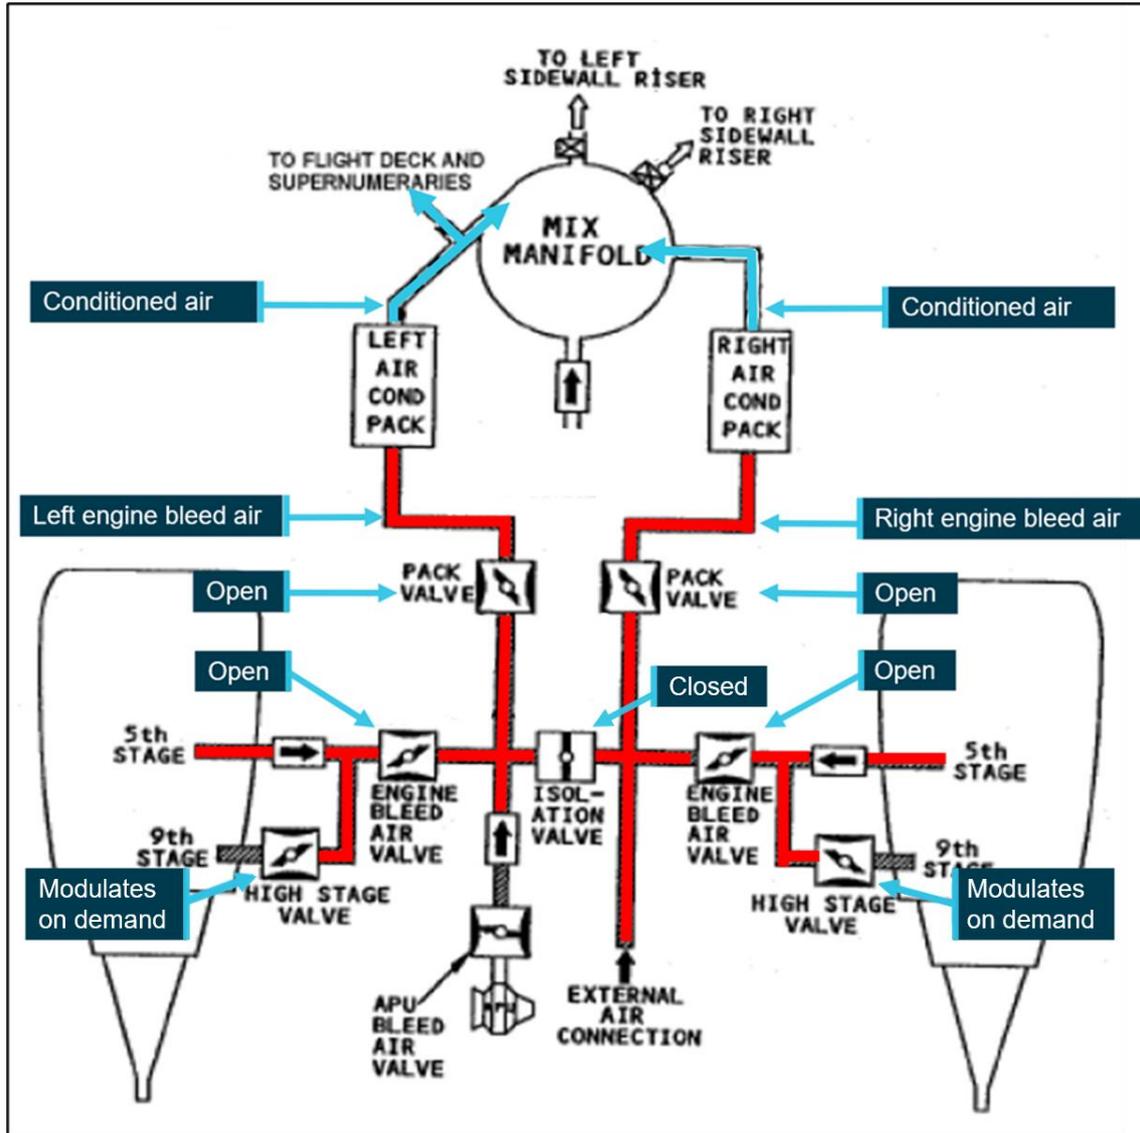
Figure 2: Air conditioning schematic for the Boeing 737-300 series aircraft showing the configuration of the system during normal operation

The left air conditioning pack is supplied by stage-five bleed air from the left engine and the right air conditioning pack is supplied by stage-five bleed air from the right engine. The left and right engine stage-nine valves modulate open if stage-five bleed air is insufficient for system requirements.

It was also identified that the isolation valve between the left and right systems was not completely closing, resulting in leakage and the right bleed air duct to remain partially pressurised (Figure 2).

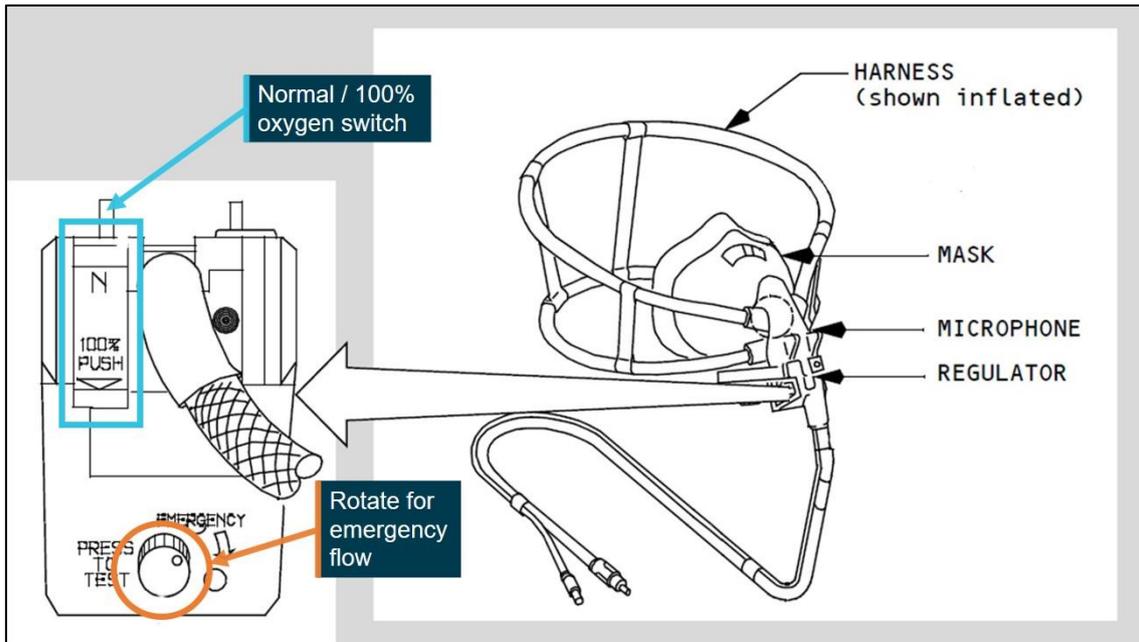
Figure 3: Oxygen mask and regulator fitted to the Boeing 737-300 series aircraft

A push button switch activates the pilot oxygen system for normal use. A rotary dial is used to enable the emergency flow mode.
 Source: Express Freighters Australia, annotated by the ATSB.

While wearing an oxygen mask during the descent, the captain selected the emergency purge setting on the oxygen mask resulting in the inhalation of pressurised 100 per cent oxygen. The flight crew operations manual stated that the emergency position of the oxygen regulator was to

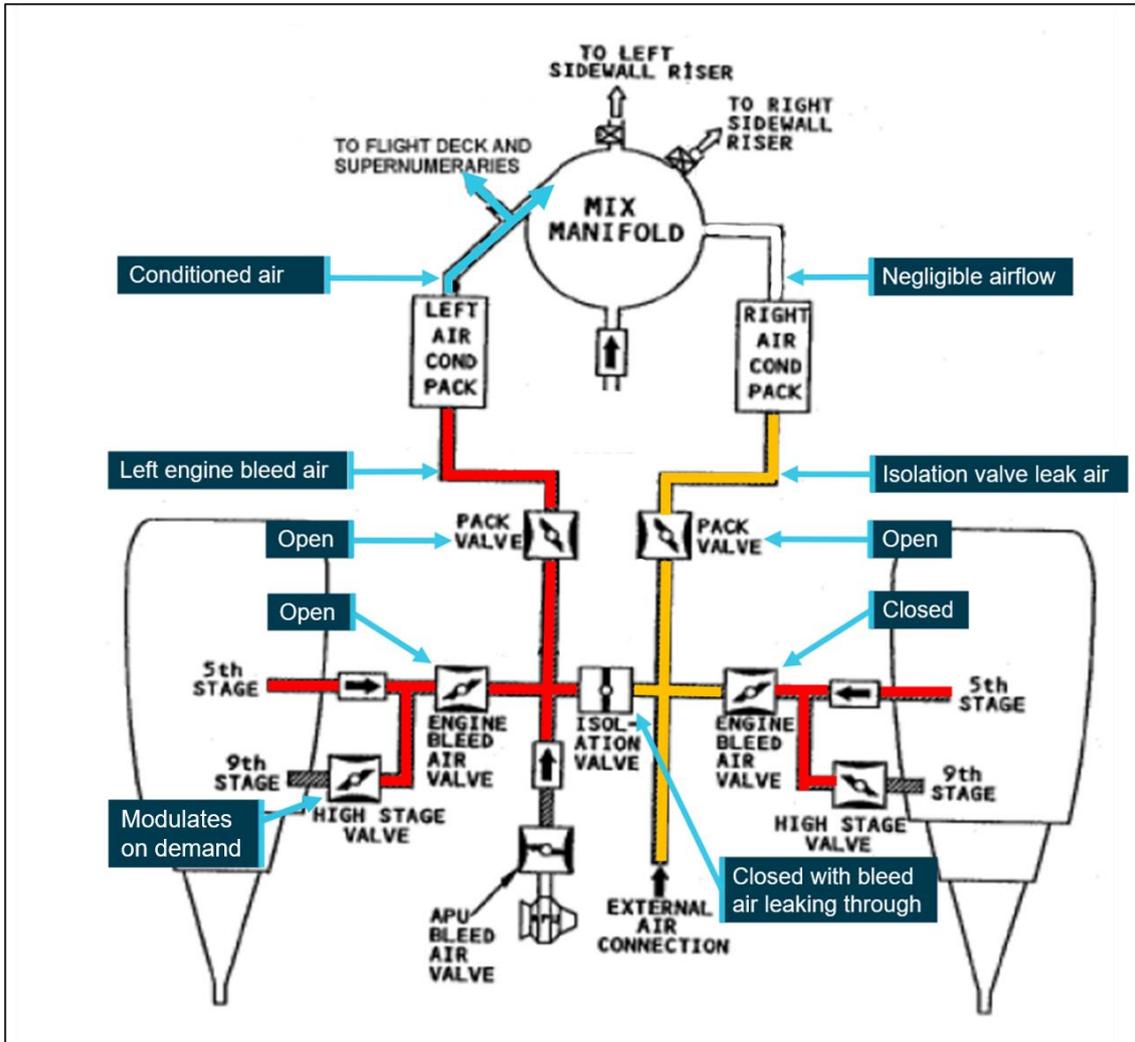
Figure 4: Air conditioning schematic for the Boeing 737-300 series aircraft showing the final configuration of the system post troubleshooting by the flight crew prior to the descent.

The residual pressure after completion of the non-normal checklist operations led to the flight crew conducting further troubleshooting activities outside of that checklist in consultation with the Sydney Line Maintenance engineer. This resulted in the right air conditioning pack switch being selected to AUTO from OFF, which then transitioned the left (operating) pack from high flow to low flow, leading to a significant reduction of air available to pressurise the aircraft (Figure 4).

As the right air conditioning system remained partially pressurised, the captain's decision to conduct further troubleshooting outside the non-normal checklist instructions was appropriate and completed in conjunction with assistance from Sydney Line Maintenance. Despite the attempts to extinguish the overheat alert by isolating the right bleed ducting, the effects of those actions unknowingly contributed toward a gradual depressurisation of the aircraft.

The right air conditioning system had been selected by the flight crew to AUTO mode which commanded the left air conditioning package from high flow to low flow. This reduced the conditioned air (highlighted blue) that was directed into the flight deck. The right engine bleed valve had been selected closed by the flight crew as part of their troubleshooting actions. The isolation valve had also been selected closed by the flight crew. A fault with the isolation valve allowed the right duct to become partially pressurised (highlighted yellow). Source: Express Freighters Australia, modified by the ATSB.
