SERIOUS INCIDENT

Aircraft Type and Registration:	Boeing 787-900, VH-ZND	
No & Type of Engines:	2 General Electric 1B P2G01/02 turbofan engines	
Year of Manufacture:	2018 (Serial no: 63390)	
Date & Time (UTC):	9 February 2020 at 1300 hrs	
Location:	London Heathrow Airport	
Type of Flight:	Commercial Air Transport (Passenger)	
Persons on Board:	Crew - 13	Passengers - 224
Injuries:	Crew - None	Passengers - None
Nature of Damage:	Tail strike sensor damaged	
Commander's Licence:	Airline Transport Pilot's Licence	
Commander's Age:	52 years	
Commander's Flying Experience:	13,538 hours (of which 562 were on type) Last 90 days - 60 hours Last 28 days - 17 hours	
Information Source:	Aircraft Accident Report Form submitted by the pilot and further enquiries by the AAIB

Synopsis

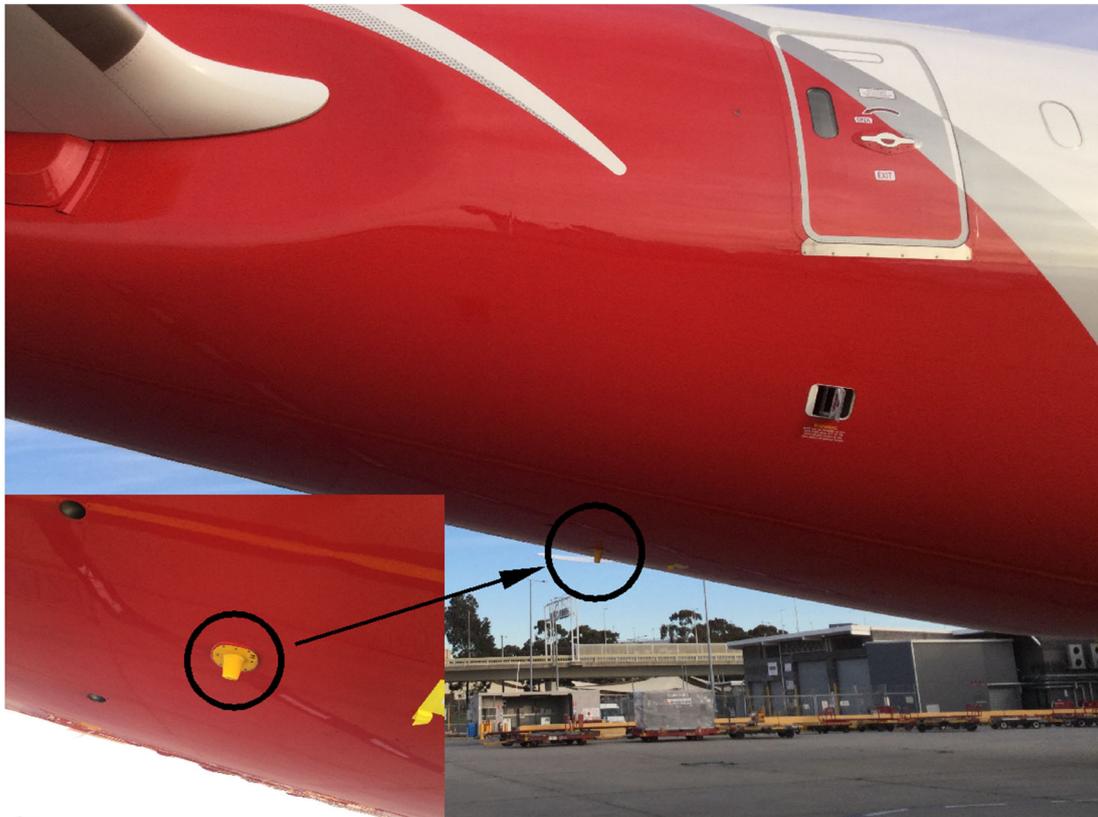
Figure 1
Tail strike sensor

Tail strike detection is provided by a 2" blade sensor fitted to the rear lower fuselage of the aircraft (Figure 1). If the electrical circuit within the sensor is compromised due to contact with the ground, a TAIL STRIKE caution message is displayed on EICAS after five seconds. This is accompanied by an aural warning and master caution light being presented in the cockpit.

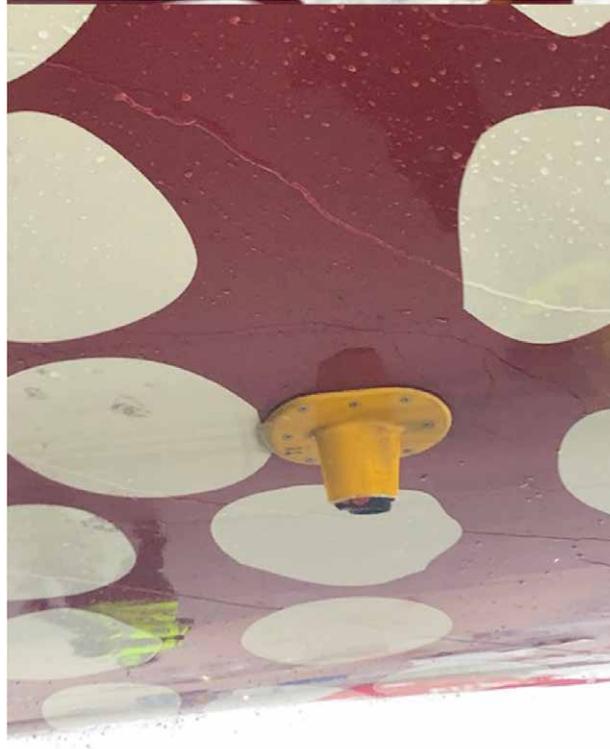
Figure 2

After landing, it was identified that the tip of the tail strike detection sensor (Figure 2) had been abraded due to contact with the runway. No further damage was found.

Damage to aircraft tail strike sensor

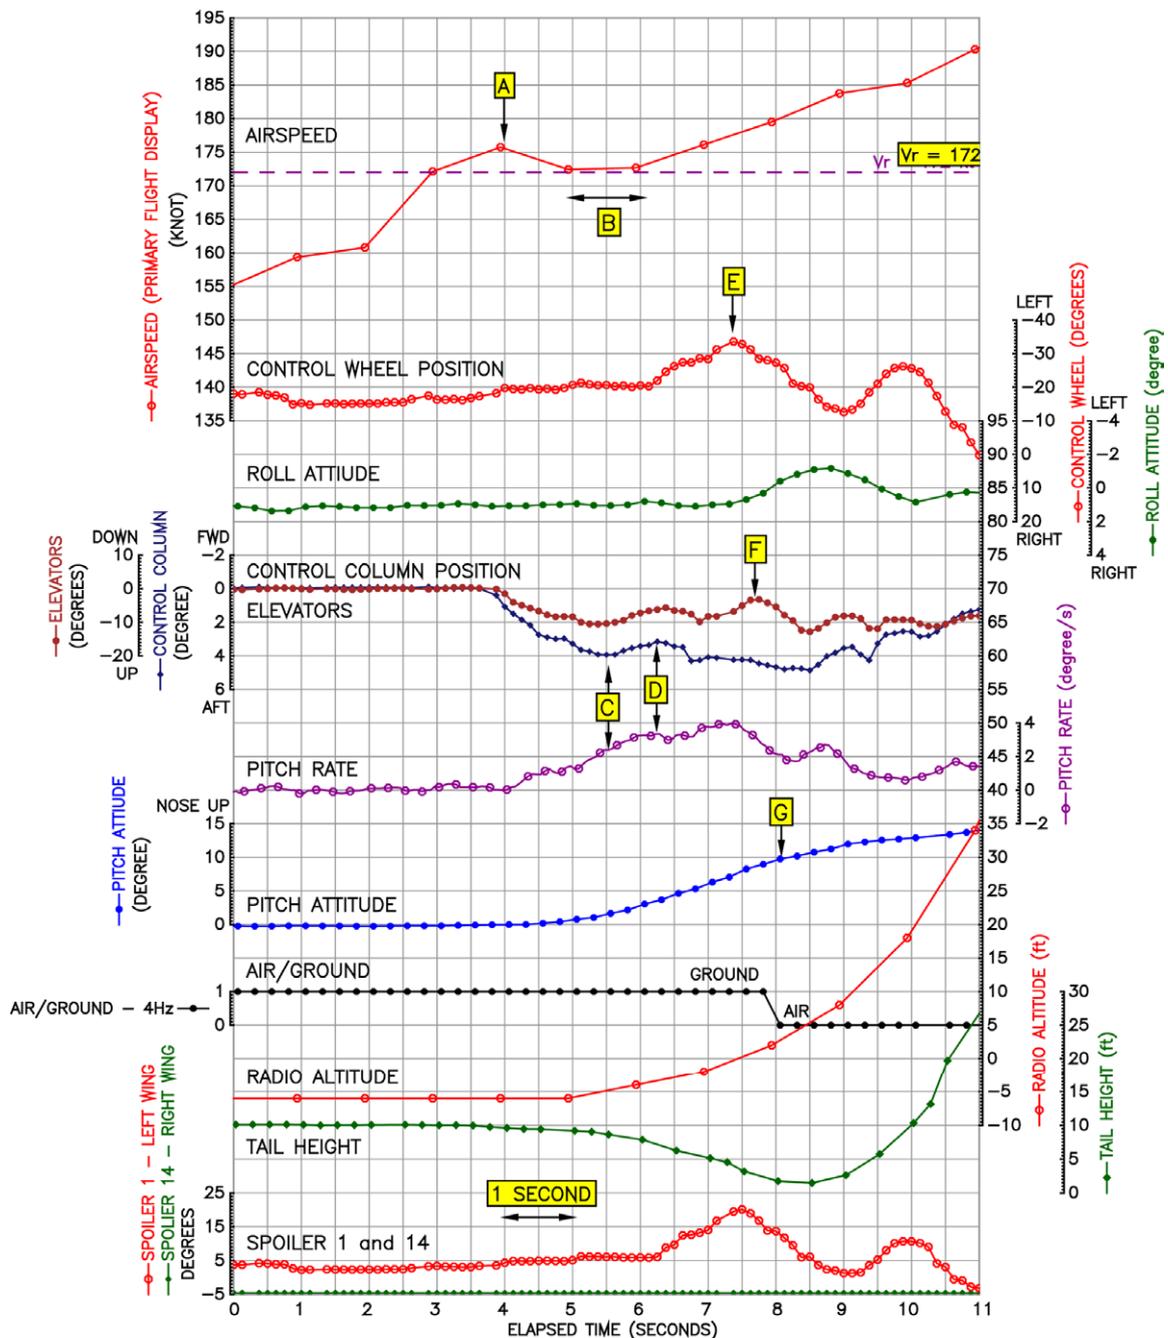
Figure 3
Salient flight data parameters

The data showed that during the takeoff run, there were airspeed fluctuations consistent with the gusty wind conditions. Upon reaching an airspeed of 160 KIAS, the airspeed rapidly increased to 175 KIAS, at which point the PF initiated the rotate (Figure 3 - Point A).

As the aircraft pitched up, the airspeed reduced to 172 KIAS, where it briefly stagnated (Figure 3 - Point B). The PF had progressively moved the control column aft to 4° (Figure 3 - Point C) at which point the pitch rate was just over 2°/s; the maximum aft movement of the control column was 9.8°. The control column was then moved slightly forward (Figure 4 - Point D) to 3°, but the pitch rate increased to 3.2°/s. The airspeed then started to increase, which coincided with the PF pulling back on the control column whilst also moving the control wheel from 20° counter-clockwise (CC) to 33° CC (Figure 3 - Point E). This caused the left spoilers to further deploy from 5° to 20°.

As the pitch attitude increased through 6.3° nose-up, the pitch rate was nearly 4°/s, and the calculated tail height above the runway was 4.5 ft. The aircraft's tail strike prevention system then started to move the elevators (Figure 3 - Point F), which reduced the pitch rate to just over 2°/s. The pitch attitude at takeoff was about 9.7° (Figure 3 - Point G) and the tail height indicated just less than 2 ft.

'The near tail contact was the result of a combination of factors including: high pitch rate close to lift-off, airspeed stagnation, and control wheel usage deploying spoilers on the left wing. The high pitch rate allowed pitch attitude to increase towards the tail contact attitude prior to airspeed reaching lift-off speed. The deployed spoilers on the left wing decreased lift and necessitated a higher pitch attitude for lift-off.'

The aircraft was being operated within its weight, CG and wind limitations for the takeoff. The weather conditions created strong gusting winds which, just before the point of rotation, rapidly increased the aircraft's airspeed from 160 KIAS to 175 KIAS. The initial pitch rate of 2°/s increased to 3.2°/s and then 4°/s, when the tail strike prevention system activated and reduced the pitch rate to 2°/s. The lateral control wheel inputs caused the left spoilers to deploy from 5° to 20°, decreasing the lift. The combined effect was that during rotation, an increase in aircraft pitch angle with the main landing gear wheels still on the runway, led to the tail contact angle of 9.7° being reached and the crew receiving an EICAS TAIL STRIKE message.

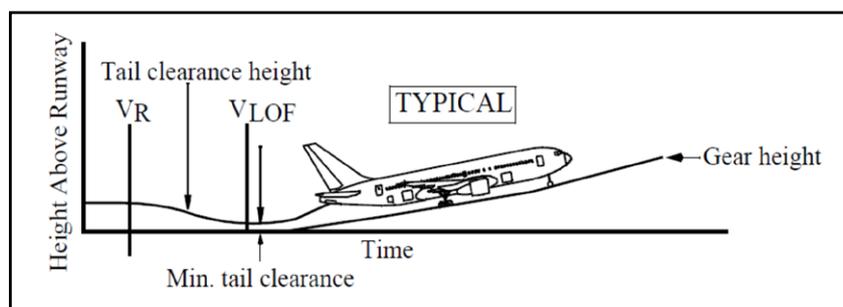
The pitch attitude for tail contact is 9.7° with wheels on the runway and landing gear struts extended. A normal lift off pitch angle is between 6° and 7.5° giving a minimum tail clearance height of 29 inches (74 cm). The normal tail clearance profile is shown at Figure 5 below.
