AIR TRANSPORTATION SAFETY INVESTIGATION REPORT A20A0001

RUNWAY OVERRUN

WestJet Airlines Ltd.
Boeing 737-8CT, C-FUJR
Halifax/Stanfield International Airport, Nova Scotia
05 January 2020

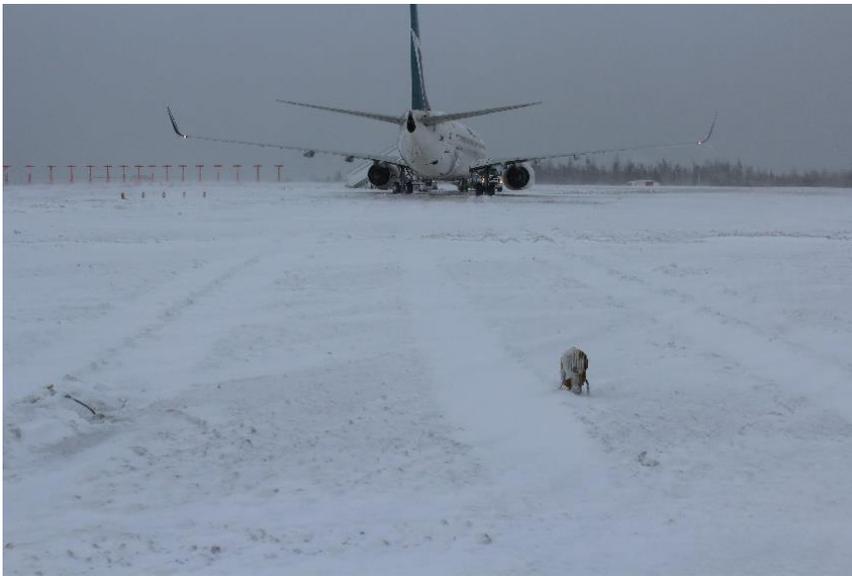
Figure 2. Occurrence aircraft (Source: TSB)

At 1207:45, the aircraft continued beyond the end of the runway at 26 knots. It came to a complete stop approximately 300 feet (91 m) past the end of the runway, on the snow-covered grass, and within the runway end safety area (RESA)(Figure 2).

There was no damage to the aircraft. As a precaution, WestJet maintenance replaced the tires and brakes before returning the aircraft to service.

Two runway end lights were damaged when they were struck by the main landing gear.

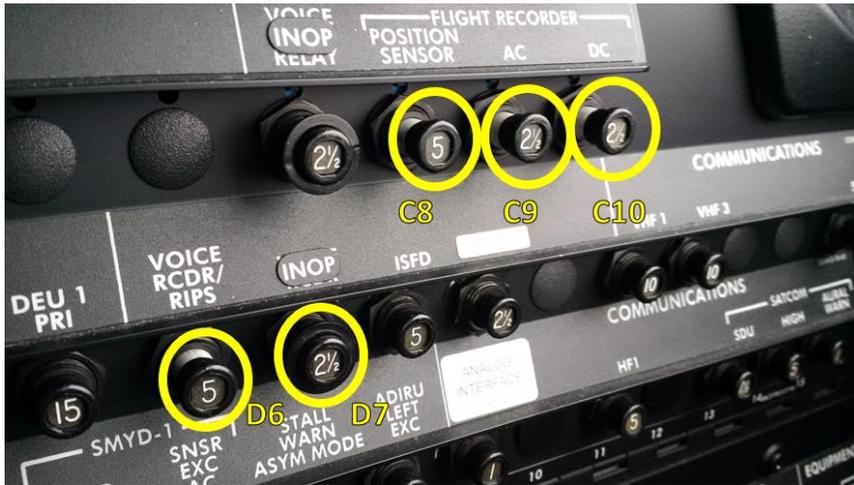
Figure 3. Occurrence aircraft panel with correct cockpit voice recorder and flight data recorder circuit breakers disabled (Source: TSB)

The maintenance controller typed an ACARS message to the occurrence aircraft, advising the flight crew to pull the FDR and CVR circuit breakers, and mistyped the locations as P18-2 C7 and C8 (rather than D6 and D7), and P18-2 C8, C9, and C10.

The PF followed the instructions from the maintenance controller, and disabled the circuit breakers as indicated in the ACARS message. The flight crew did not reference the COM.
