SERIOUS INCIDENT

Aircraft Type and Registration:	Bombardier BD700-1A10, CS-GLD	
No & Type of Engines:	2 BR700-710A2-20 Turbofan engines	
Year of Manufacture:	2014 (Serial no: 9538)	
Date & Time (UTC):	17 September 2020 at 1145 hrs	
Location:	Biggin Hill Airport, Kent	
Type of Flight:	Commercial Air Transport (Non-Revenue)	
Persons on Board:	Crew - 4	Passengers - None
Injuries:	Crew - None	Passengers - N/A
Nature of Damage:	Abrasion of wing tip, flap, aileron, and canoe fairings	
Commander's Licence:	Airline Transport Pilot's Licence	
Commander's Age:	50 years	
Commander's Flying Experience:	7,334 hours (of which 2,422 were on type) Last 90 days - 55 hours Last 28 days - 25 hours	
Information Source:	Aircraft Accident Report Form submitted by the pilot

Synopsis

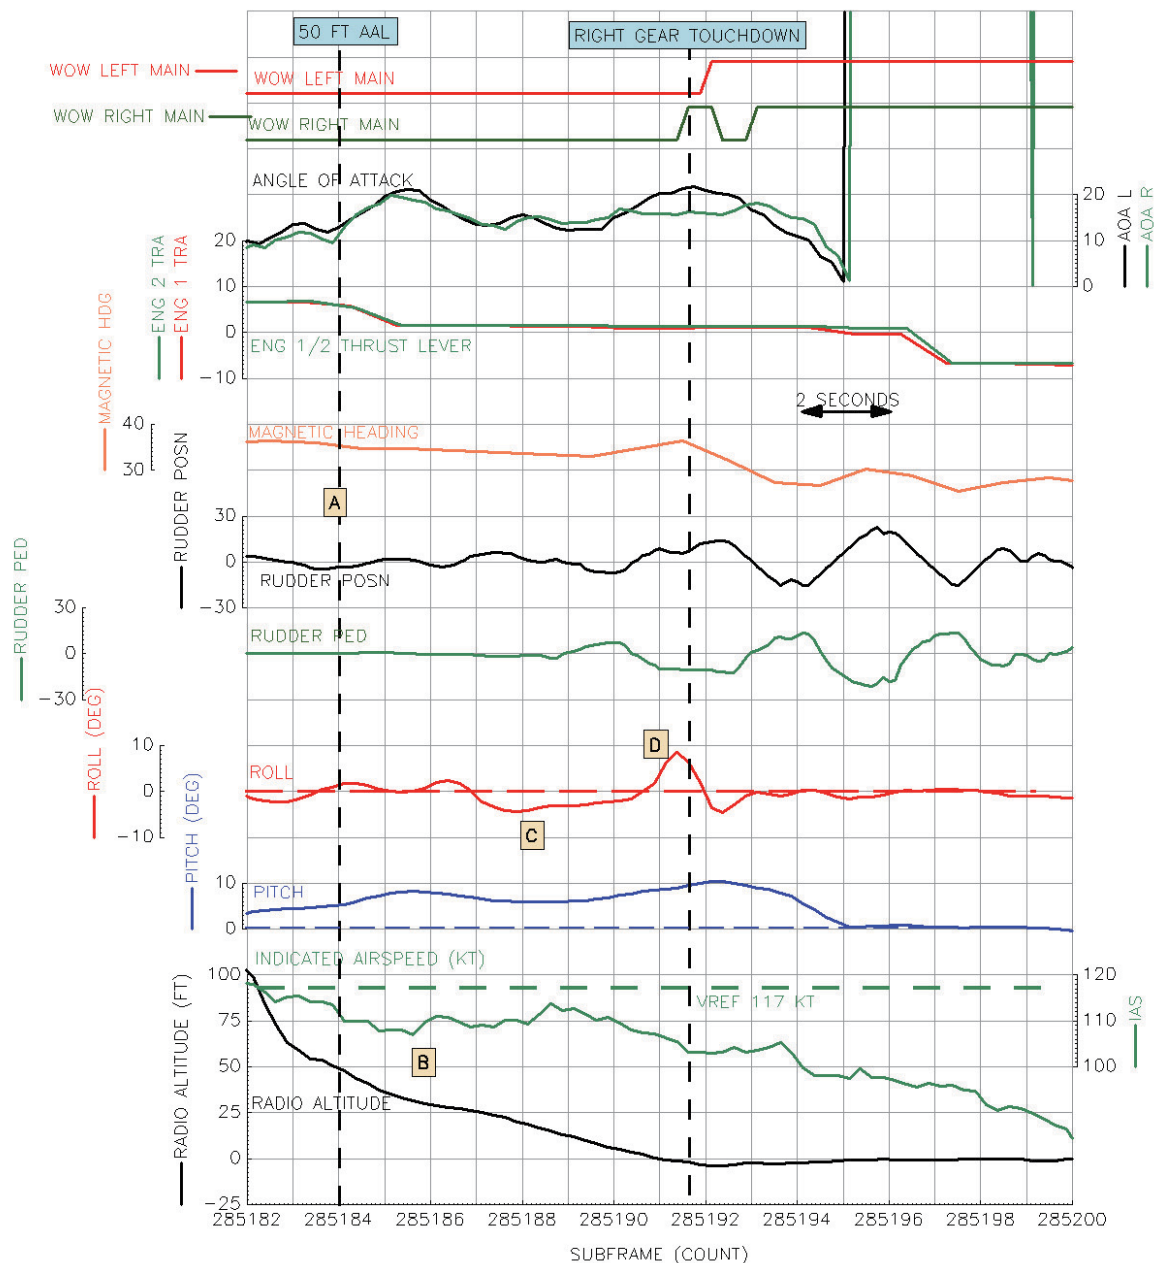
Figure 1
CS-GLD FDR parameters

At 1145:01 hrs, the aircraft reached 50 ft radio altitude (RA) (Figure 1, point A) with an indicated airspeed of 114 kt and a magnetic heading of 035.4° . The onboard derived wind was a 16.8 kt crosswind from the right.

Two seconds later the aircraft passed through a RA of 30 ft (point B) at an airspeed of 109 kt. The control column was moved progressively aft, with a corresponding increase in aircraft attitude to 9.1° nose up. The aircraft started rolling left (point C) reaching a maximum bank angle of 4.4° left wing down at a RA of 20 ft. As the aircraft started rolling left, the control wheel was moved to a 34.7° right roll command, reducing to 24.2° 1.3 seconds later, along with right rudder pedal producing a rudder deflection of 7.4° to the right. Within this time frame, the aircraft started rolling back to wings level, and the right multifunction spoiler had started to deploy, reaching 5° deflection, where it remained for 1.5 seconds before returning to the retracted position. A data plot of the relevant parameters is shown at Figure 1.

Half a second before touchdown (point D), the roll rate increased to a peak of $14.3^\circ/s$ right wing down, to which a control wheel input was made to 62.1° left wing down. The right main landing gear touched down first with the aircraft at its peak roll attitude of 8.5° to the right and a pitch attitude of 9.1° nose-up. The aircraft then rolled to the left as the pitch continued to increase to a peak of 10.5° nose-up a second later.

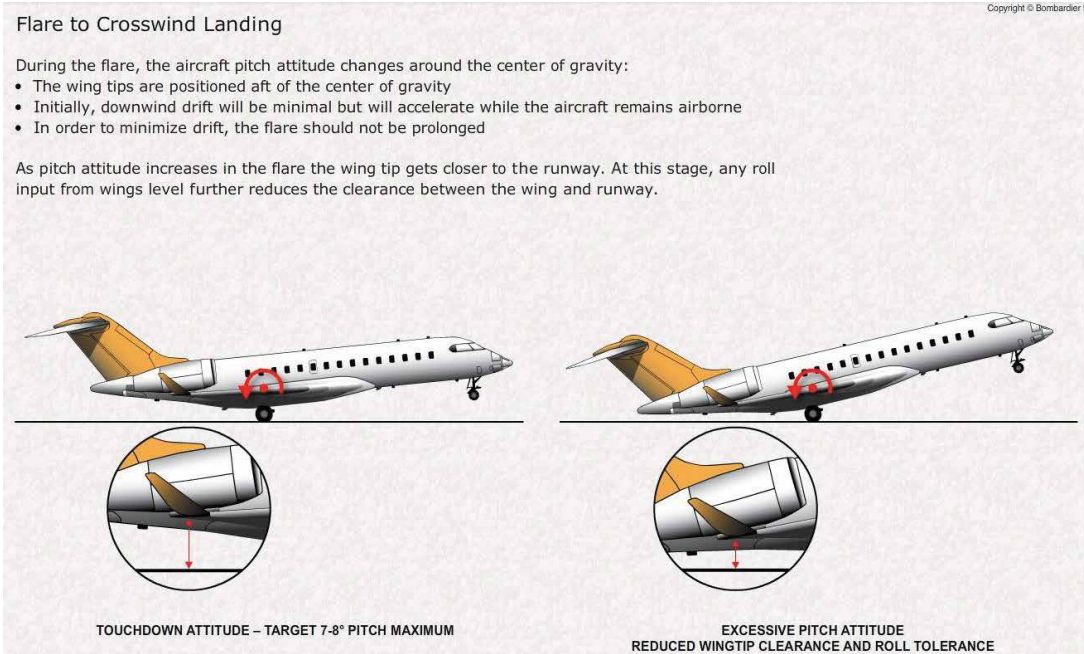
Figure 3

A diagram provided by the manufacturer illustrating the relationship between nose-up pitch and wingtip clearance is shown at Figure 3, along with the angle of bank at which the tip will contact the runway (with the wing on the ground but not producing lift (JIG), and in flight).

The aircraft was yawed to the right during the final stages of the approach but, apart from a small left rudder input, it did not appear to have been yawed left to align with the runway. During the flare, a roll angle of 8.5° developed to the right, which was greater than the 3° limit given by the manufacturer for landing in a crosswind. With a nose-up pitch attitude of 9° , the roll angle required for a wingtip to contact the runway is 7.4° with the wing unloaded and 10.1° in flight.

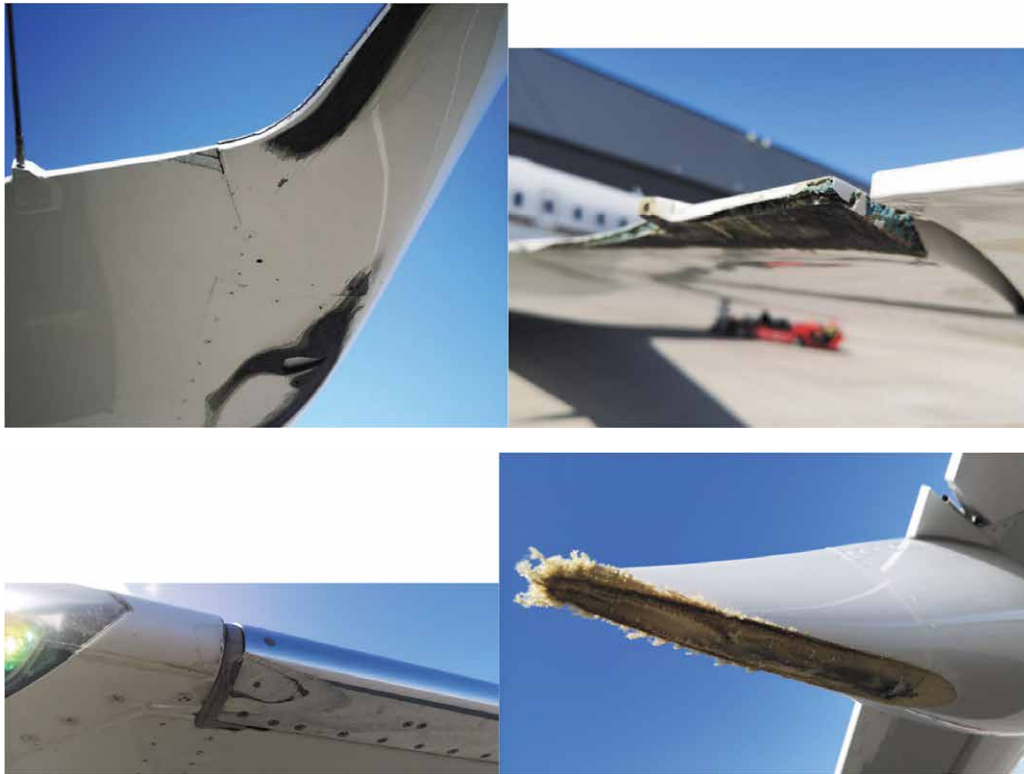
Figure 6

When the right wingtip contacted the runway, four areas of the structure were damaged as they briefly scraped along the runway. They were the underside of the winglet, the aileron, wing leading edge and both outer canoe fairings. The damage is shown below at Figure 6.

The damaged components which contacted the runway
