DUTCH
SAFETY BOARD

Near miss between two aircraft during taxi

The Hague, September 2021

Identification number:	2019017
Classification:	Serious incident
Date, time of occurrence:	3 February 2019, around 19.37 hours ¹
Location of occurrence:	Amsterdam Airport Schiphol, taxiway Z near A26
Registration 1:	G-EZWY
Call sign:	Easy 36AE
Aircraft type:	Airbus 320-200
Aircraft category:	Commercial - fixed wing
Type of flight:	Commercial Air Transport (Passenger)
Phase of operation:	Taxi
Damage to aircraft:	None
Flight crew:	Two
Injuries:	None
Registration 2:	SE-DOY
Call sign:	Scandinavian 87L
Aircraft type:	Airbus 320neo
Aircraft category:	Commercial – fixed wing
Type of flight:	Commercial Air Transport (Passenger)
Phase of operation:	Taxi
Damage to aircraft:	None
Flight crew:	Two
Injuries:	None
Other damage:	None
Light conditions:	Darkness

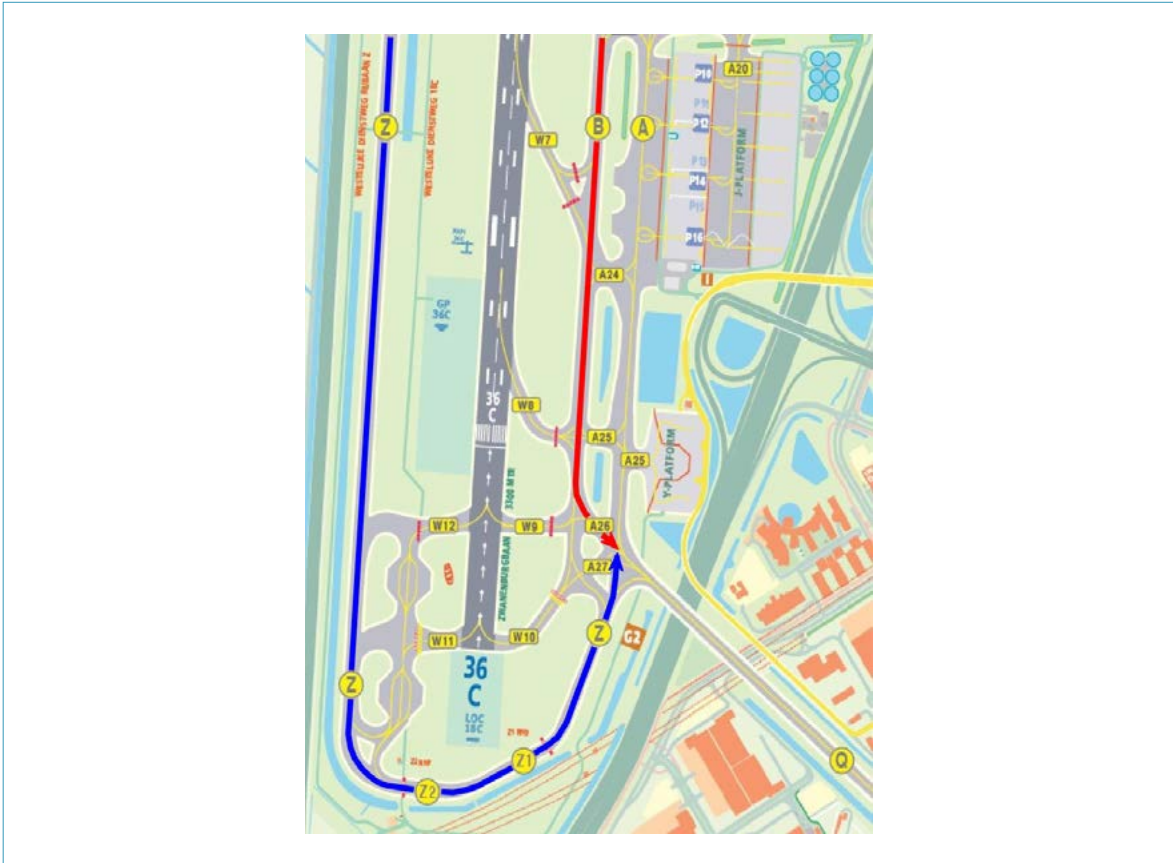
At Schiphol both runways 18C and 18R were in use for landing. G-EZWY, an Airbus 320-200 (blue in Figure 1), had landed on runway 18R and taxied via taxiway Z northbound to its stand at H1. SE-DOY, an Airbus 320neo (red in Figure 1), had landed on runway 18C and taxied southbound via taxiway B to taxiway Q for gate C10.

Figure 1: Taxi route of both aircraft: blue G-EZWY, red SE-DOY. (Source: Amsterdam Airport Schiphol)

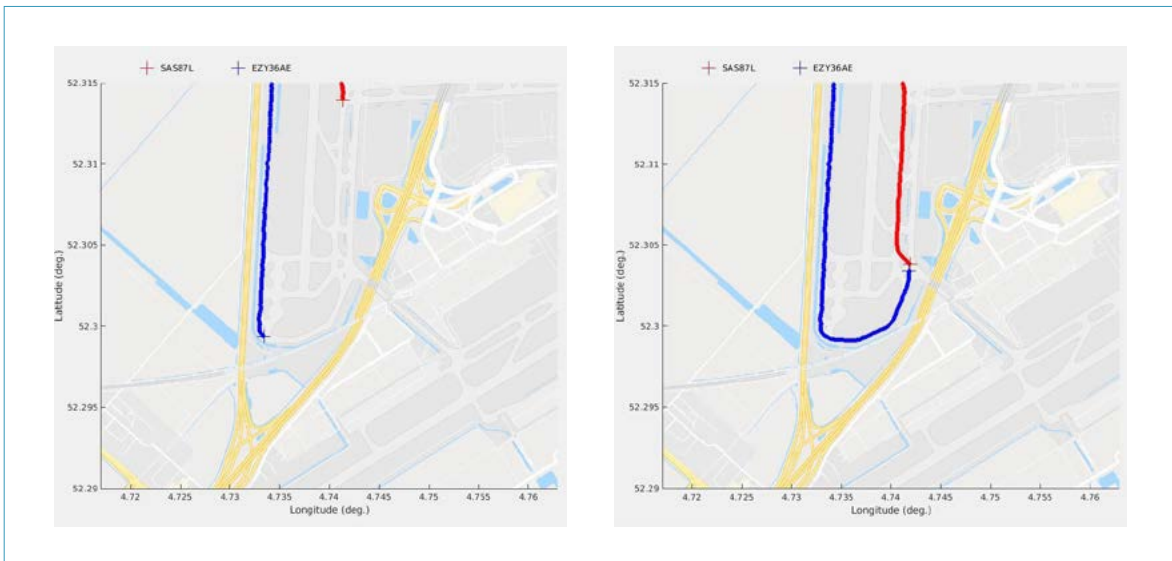
At the time of the instruction to give way to G-EZWY, SE-DOY was on taxiway B near A22 and G-EZWY was taxiing on taxiway Z2 (see Figure 5a). The instruction was given while the two aircraft were around 1,700 metres apart and some 90 seconds before they would meet. Because of the distance and the circumstances (darkness and ambient lighting) the crew of SE-DOY was unable to see the other aircraft at that moment. The crew had no technical aids at their disposal to detect other ground traffic, because the A320 is not equipped with such equipment.

At 19:37:30 hours the crew of G-EZWY informed SE-DOY that a near-collision had just happened (see Figure 5b). According to radar data, the shortest distance between the two aircraft's antennas that emit the radar signals was around 42 metres. However, in view of the inaccuracy of the radar system, the distance between these antennas and the wingtips and the location of the antennas on the fuselage, this distance does not represent the actual shortest distance between both aircraft. Referring to the statements from G-EZWY's crew the distance between their cockpit and SE-DOY's right wingtip was estimated between 5 and 10 metres. Although it was not possible to determine the exact distance between the two aircraft, it is clear that it was close and that a collision between the two aircraft was prevented only because the crew of G-EZWY made an effective emergency stop.

Figures 5a and 5b: positions of the aircraft at 19.36:01 and 19.37:30 hours respectively (Blue G-EZWY, red SE-DOY). (Source ATC the Netherlands)

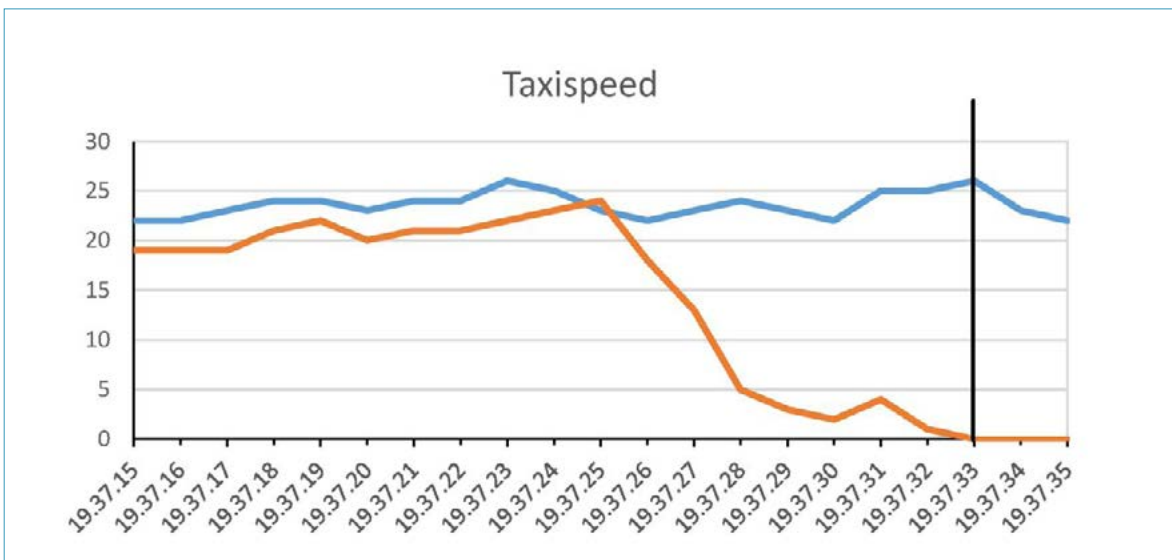
The taxi speed of both aircraft during the last 20 seconds before the incident was analysed using radar data. The taxi speed of both aircraft initially varied between 20-25 knots. This is considered to be a normal taxi speed. The taxi speed of SE-DOY remained unchanged throughout the period, indicating that the crew did not realise that they approached the location where they had to give way to the other aircraft. Around eight seconds before the occurrence, the taxi speed of G-EZWY decreased. This confirms the statement of the captain that he slowed down when he saw SE-DOY not reducing speed. G-EZWY came to a standstill around 19.37:33 hours³ (see Figure 6).

Figure 6: Graph of the taxi speeds during 20 seconds. The black line depicts the moment of the near collision. (Source: ATC the Netherlands)
