**KOMITE NASIONAL KESELAMATAN TRANSPORTASI
REPUBLIC OF INDONESIA**

Aircraft Serious Incident Investigation Report

PT. Garuda Indonesia

ATR 72-212A; PK-GAF

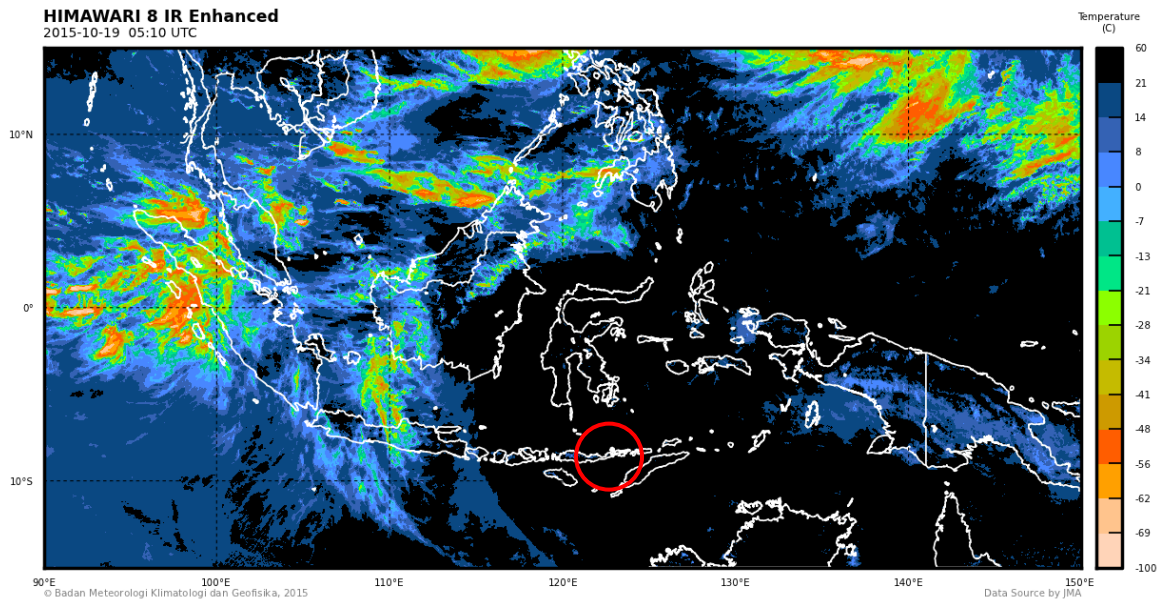
Figure 1: The satellite image at 0510 UTC

The satellite weather image was provided by *Badan Meteorologi Klimatologi dan Geofisika* (BMKG) on the day of the occurrence at 0510 UTC and 0610 UTC indicated that the weather over Ende (red circles) was clear.

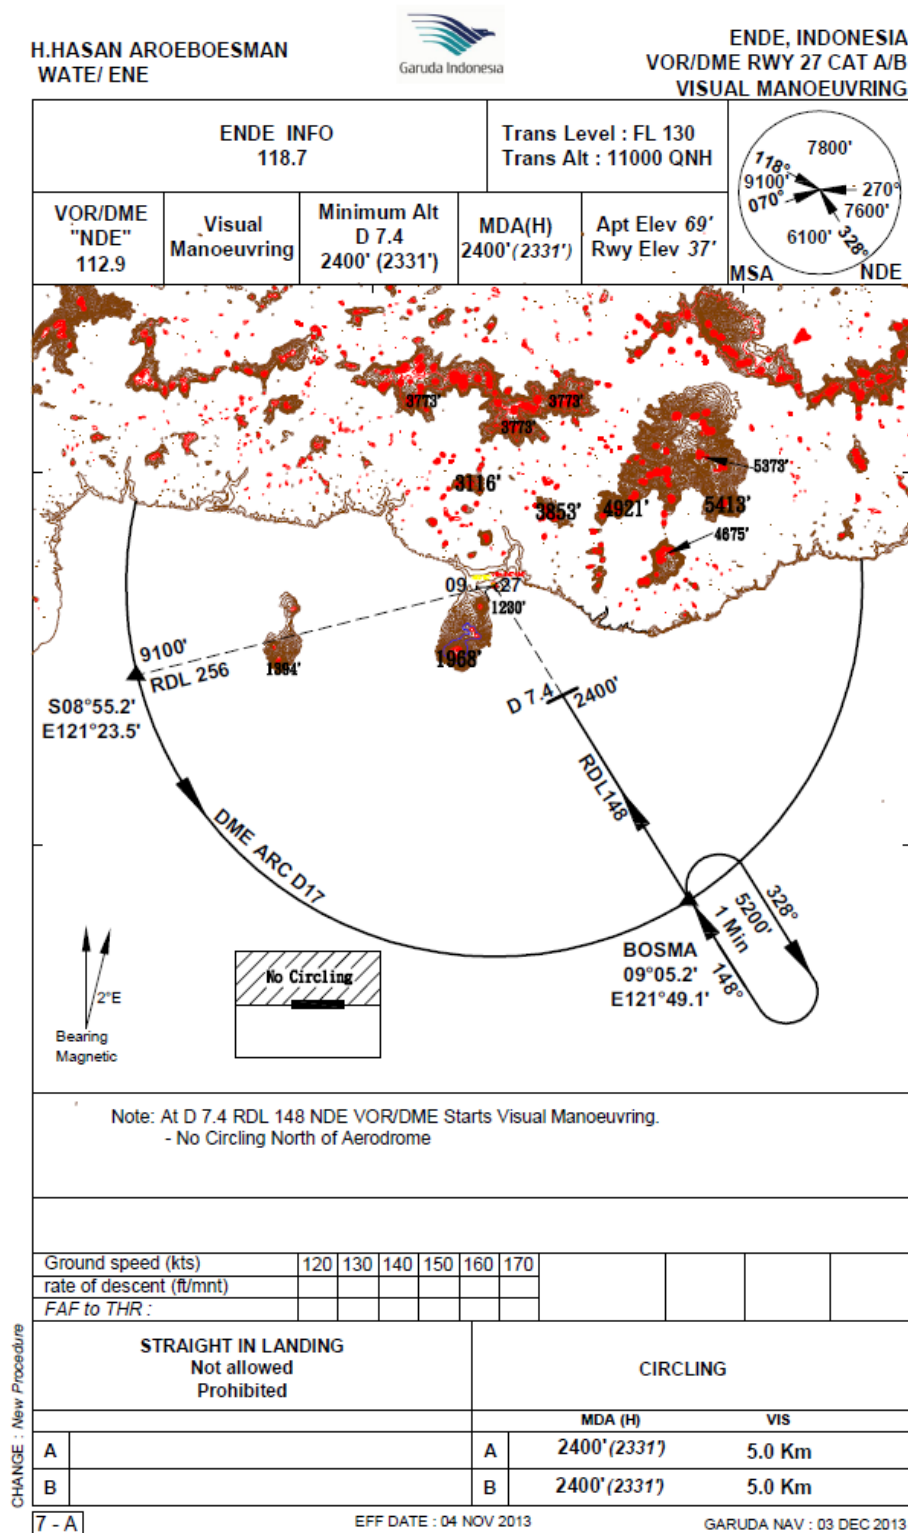
Figure 3: Visual manoeuvring chart of runway 27

The Visual Maneuvering Chart of runway 27 Ende published by the Garuda Indonesia that had been approved by the DGCA did not mention the procedure to manage the flight in avoiding the atoll. The absence of procedure for specific approach condition may trigger the pilot to improvise the approach based on their knowledge, skill and experience that may deviate from the standard.

Therefore, the KNKT recommend the Garuda Indonesia to review the Visual Maneuvering Chart of runway 27 Ende to prevent pilot improvisation that may deviate from standard.

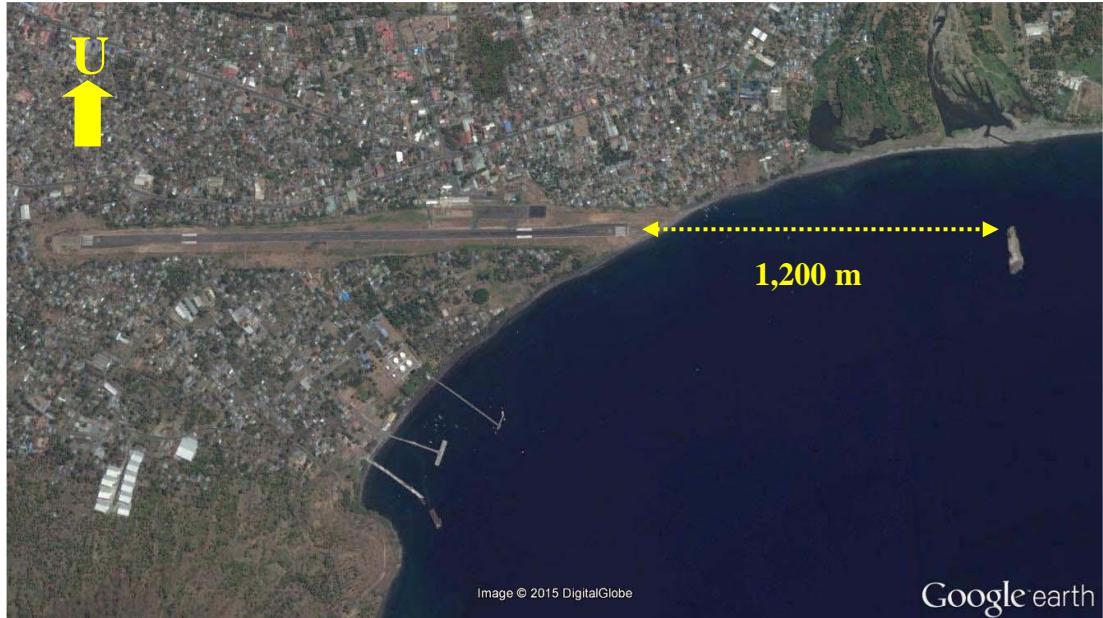
Figure 4: Atoll on final path Runway 27

There was an atoll on final path runway 27 (figure 4 and 5), which was about 1,150 meters (0.62 Nm) from beginning of runway 27 and the height of atoll was approximately 180 feet.

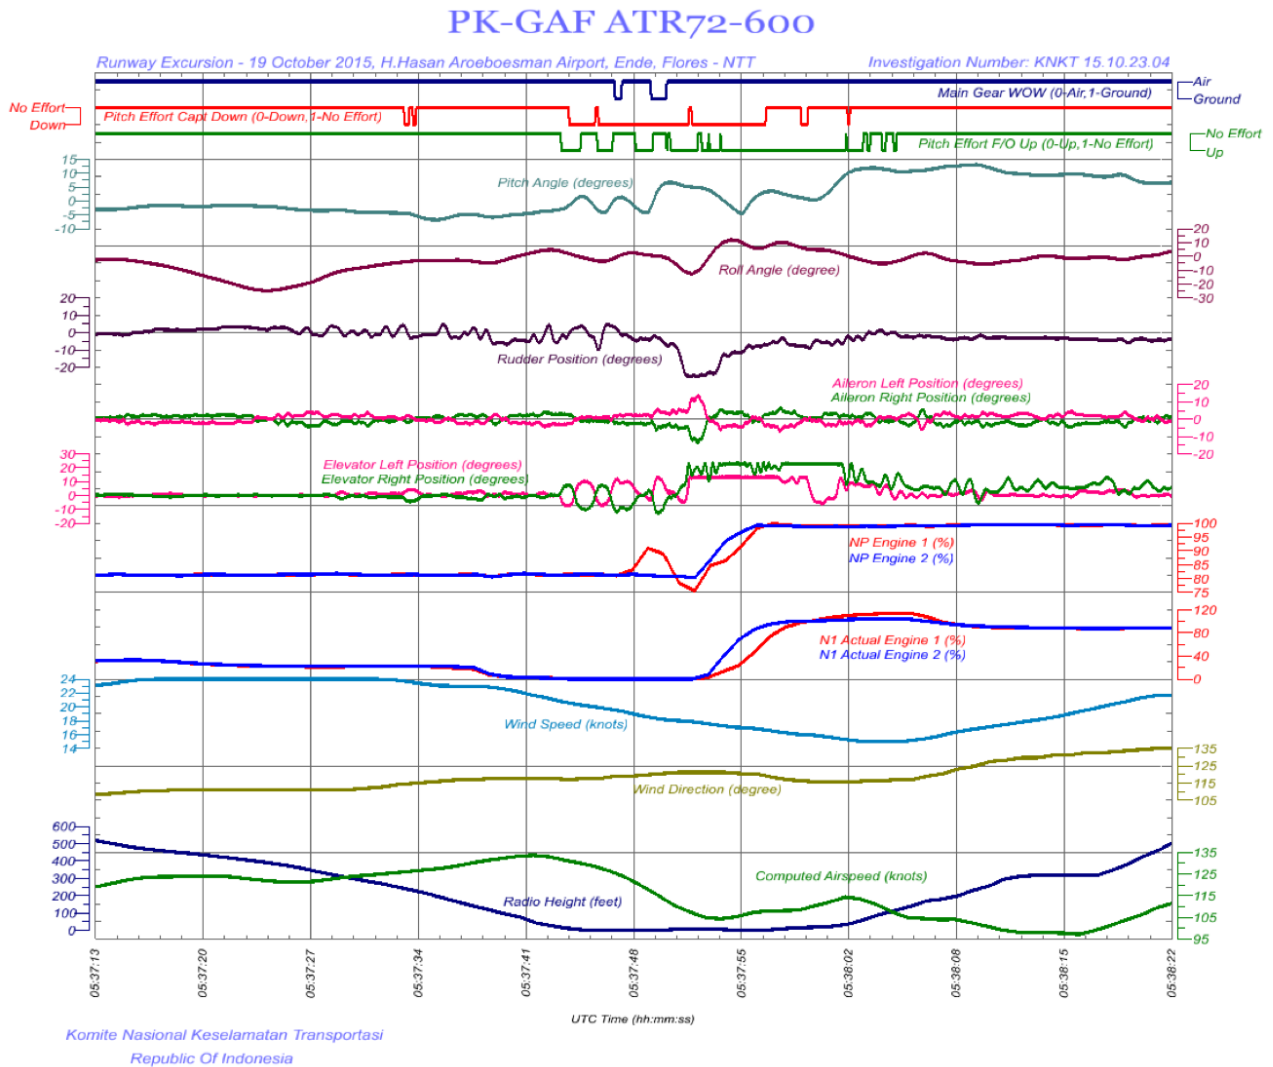
Figure 6: The significant parameters of FDR data during approach and go around

- 05:37:55 UTC, the vertical acceleration was $+1.9$ g, the IAS was 100 knots and the pitch angle reached a minima at -4.6° and the roll angle reached a maxima at $+11.1^{\circ}$.

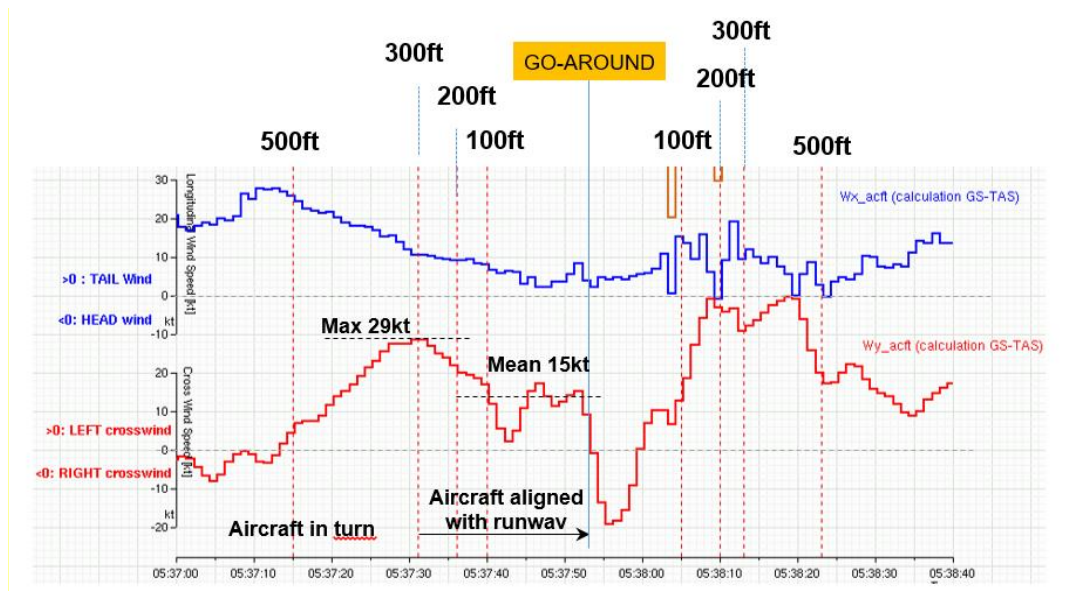
Figure 7: The wind computation

From 500 feet RA to the touchdown, the mean wind direction was around 140° , the wind speed varied between 7 knots and 33 knots (mean value 24 knots).
