AIRCRAFT ACCIDENT REPORT

ARIK/2018/03/06/F

**Report on the Serious Incident involving a Bombardier
DHC-8-Q400 aircraft owned and operated by Arik Air
Nigeria Ltd with nationality and registration marks
5N-BKX which occurred en route Kotoka International
Airport, Accra, Ghana
On 6th March, 2018**

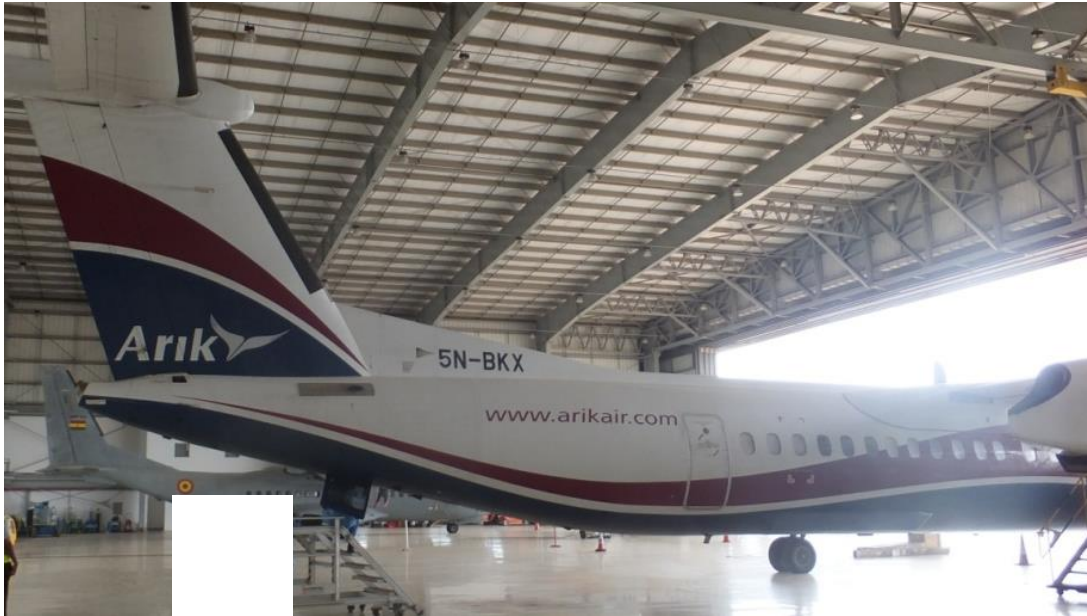
Figure 1: Photo of 5N-BKX in the maintenance hangar

The aircraft was not damaged.

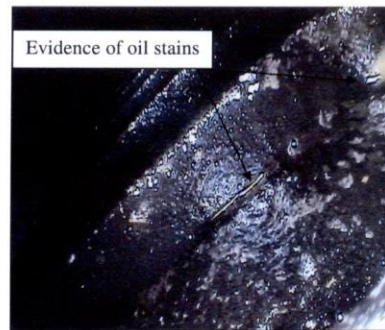
LPC STAGE 2 BLADES

| | | Evidence of oil stains found within vicinity of blades. |
