# Runway overrun involving Fokker 100, VH-NHY

Newman Airport, Western Australia, on 9 January 2020

**ATSB Transport Safety Report**

AO-2020-002

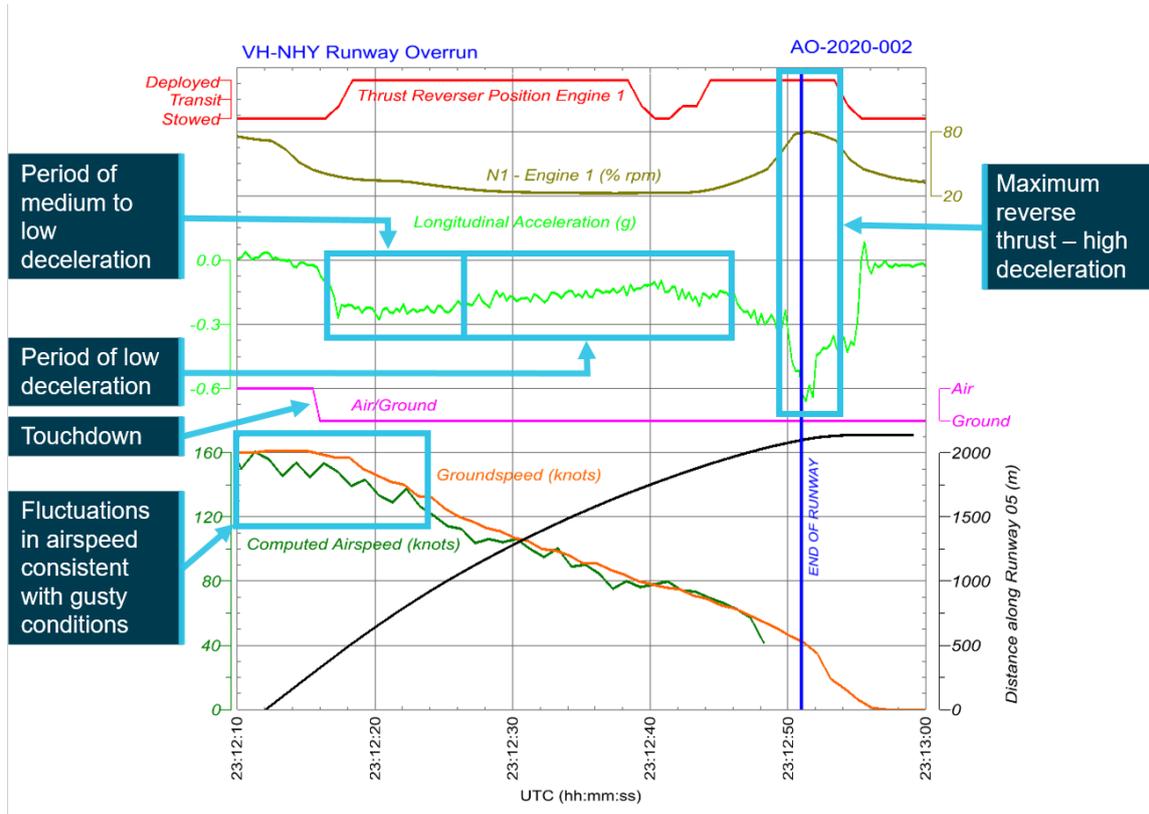
**Figure 1: Flight data from the occurrence landing**

35 knots. The aircraft touched down at 154 knots airspeed and a groundspeed of 159 knots (Figure 1). The touchdown was positive<sup>11</sup> and at, or slightly before, the touch down zone.

Eleven seconds after landing, the captain requested assistance with the brakes<sup>12</sup> from the FO. The recorded deceleration during this part of the landing was medium to low (less than 0.25 G) and reduced further as the landing roll progressed (Figure 1). Throughout the landing, there were directional oscillations about the runway heading as the aircraft weathercocked into the strong crosswind.

The captain reported that the aircraft aquaplaned during the landing. Approximately 20 seconds after touching down, the aquaplaning response technique was conducted. This involved reducing manual braking (brake pressure) with the intent of regaining traction and stowing the thrust reversers to increase directional stability. After completion of the aquaplaning response technique, maximum reverse thrust was applied which provided high deceleration (greater than 0.5 G) just before the aircraft departed the runway.

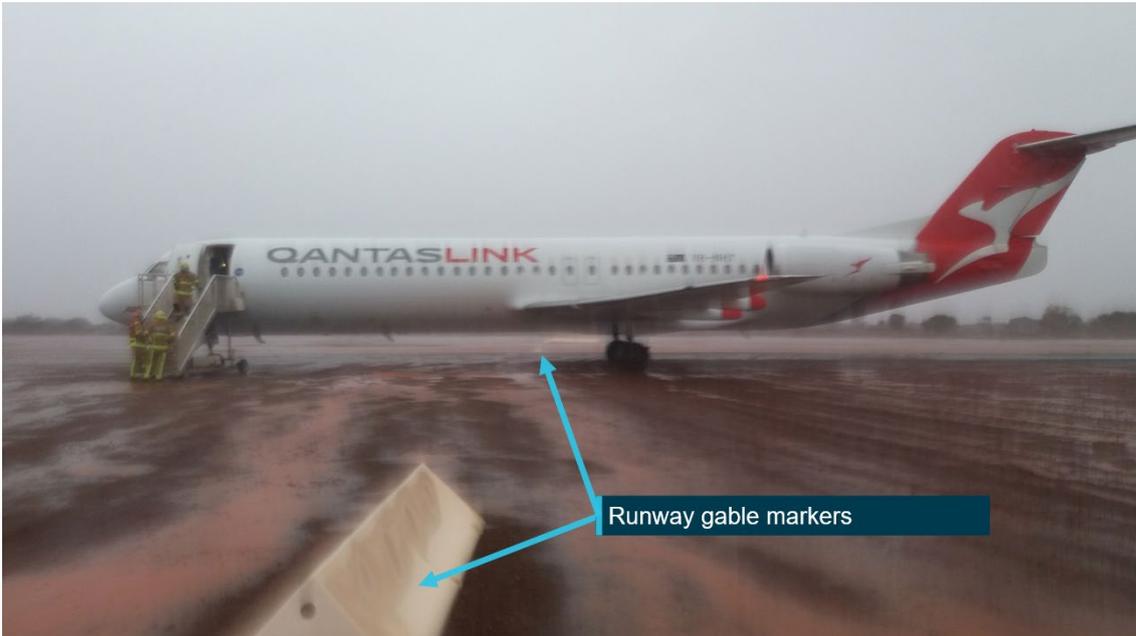
**Figure 2: Image taken of the aircraft stopped within the runway end safety area**

The aircraft stopped about 70 m beyond the upwind runway threshold, off the runway surface, within the runway end safety area<sup>13</sup> (Figure 2). There were no injuries and the passengers and crew disembarked via the front stairs and were transported to the terminal.

A visual examination of the tyres identified some deep scratches, likely due to the abrasive surface of the runway end safety area. An inspection of the aircraft found that the loose gravel had damaged some of the landing gear components.

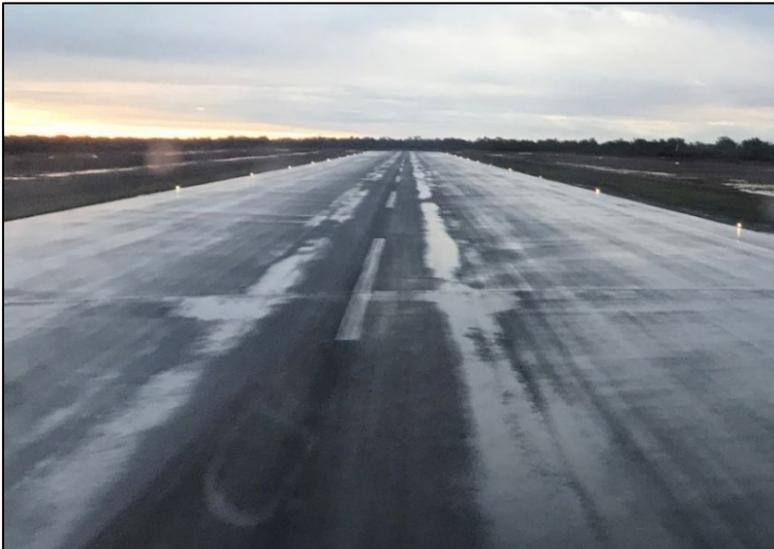
**Figure 3: Image of standing water on the runway at Newman Airport.**

About a year after the occurrence, an image was taken of the runway showing standing water on the runway after rainfall (Figure 3).

The water pooling observed a year after the occurrence may have been present at the time of the occurrence but would have been hard to identify during active precipitation.

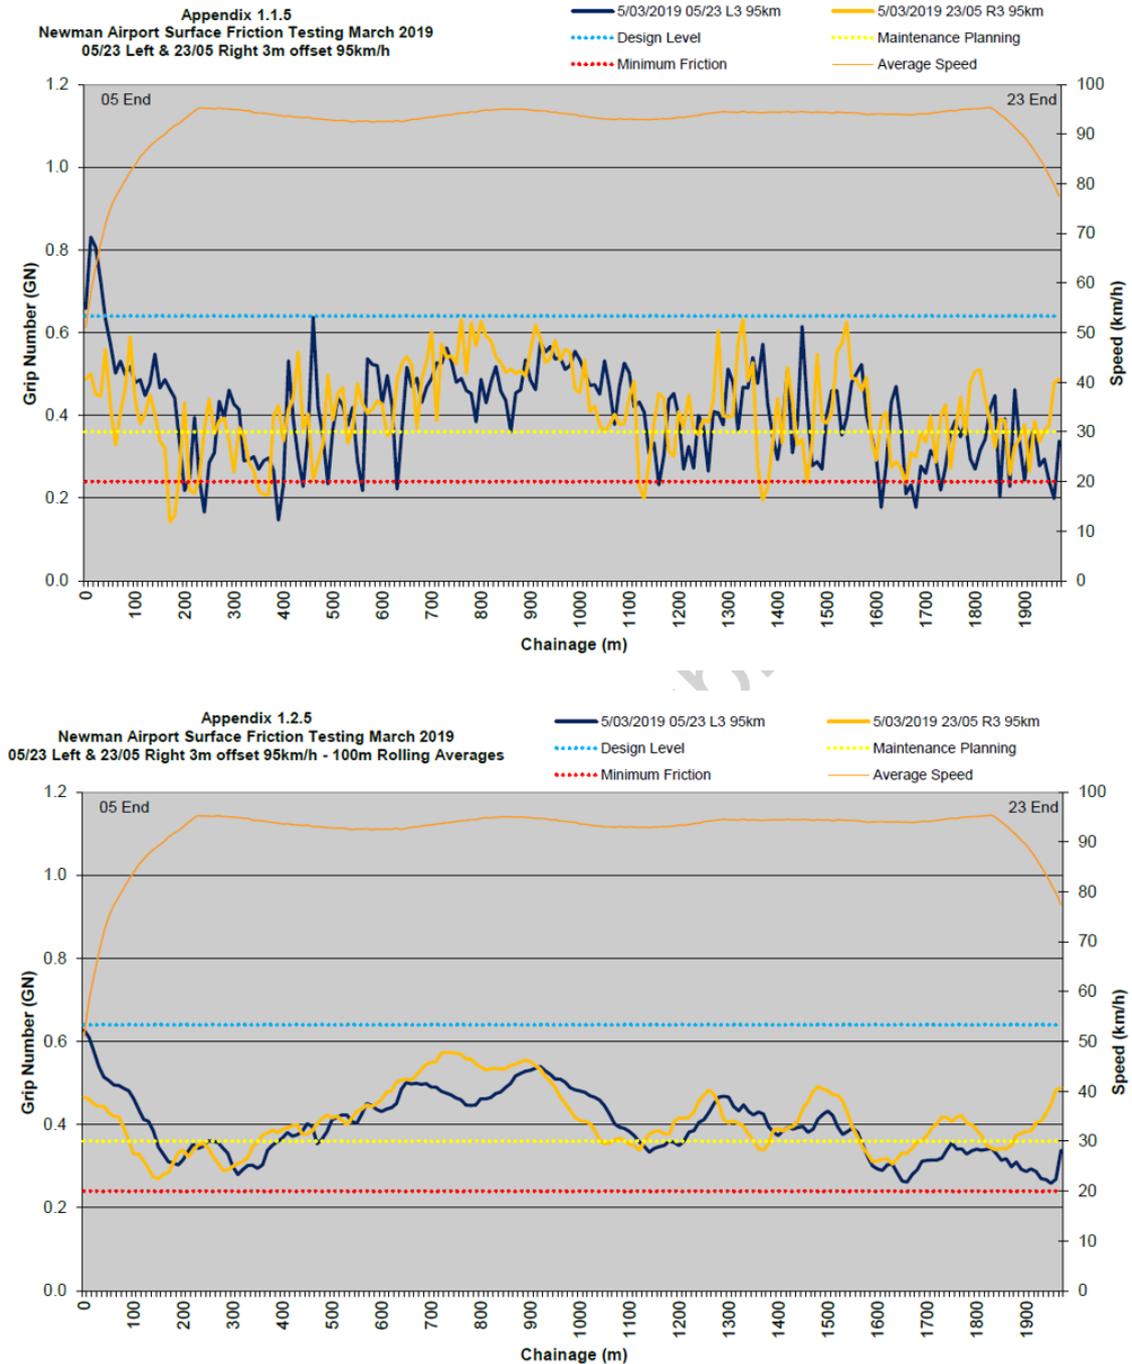
Figure 4: Results from runway friction report

These plots show the data from the 95 km/h test at 3 m offset from centreline. The upper image shows 10 m averages considered to the continuous friction measurement, the lower image is the same data using 100 m rolling averages.  
Source – Fulton Hogan

The report did not mention the friction values below the minimum design limit and concluded that:

The runway friction measurements taken in 2019 had values below the recommended maintenance planning levels and some measurements below the minimum friction limits as specified by the Manual of Standards. Although still safe for operations, at the levels recorded, it would generally be expected that maintenance should be performed in the lower friction areas to ensure ongoing safe operation on the runway.
