# Air Accident Investigation Unit Ireland

**FORMAL REPORT**

**Sikorsky S-92A, EI-ICR  
Black Rock, Co. Mayo, Ireland**

**14 March 2017**

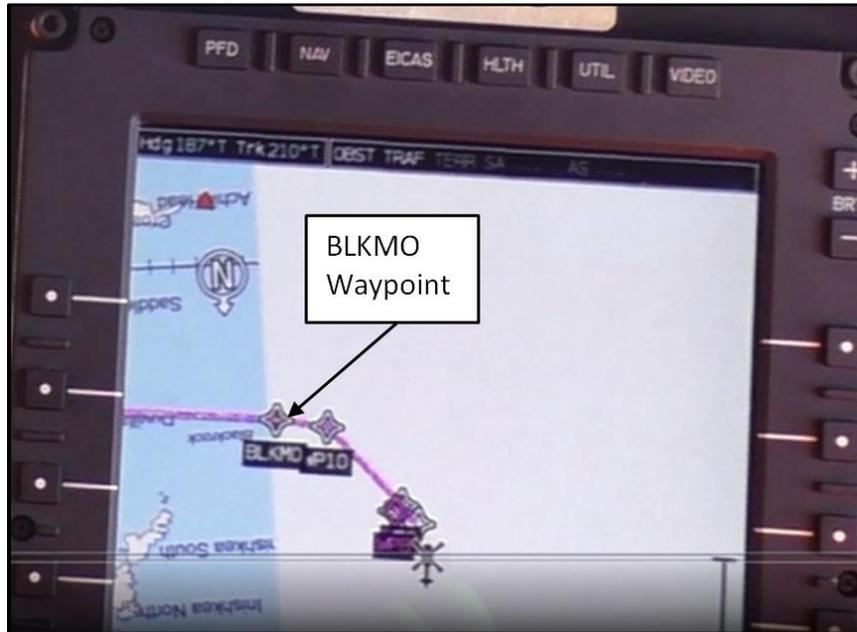
During a Review Flight (**Section 1.16.1**), which the Investigation undertook on one of the Operator's helicopters, it was noted that the moving map imagery did not extend as far as Black Rock and instead, the BLKMO waypoint was shown against a white, featureless, chart margin (**Photo No. 6**).

**Photo No. 6:** Euronav imagery from Investigation's Review Flight

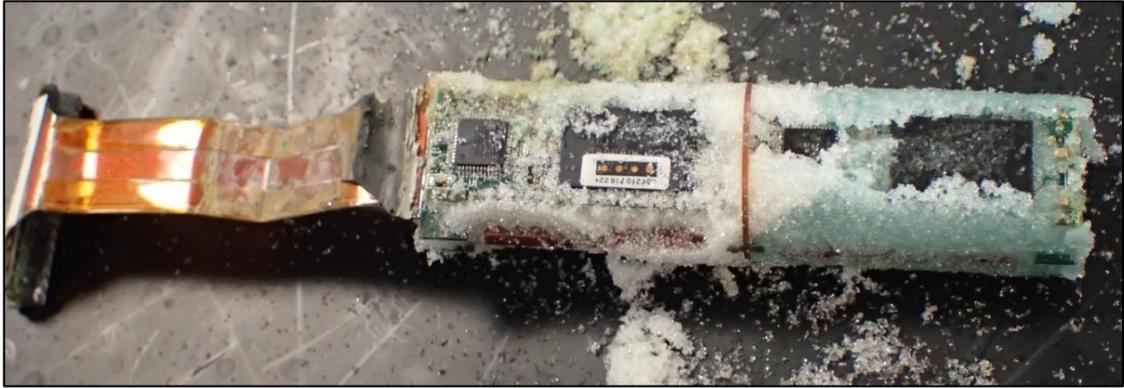
It was noted that water had entered the inside of the crash protected enclosure. **Photo No. 12** shows the MPFR memory board following removal. Examination of the memory board showed evidence of corrosion on the contacts of several of the memory devices. Electrical testing revealed short circuits which necessitated additional measures to recover the CVR and FDR recordings. These measures included de-soldering individual memory devices and re-installing them on a functional memory board provided by the MPFR manufacturer.

**Photo No. 12:** MPFR Memory Board with discolouration of glass spheres

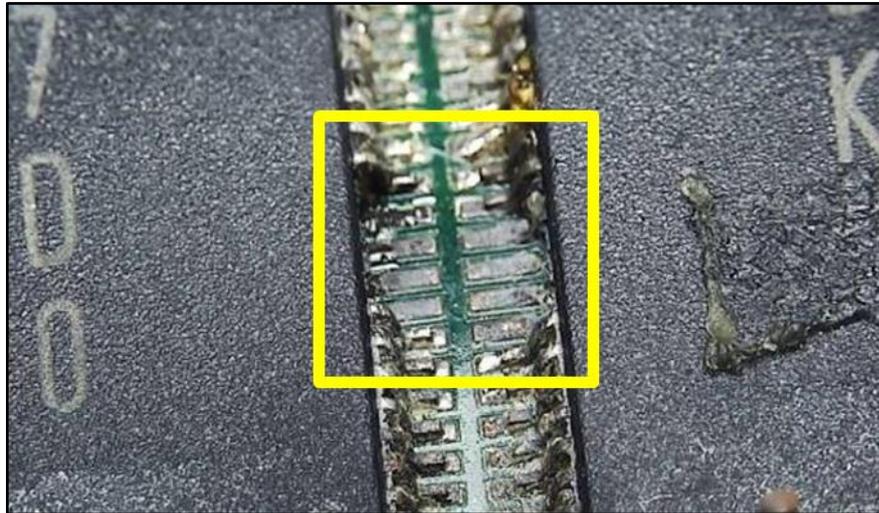
Thereafter, a chemical '*single substitution reaction*'<sup>32</sup> took place, whereby the iron in the *Alloy 42* was depleted to the extent that the pins' structural integrity was lost and their electrical connections were broken.

**Photo No. 13:** Underside of FDR1 DOC; pins are damaged or missing due to corrosion

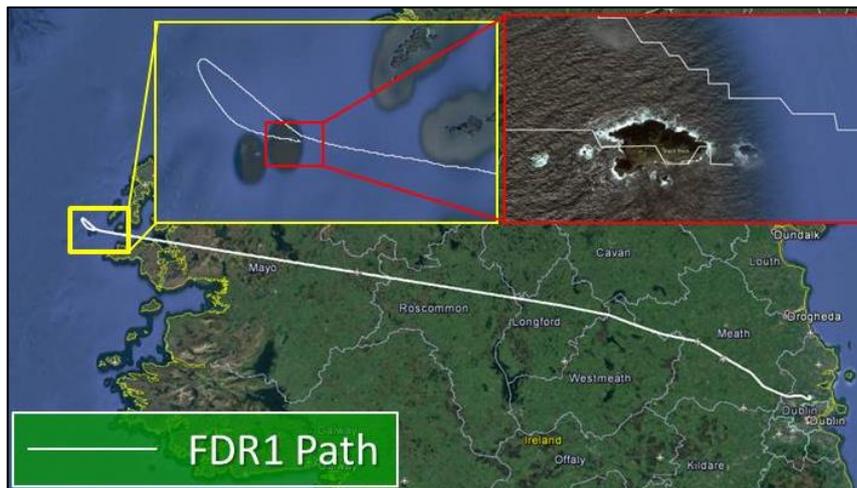
As noted in the Investigation's First Interim Statement, during the examination of the data recovered from the FDR, the Investigation found that the latitude and longitude position information, whilst generally consistent with the expected flight path, appeared anomalous (**Figure No. 16**).

**Figure No. 16:** Position data from FDR1 showing the flight path of EI-ICR

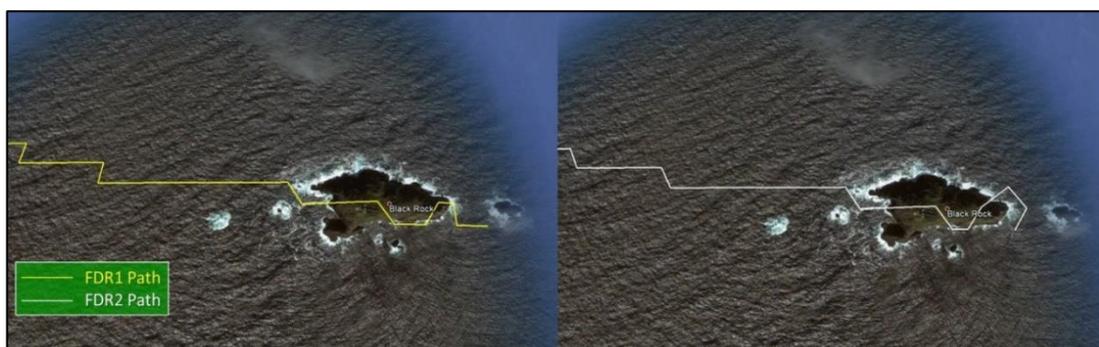
The Investigation reviewed the FDR positional data for EI-ICG, another IRCG S-92A helicopter. This data also produced the jagged or 'zigzag' flight path. The Investigation informed the Helicopter Manufacturer of this finding; the Manufacturer conducted an examination of the data processing and recording system for present position on the S-92A helicopter.

**Figure No. 17:** Position data from FDR1 and FDR2 showing the flight path of EI-ICR

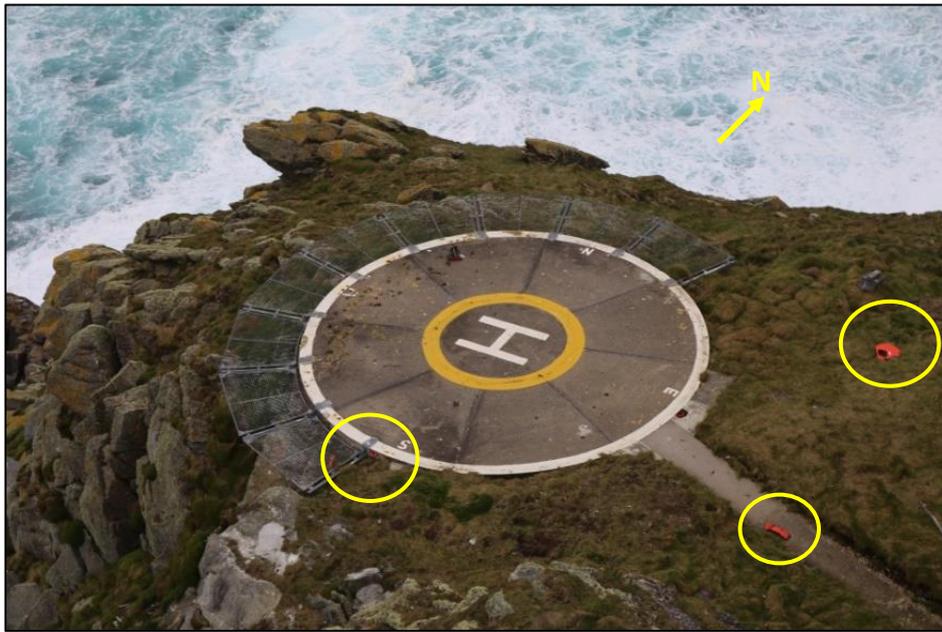
**Photo No. 20:** Debris situated close to the helipad and below its steel grid

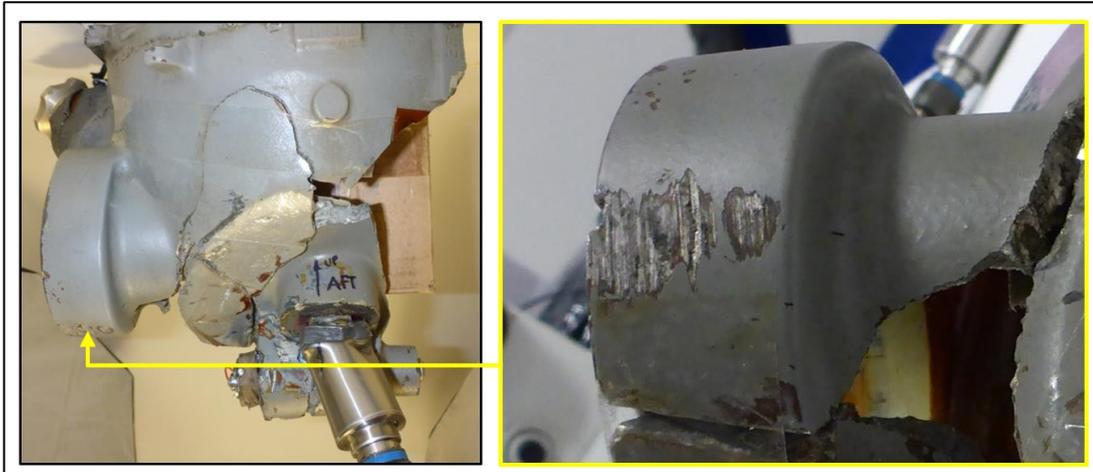
**Figure No. 33:** Reconstructed IGB casing and damage to base of oil-level sight-glass housing

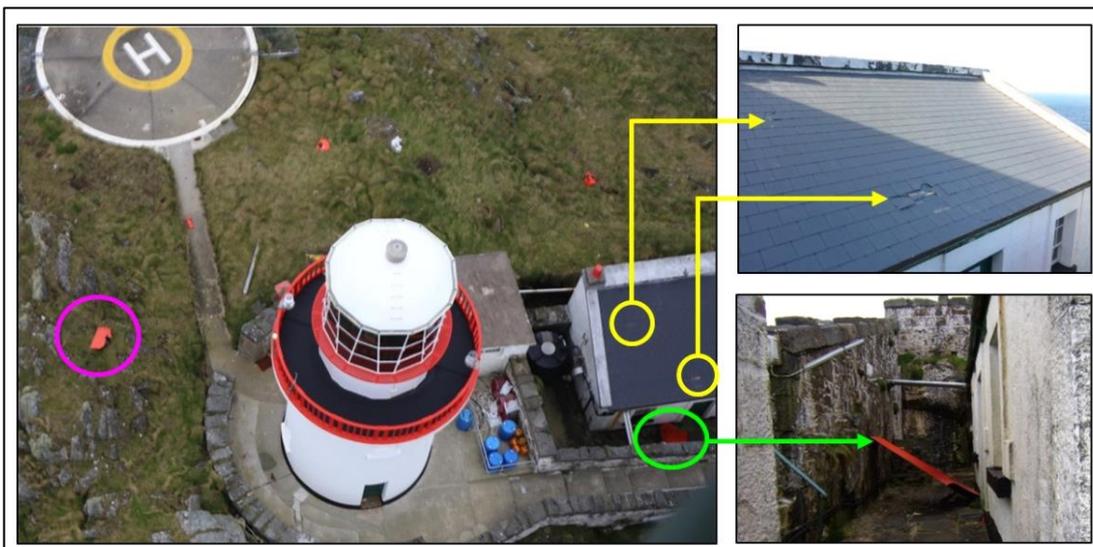
**Figure No. 34:** Sections of horizontal stabiliser (circled in magenta and green) and roof damage (circled in yellow)

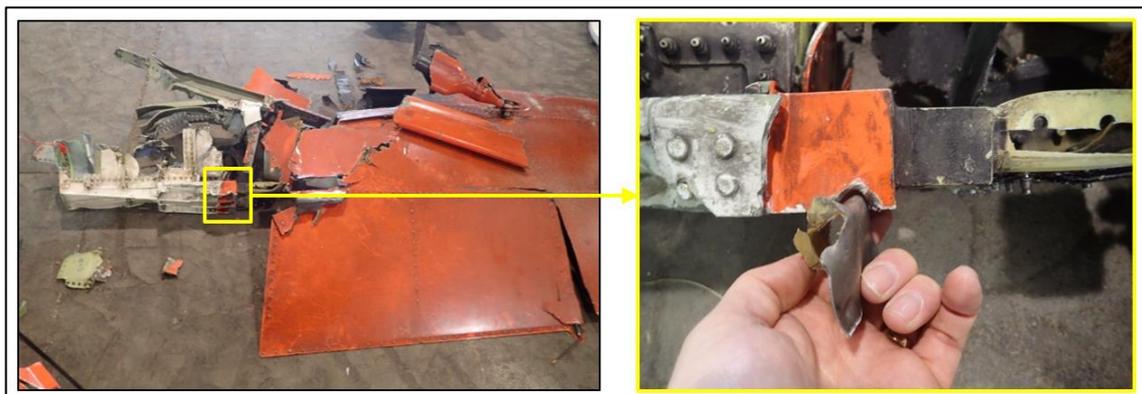
**Figure No. 35:** Gouge in upper aft edge of aft section of horizontal stabiliser

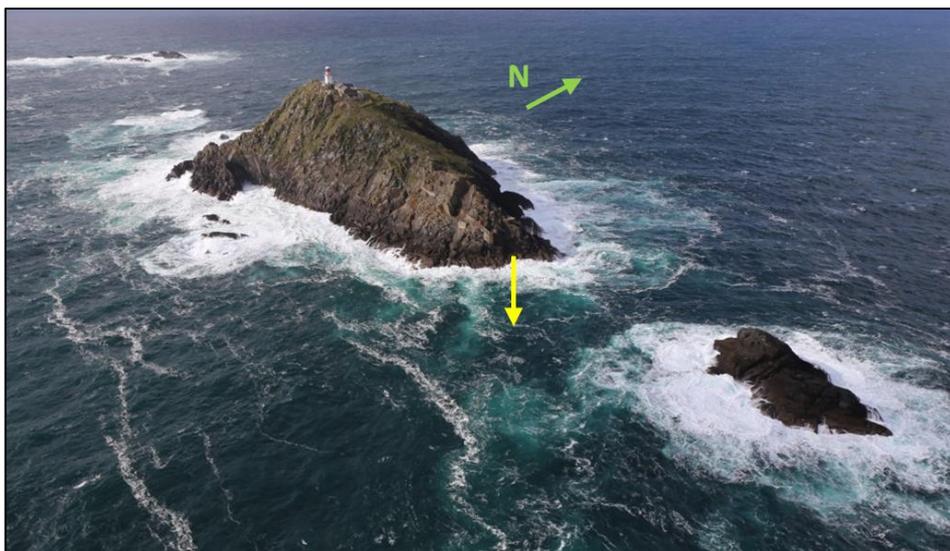
**Photo No. 23:** Approximate position of main wreckage indicated by yellow arrow

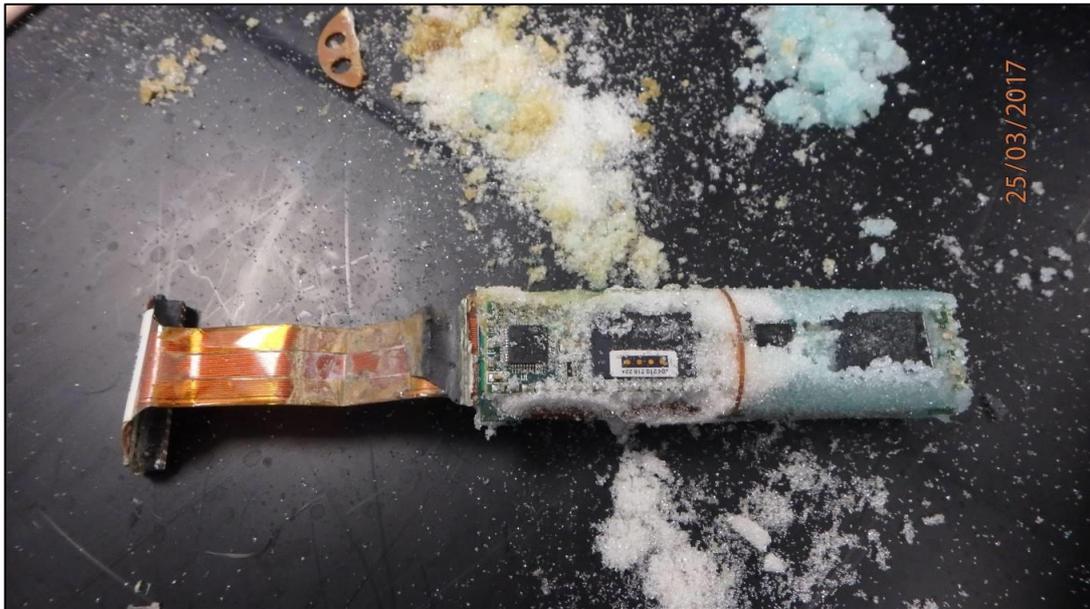
**Image No. K7:** APMB from EI-ICR showing copper based insulation staining of glass beads

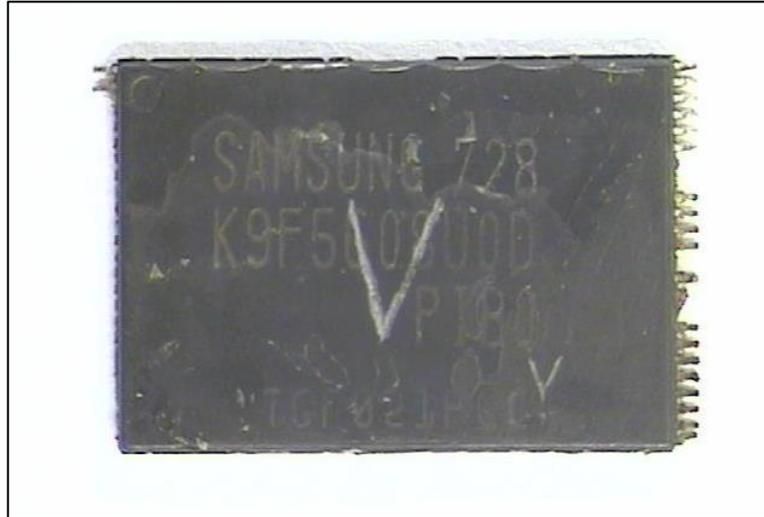
**Image No. K8:** Helicopter registration B516 missing pins from MPFR non-volatile memory device due to corrosion

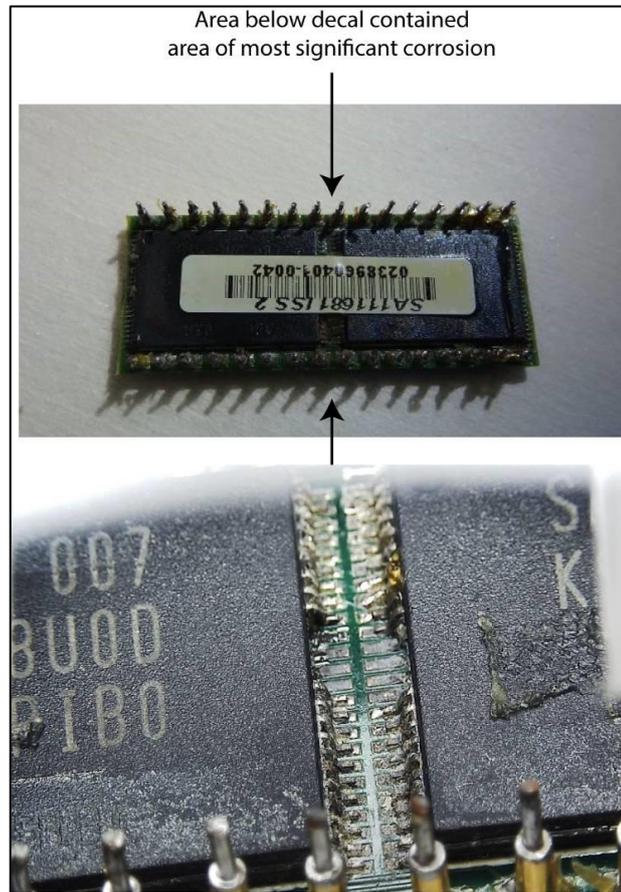
**Image No. K9:** Underside of FDR1 DOC module from EI-ICR showing missing pins due to corrosion

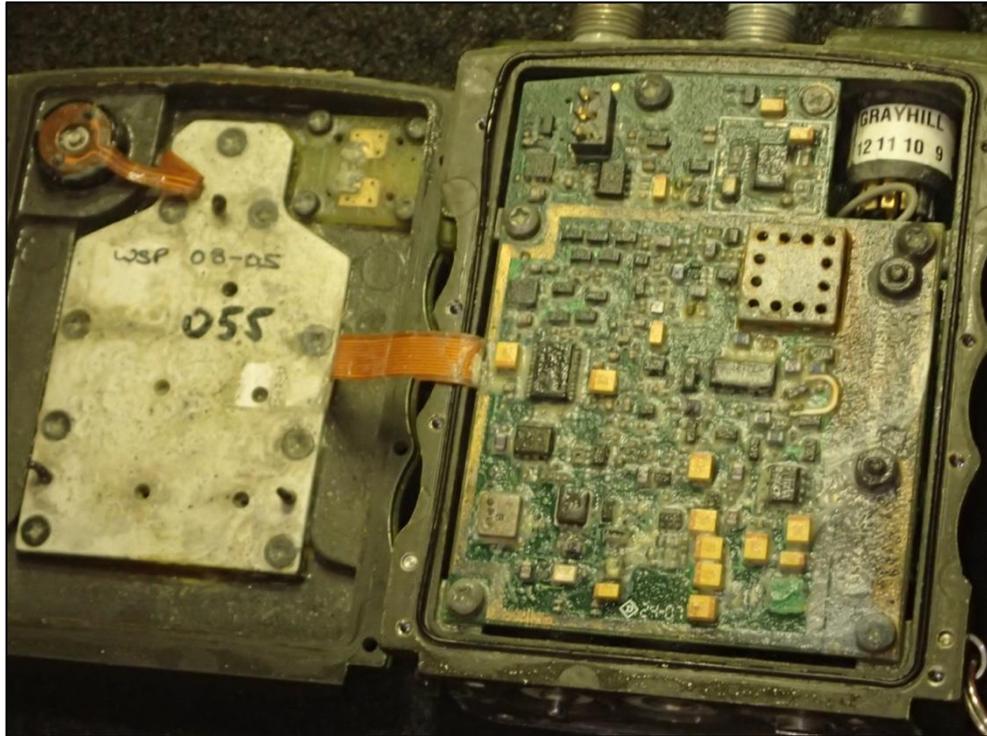
**Photo No. R1:** Internal Water Damage to Commander's SARBE 6-406G
