Summary Report

Aircraft	Airbus A330-343	HB-JHC	
Operator	Swiss International Air Lines Ltd., 4002 Basel, Switzerland		
Owner	Swiss International Air Lines Ltd., 4002 Basel, Switzerland		
Commander	Swiss citizen, born 1964		
Licence	Airline Transport Pilot Licence Aeroplane (ATPL(A)) according to the European Union Aviation Safety Agency (EASA), issued by the Federal Office of Civil Aviation (FOCA)		
Flying hours	total 14 931:22 h	during the last 90 days 140:03 h	
	on the type involved in the incident 3933:21 h	during the last 90 days 133:34 h	
Copilot	German citizen, born 1988		
Licence	ATPL(A) according to EASA, issued by the FOCA		
Flying hours	total 3889:48 h	during the last 90 days 97:48 h	
	on the type involved in the incident 429:16 h	during the last 90 days 97:48 h	
Location	Runway 32 of Zurich Airport (LSZH)		
Coordinates	---	Altitude ---	
Date and time	26 February 2020, 10:38 UTC (LT ¹ = UTC ² + 1 hour)		
Type of operation	Commercial flight

Flight rules	Instrument Flight Rules – IFR		
Point of departure	Zurich Airport (LSZH)		
Destination	Nairobi Airport (HKJK), Kenya		
Flight phase	Takeoff and climb		
Art des schweren Vorfalles	Tail contact with runway		
Type of serious

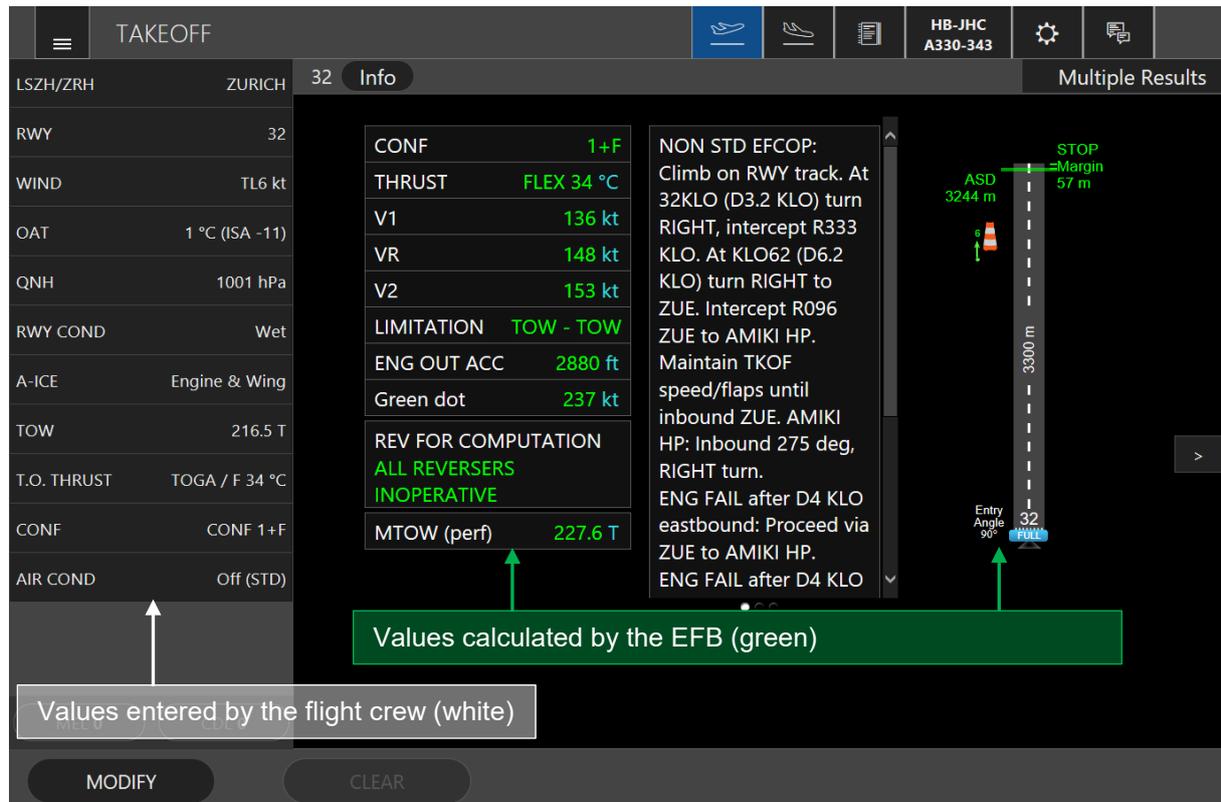
Figure 1: Representation of the calculation of the takeoff power values on the EFB, as carried out by the crew shortly before takeoff of HB-JHC on runway 32 in Zurich. The arrow on the right of the screen can be used to retrieve two further pages with additional information relating to takeoff.

In the present case, the calculations in the EFB indicate an optimal flap setting 2 (CONF 2) for takeoff, which is also recommended by the operating company and specified in the EFB as standard. Compared to the CONF 1+F position selected by the flight crew, the calculation with CONF 2 shows a «V_{2VSRatio}» which at 1.21 is significantly higher than the 1.14 with CONF 1+F (cf. figure 2).

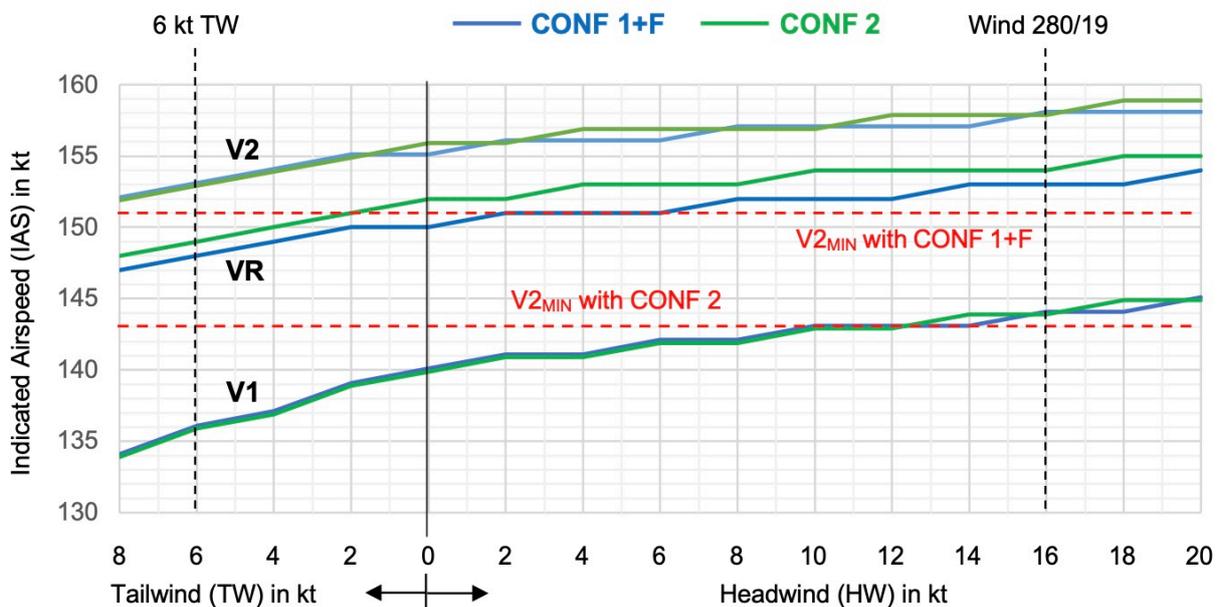
Figure 2: Influence of wind input in the EFB on the V-speeds at CONF 1+F and CONF 2. The other input parameters in the EFB correspond to the values chosen by the crew according to figure 1. V2MIN denotes the minimum prescribed V2 which corresponds to 1.13 times V_{S1g} .

On the other hand, the flap setting has a significant influence on takeoff power values (cf. figure 2):

- When flap setting 2 (CONF 2) is selected, rotation speed V_R for all headwind or tailwind components is above V_{2MIN}, which is 1.13 times the stalling speed.
- With flap setting 1+F (CONF 1+F), the rotation speed V_R is higher than V_{2MIN} only from a headwind component of 6 kt.

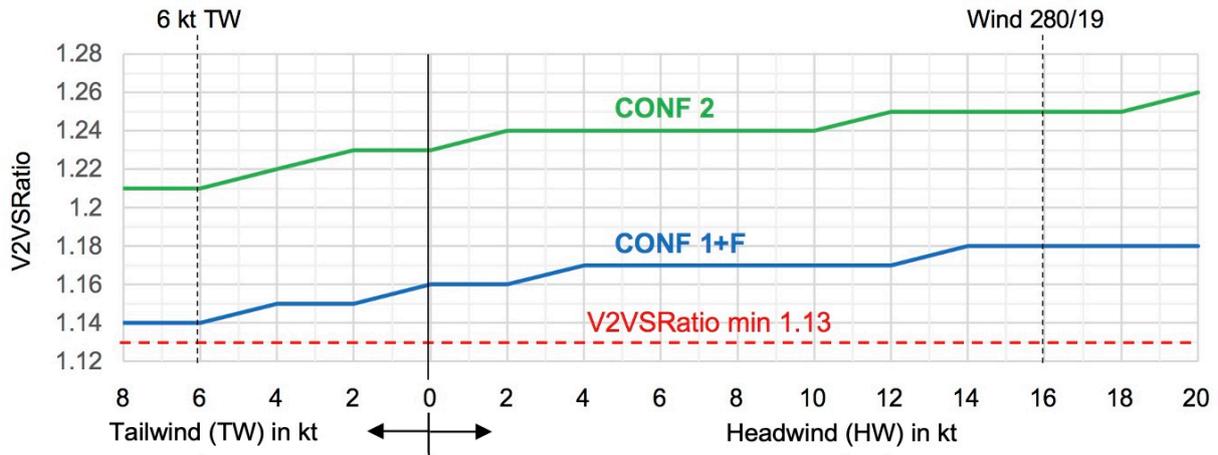
Since stall speed V_{S1g} increases with a lower flap setting, this results in a significantly lower «V2VSRatio» and thus a lower safety margin in relation to a stall (cf. figure 3). The aircraft is also rotated at a speed that is much closer to the stalling speed.

Figure 3: Influence of wind input in the EFB on the ratio between V2 and V_{S1g} for different configurations. The other input parameters in the EFB correspond to the values selected by the crew as shown in figure 1.

In addition to the selection of the flap setting, the selection of wind input is also an important factor. With the selected tailwind component of 6 kt, the flight crew created a safety margin for an aborted takeoff of 278 m ASD (cf. figure 4). However, as the present case shows, the tailwind input had a significant influence on rotation speed V_R. This was reduced to 148 kt. Taking into account the current wind, V_R would have been 153 kt (cf. figure 2). At the lower rotation speed, the risk of a tailstrike increased. In addition, this reduced the stall margin (cf. figure 3).

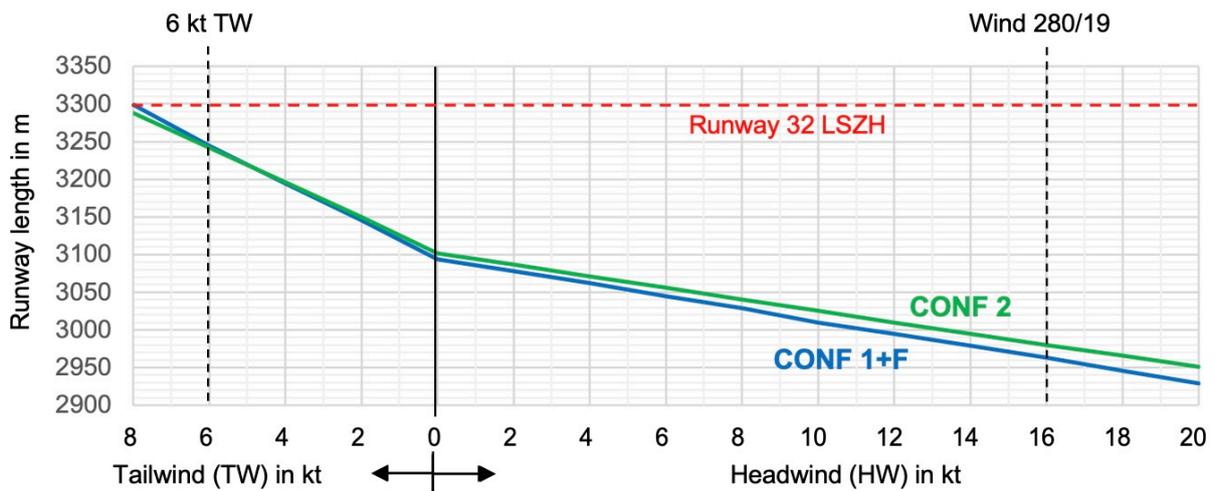
The ASD is significantly influenced by the wind input and decreases with increasing headwinds. The flap setting (CONF) has a negligible influence on the ASD (cf. figure 4).

Figure 4: Influence of wind input in the EFB at different flap settings (CONF) on the ASD (runway length in m). The other input parameters in the EFB correspond to the values selected by the crew as shown in figure 1.

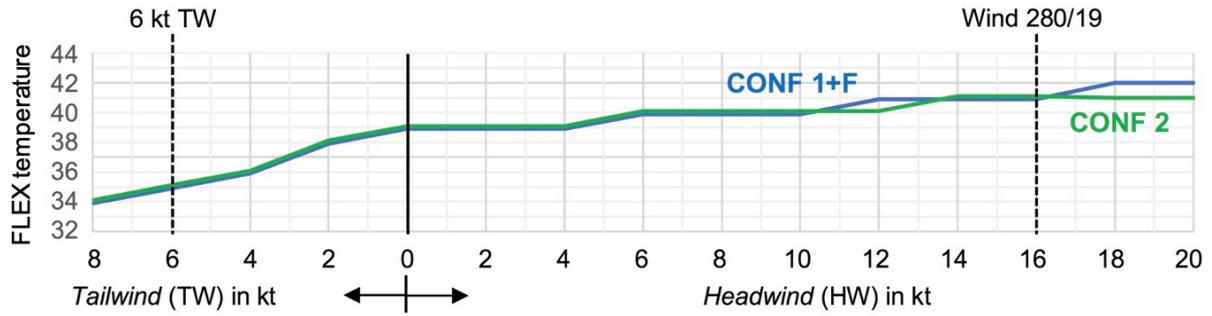
The dependence of the maximum possible flex temperature on the wind input can be seen in figure 5: with a larger headwind component, the optimal flex temperature increases.

Figure 5: Influence of wind input in the EFB on the optimal flex temperature. The other input parameters in the EFB correspond to the values selected by the crew as shown in figure 1.

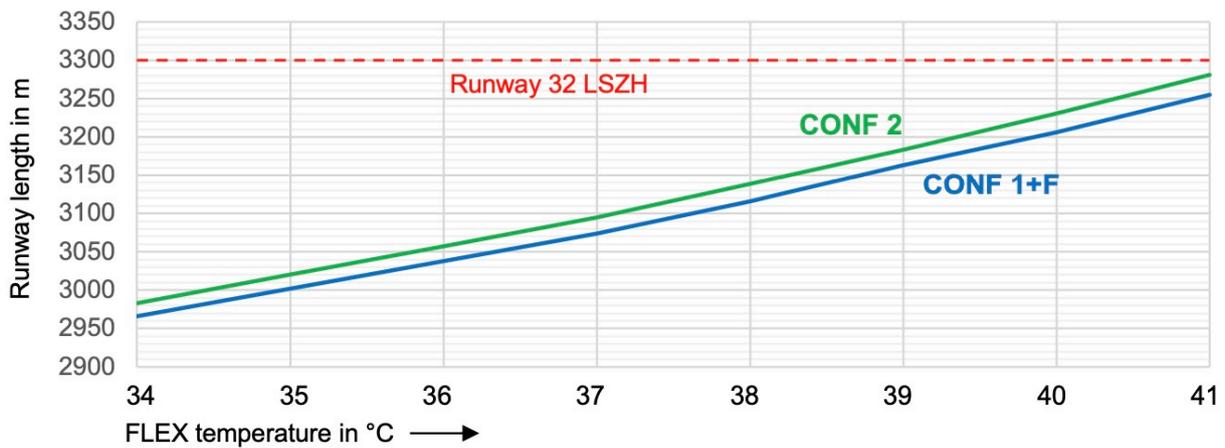
For a reduction by the flight crew of the flex temperature with otherwise constant inputs, the ASD decreases (cf. figure 6). The V-speeds are almost unaffected.

Figure 6: Influence of the flex temperature, or rather reduced takeoff power, on the ASD (runway length in m) taking into account a wind from 280° at 19 kt (HW 16 kt). The other input parameters in the EFB correspond to the values selected by the crew as shown in figure 1.

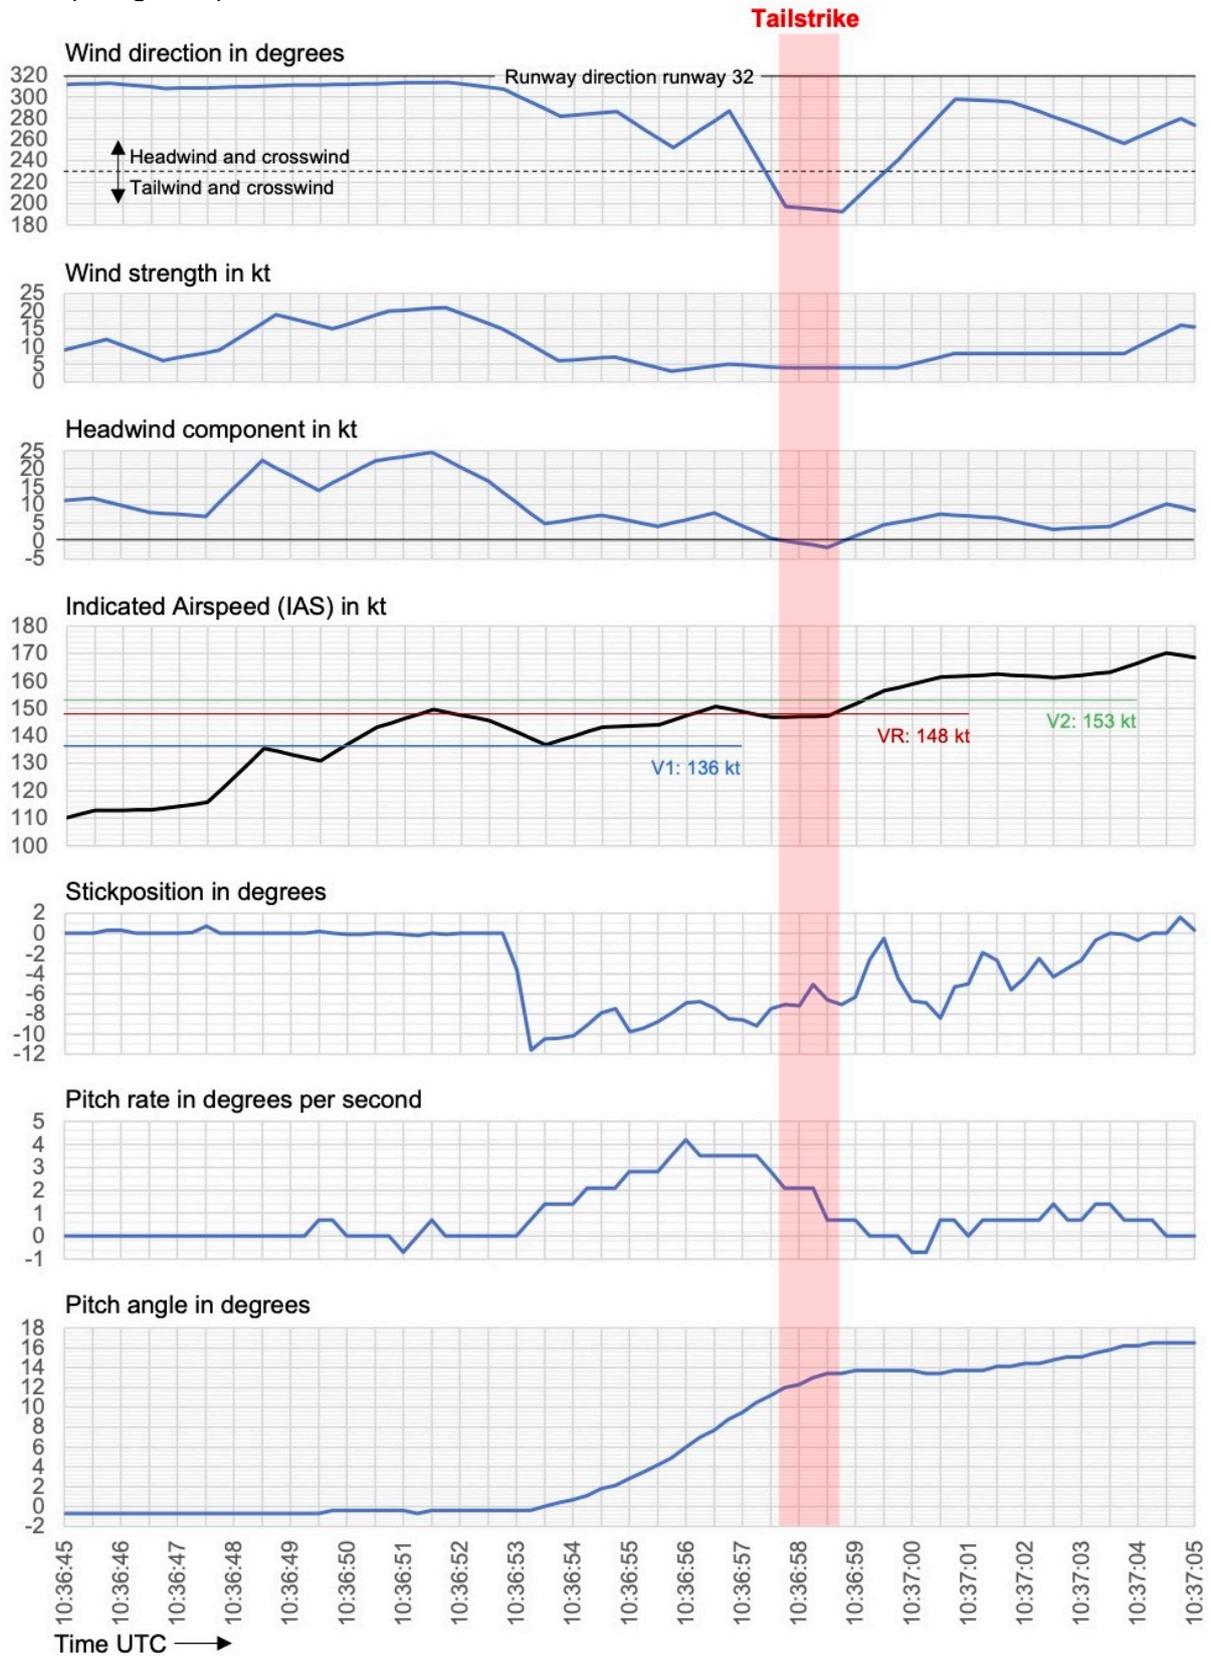
Figure 7: Recording of the DFDR data in the rotation and lift-off phase of HB-JHC. The headwind and pitch rate data were calculated.

The recordings indicate no abnormalities for the initiation and initial acceleration of the takeoff run until decision speed V1 is reached. Subsequently, it becomes apparent that the prevailing and recorded wind gusts significantly influenced the further course of events. With regard to the tailstrike, the rotation phase is of particular interest. The relationship between wind, Indicated Airspeed (IAS), pitch angle and pitch rate is shown in figure 7 above.

The fluctuations in the IAS due to wind gusts shortly before and during the initiation of rotation are significant: at 10:36:47 UTC, the IAS increased from 115 kt to 135 kt within 1.5 seconds. Subsequently, the IAS dropped again to 131 kt within 3 seconds and rose again to 150 kt. Only 1.5 seconds later the IAS decreased again to 139 kt and increased to 150 kt within the subsequent 3 seconds.

At 10:36:53 UTC, the PF initiated rotation. The IAS at that time was 142 kt. The stick was pulled back to approximately 3/4 of full deflection and then immediately returned to approximately half of full deflection. At 10:36:54 UTC, the IAS was 140 kt; it increased to 151 kt and dropped back to 147 kt (10:36:58 UTC). The IAS then increased continuously and was 154 kt when the aircraft took off (10:36:59 UTC).

The movements of the PF's stick resulted in a change in the pitch angle of the aircraft from 0° to 11.2° within 4 seconds and to 13.7° (10:36:59 UTC) in the following 1.5 seconds. The maximum pitch rate was 4.2 degrees per second (10:36:56 UTC).

As the analyses of the DFDR indicate, the greatly fluctuating wind gusts during the takeoff run, especially during the rotation phase, had a decisive influence. At 10:36:51 UTC, the IAS indicated the rotation speed set for rotation of 148 kt, after which the PF initiated rotation with the corresponding stick movement to approximately three-quarters of full deflection and an immediate gradual return to approximately half of full deflection. At this stage, the IAS dropped to 137 kt due to the fluctuating wind, before rising again. The average rotation rate was approximately 3 degrees per second and decreased again shortly before the tailstrike (cf. figure 7). The rotation process therefore complied in principle with the operating company's procedural requirements.

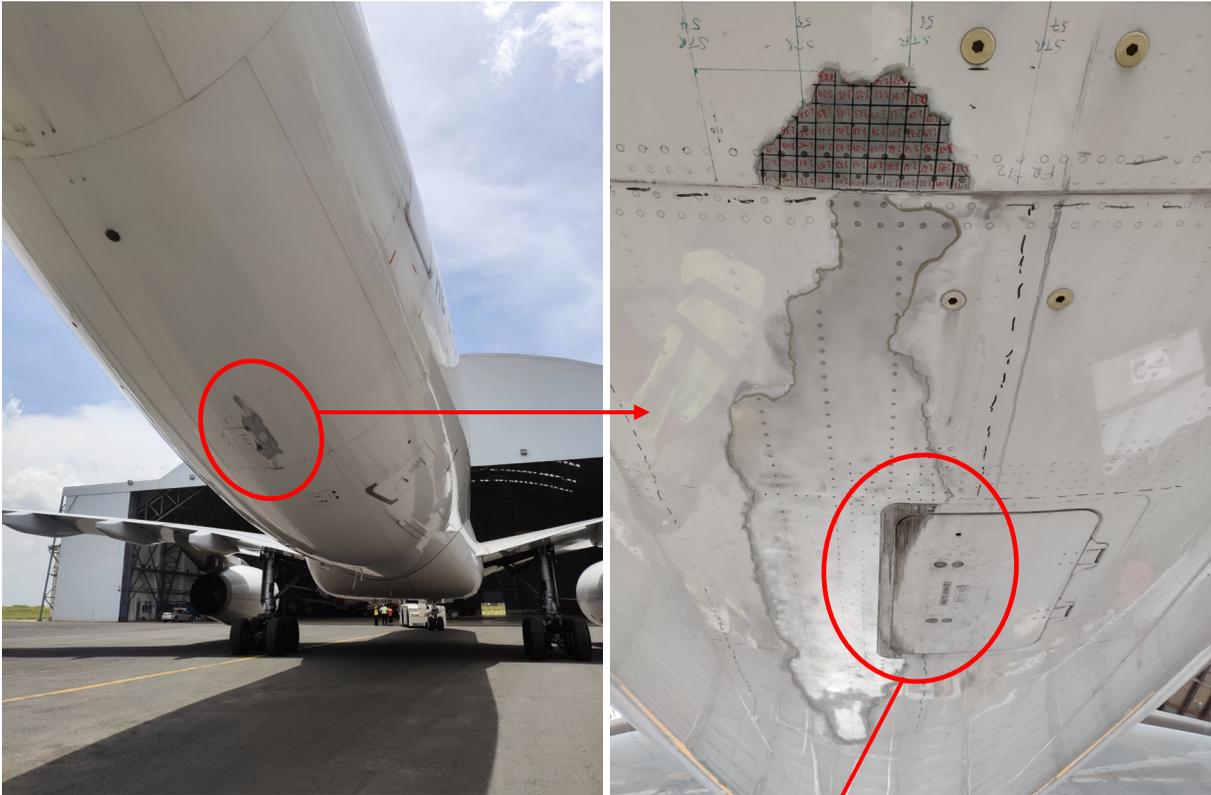
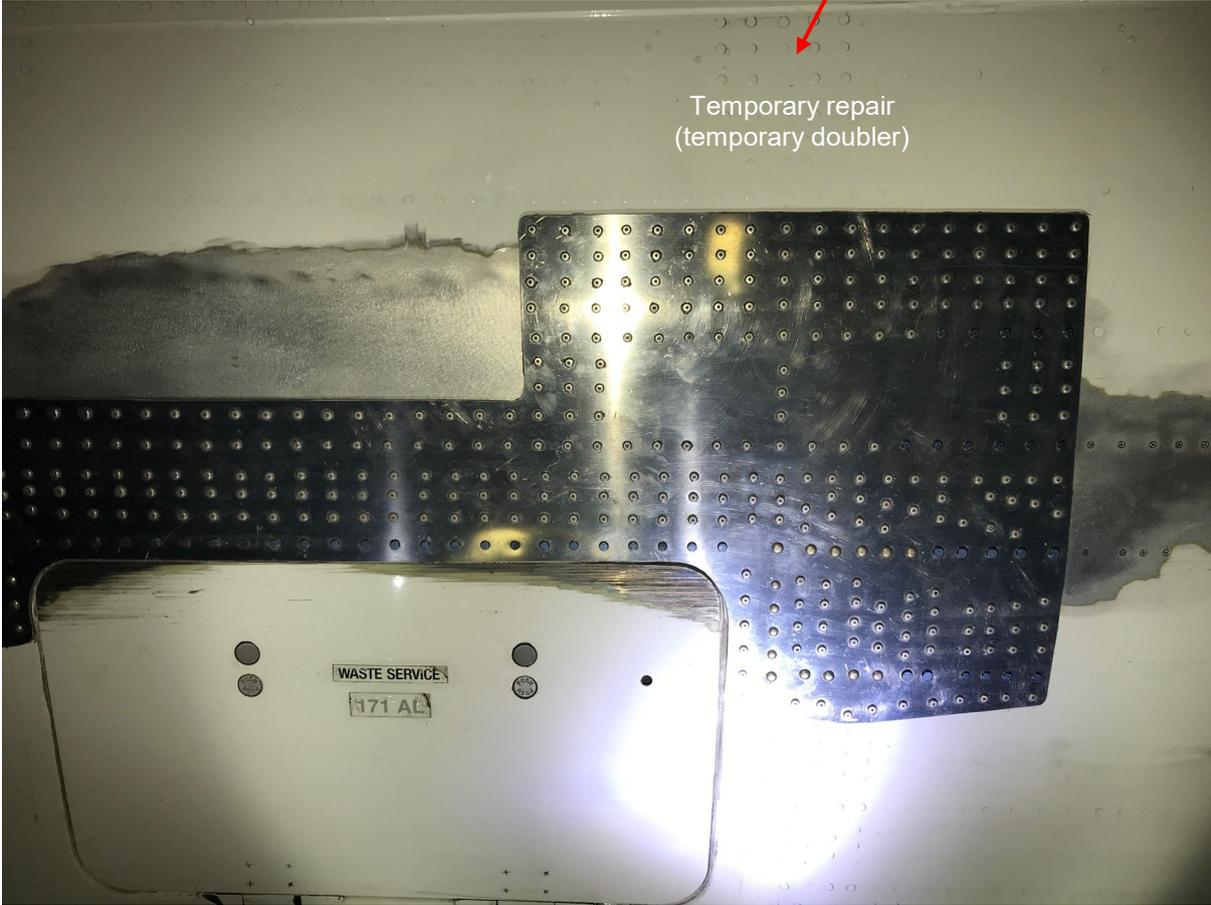
Annex 1: Damage to aircraft HB-JHC

Before continuing the flight to Dar es Salaam, the station mechanic informed the flight crew that he had detected fresh scratches and grinding marks on the lower fuselage of the aircraft's rear, near the waste water door (see Annex 1). After consultation with the maintenance company in Zurich, the onward flight was cancelled.

After a detailed and extensive inspection by specialists from the airline's maintenance company who were flown to Nairobi, and in consultation with the aircraft manufacturer, a temporary repair was carried out (see Annex 1). This was completed on the evening of 9 March 2020 and the aircraft was subsequently cleared for operation.
