Air Accident Investigation Unit Ireland

SYNOPTIC REPORT

SERIOUS INCIDENT

**Boeing 767-33A, N378AX
Shannon Airport, Co. Clare**

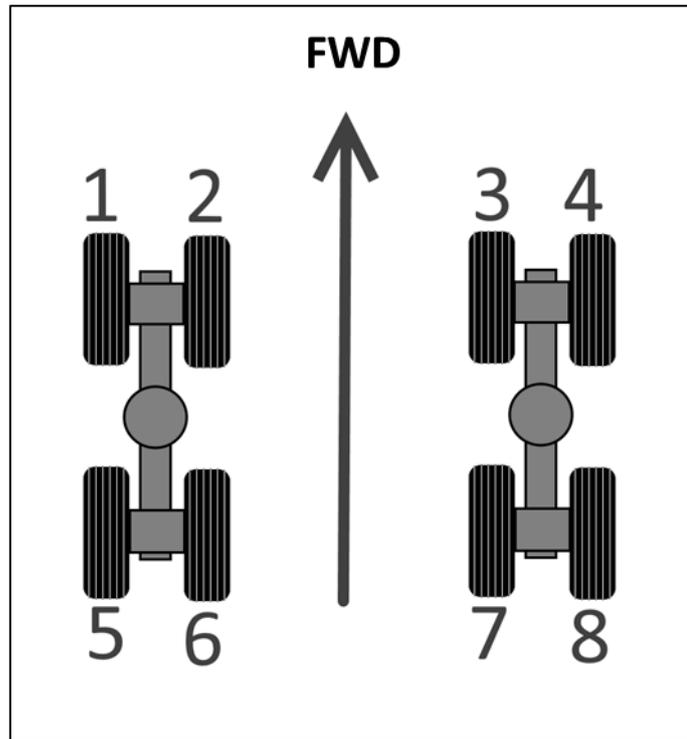
Figure No. 1: Wheel Position Numbering Convention

The two forward wheels identified as No. 1 and No. 2 (**Figure No. 1**) and their associated brake units on the left main bogie⁸ sustained substantial fire damage and burst tyres. The two aft tyres on the left main bogie sustained minor fire damage (**Photo No. 1**). The left main bogie and associated hydraulic lines sustained fire damage.

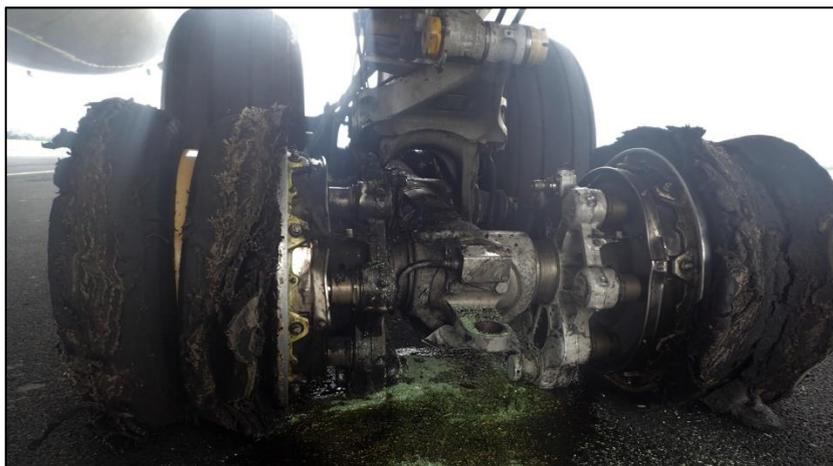
Photo No. 1: Fire Damage to Left Main Landing Gear (looking rearwards)

An examination of the main landing gear bogie, wheels, brakes and hydraulic lines carried out by the respective Manufacturers and witnessed by the FAA, found that there was no identifiable source of the fire. The examination found that all of the brakes on the left main gear were found to be within acceptable limits. Analysis of the flight recorder data by the Aircraft Manufacturer showed that the brakes functioned as expected for the weight and speed of the aircraft at the time of the occurrence and there was no evidence of brake '*dragging*'.

In summary, following a high-speed rejected take-off, and subsequent period of taxiing, a fire started in the left main landing gear area. The fire was rapidly extinguished by the AFRS, and passengers and crew were evacuated. Subsequent examination of the wheels, brakes and flight recorder data found no identifiable cause of the fire. It is therefore probable, that the combination of a rejected take-off at high speed, combined with a lengthy period of taxiing where brakes, particularly on the left side were used, caused the brake system to overheat and a fire to ignite in the left main gear bogie.

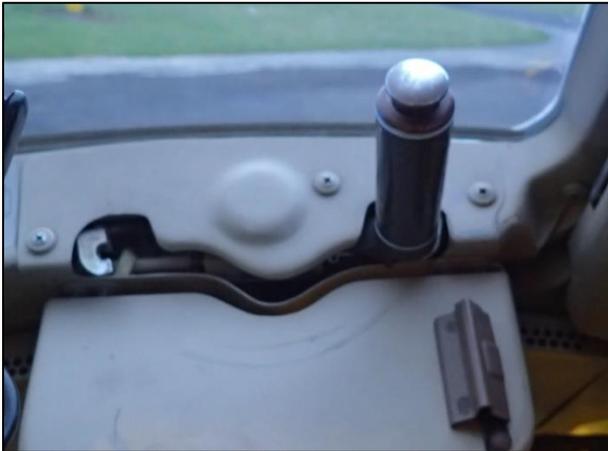
Photo No. 2: Left Centre Window Latch

A crank is used to move the window along the slide rail (**Photo No. 3**). When the window is fully seated in the closed position, it is locked by a latch lever (**Photo No. 2**). The Aircraft Manufacturer informed the Investigation that when the window is fully closed, a 'Window not closed' decal positioned below the window should not be visible. The Aircraft Manufacturer also stated that it is possible to move the latch lever into the closed position before the window is fully latched closed and for this reason Flight Crew Operations Manual (FCOM) (**Section 1.13**) specifies pre-flight checks to verify that the window is correctly closed.

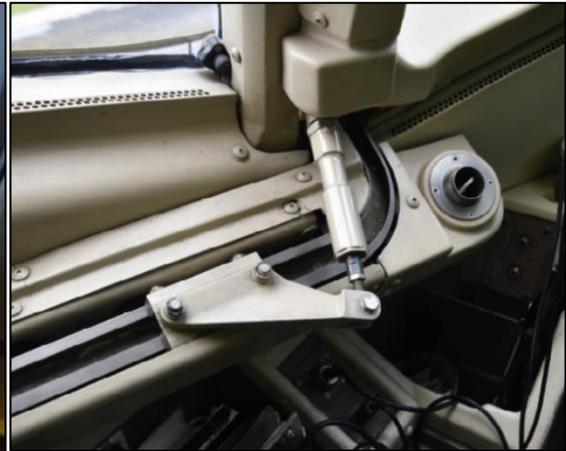
Photo No. 3: Left Centre Window Slide Rail

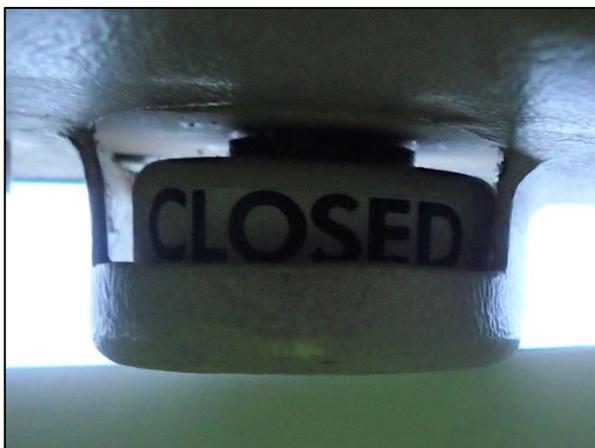
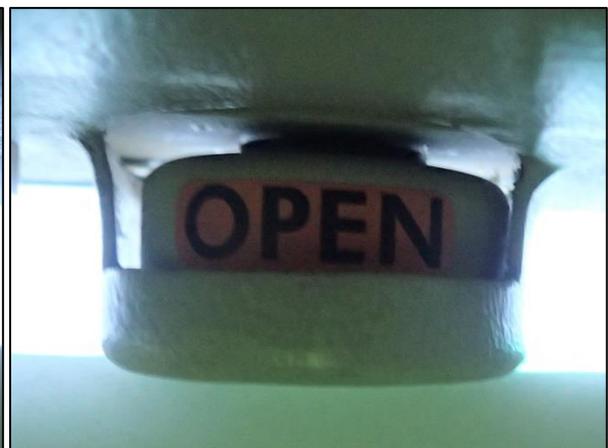
An OPEN/CLOSED indicator is located above the window (**Photos No. 4 and 5**). The Aircraft Manufacturer informed the Investigation that this indicator indicates the position of the latch cam only and is a secondary method of verifying that the window is latched after carrying out the other checks listed in the FCOM.

Photos No. 4 and 5: Window Status Indicator
