Technical report A-055/2019

Accident happened on 3 November 2019 to the BOEING B787-8 aircraft, registration N796AV, between VAKIN and DIRMU waypoints of the UN725 airway (Barcelona FIR/UIR)

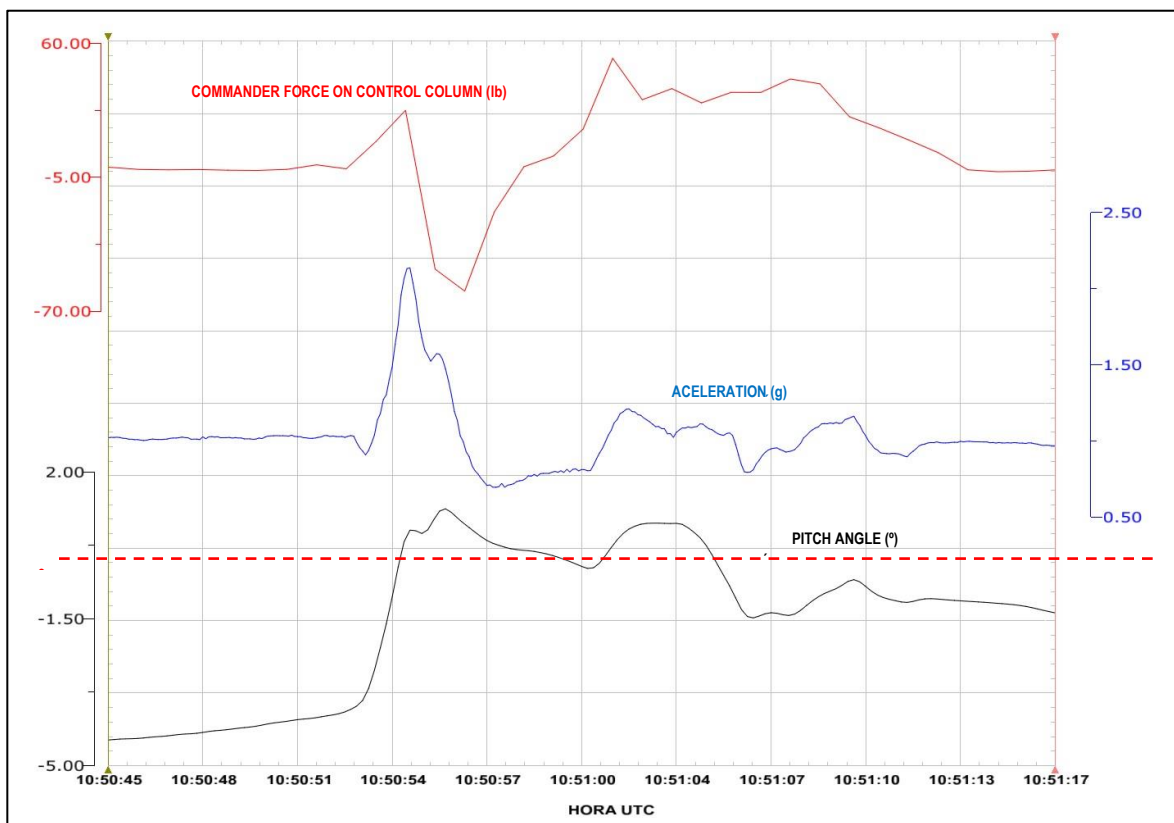
Figure 2: Parameters recorded in the flight data recorder

At 10:50:52 h, the pitch angle was -3.79°, the vertical speed was -4,300 ft/min, and the CAS was 354 kt.

At 10:50:53 h, the extension of the speed brakes was recorded.

- The aircraft reached its maximum speed of 356.87 kt CAS (10:50:54 h). The GPS coordinates for the point where the maximum speed was reached are 41° 47' 23.9" N and 000° 07' 48" E, close to the DIRMU waypoint.
- An increase in control column force was recorded, varying between +52.78 lb and -60.26 lb.

- The vertical acceleration ranged between +2.14 g and +0.69 g. The highest vertical acceleration value of +2.14 g was recorded at 10:50:55 h, dropping to +0.69 g 3 seconds later.

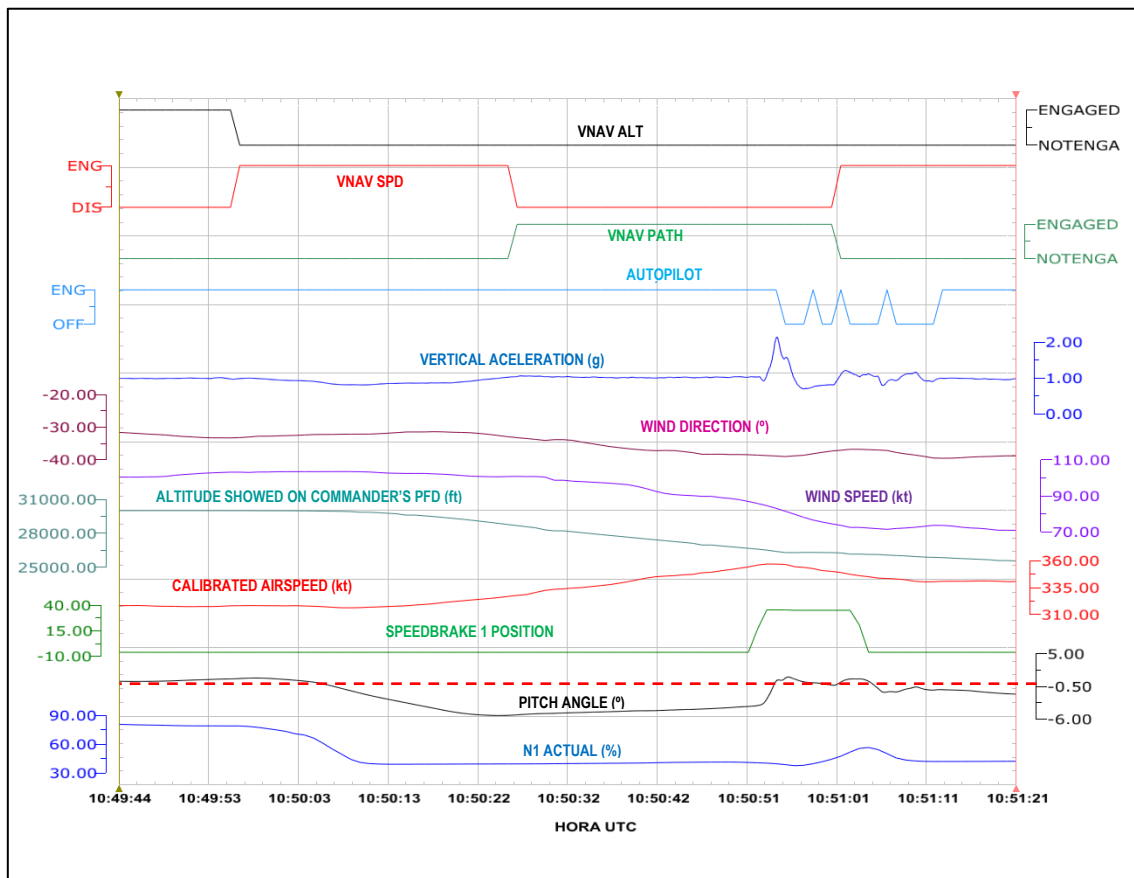
Figura 3. Parameters recorded in the flight data recorder

- During the same period, at 10:50:55 h:
 - the pitch angle reduced to +0.6 °, having changed from -3.7 ° to +0.6 ° in the space of 2 seconds.
 - the activation of the master warning and disconnection of the autopilot was recorded¹². The autopilot remained disconnected until 10:51:13 h.
- At 10:51:02 h, the autothrottle mode changed to IDLE and then HOLD. The pitch mode changed to VNAV PTH. The aircraft continued its descent in the HOLD/LNAV/VNAV SPD modes.
- After that point, the speed began to reduce, reaching 340 kt CAS at 10:51:10 h with a vertical speed of 2,077 ft/min at 25,959 ft of altitude.

- Three 1-second autopilot connections and subsequent disconnections were detected at 10:50:59 h, 10:51:02 h, and 10:51:07 h.
- At 10:51:13 h, the autopilot was permanently reconnected.
- The altitude varied between 26,527 ft and 25,866 ft.

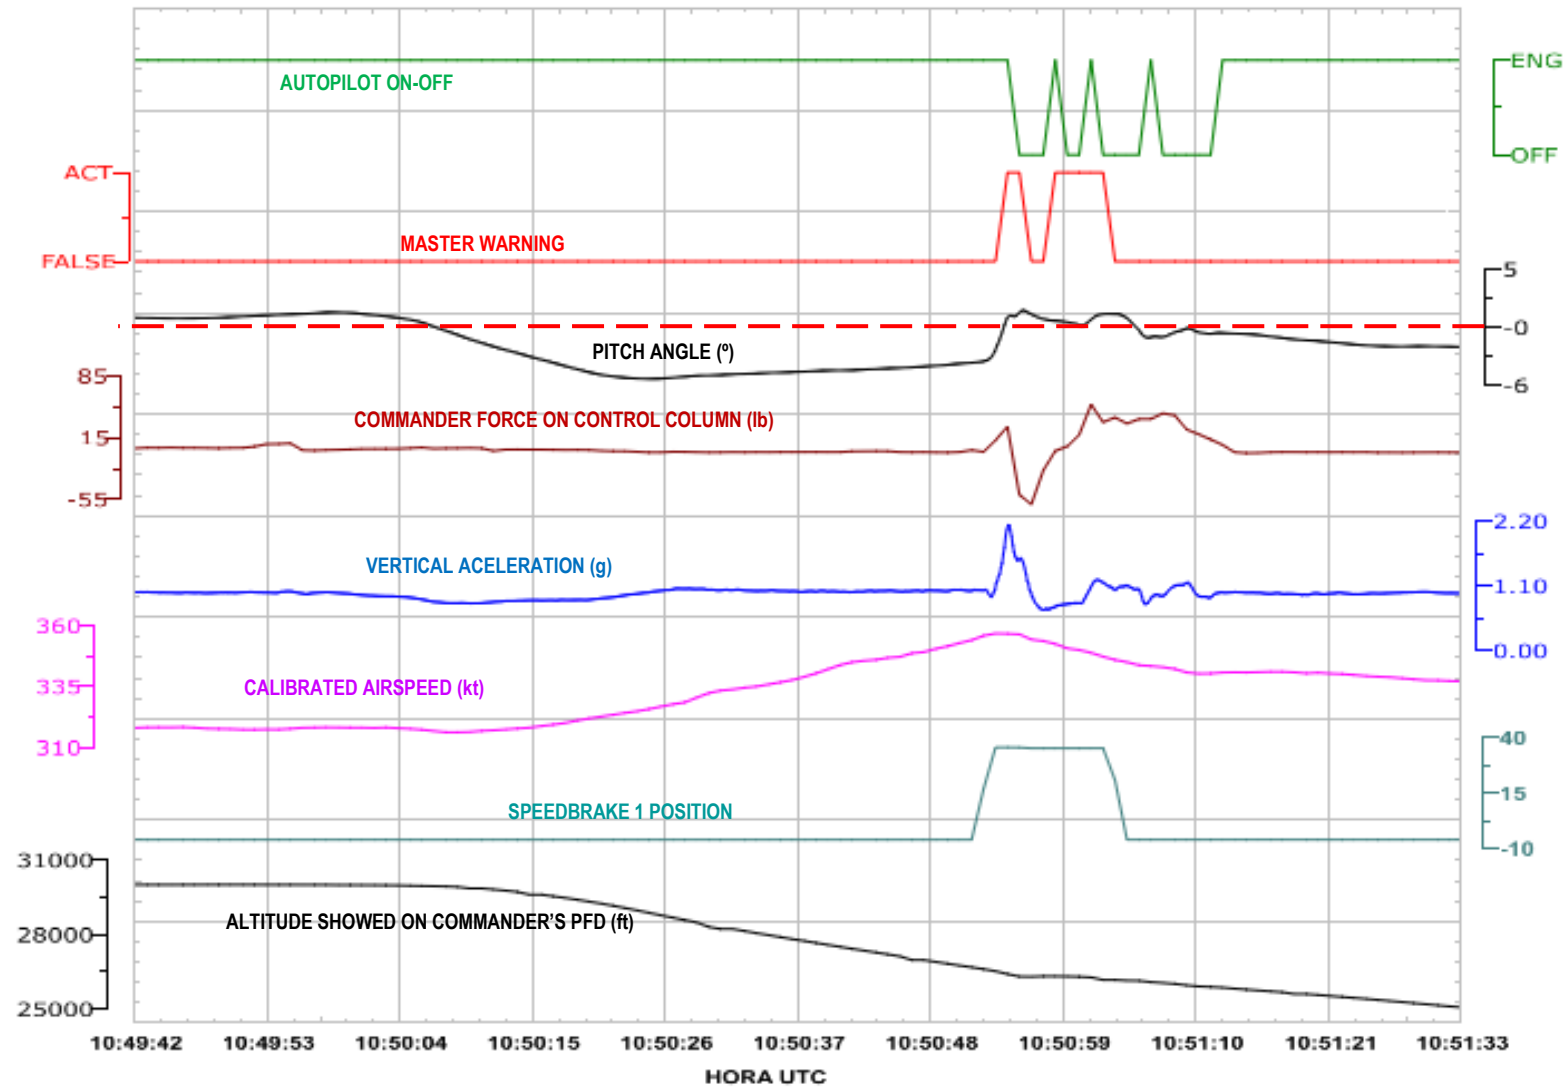
ANNEX 1 – FLIGHT PARAMETERS

With regard to the wind and temperature parameters, at 10:50:09 h, when the aircraft descended through 29,900 ft, the wind was recorded as coming from 328° at a speed of 103 kt. The SAT was -38°C. At 10:50:54 h, when the aircraft descended through 26,500 ft, the wind was recorded as coming from 322° at a speed of 84 kt. The SAT was -34°C. These parameters are illustrated in the following diagram and in annexes 1 and 2.
