SERIOUS INCIDENT

Aircraft Type and Registration:	Boeing 777-336ER, G-STBA
No & Type of Engines:	2 General Electric Co GE90-115B turbofan engines
Year of Manufacture:	2010 (Serial no: 40542)
Date & Time (UTC):	2 July 2021 at 0945 hrs
Location:	London Heathrow Airport
Type of Flight:	Commercial Air Transport (Cargo)
Persons on Board:	Crew - 16 Passengers - None
Injuries:	Crew - 1 (Minor) Passengers - N/A
Nature of Damage:	None
Commander's Licence:	Airline Transport Pilot's Licence
Commander's Age:	53 years
Commander's Flying Experience:	17,000 hours (of which 10,300 were on type) Last 90 days - 91 hours Last 28 days - 24 hours
Information Source:	Aircraft Accident Report Form submitted by the pilot

Synopsis

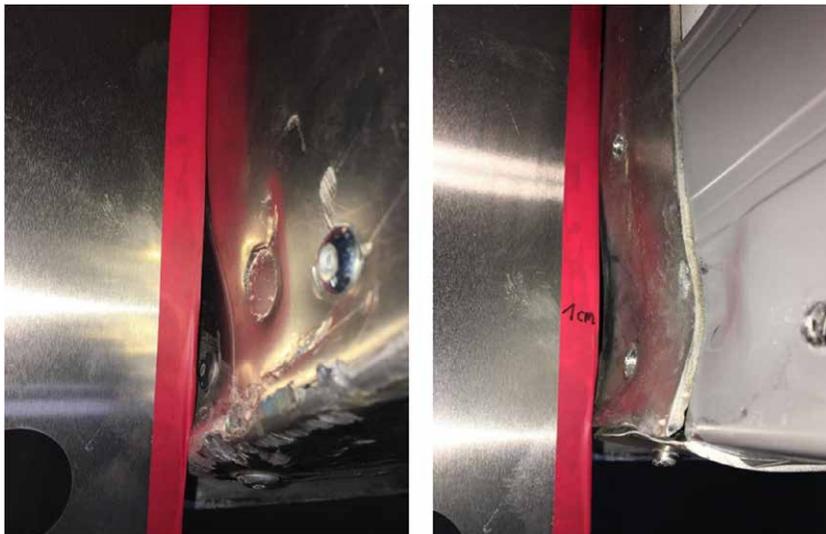
Figure 3

'the smoke was a consequence of improper handling of the container, which led to a short circuit of two of the batteries. The short circuit was caused by a significant impact/collision on the back of the container, where the affected batteries are located.'

Impact damage to container

In the opinion of the manufacturer the damage was the result of a significant impact to the container, beyond what should be expected in routine handling. The deformation caused a bracket in the battery compartment to be torn from its mounting. The manufacturer made the following finding:

'As one of the brackets to secure the batteries had been compromised, the batteries were able to shift sideways which led to the battery cables/poles rubbing against a secondary securing bracket. As a result, the battery cables sheared and heated which led to a short circuit as expected. This prevented any further incident to the container electrics that would lead to a fire outbreak. The heating of the cables caused the smoke which highlighted the incident to the ground handler.'

The examination of the container indicated that it been subject to a collision which caused damage to a battery bracket. The damage allowed the batteries to move position and

cause a short circuit. The electrical system had been designed to tolerate this damage, though the subsequent heating of the battery cables produced the smoke that triggered the FIRE CARGO AFT warning.

The container manufacturer decided to consider reinforcing the battery attachment and, if necessary, make modifications to improve the functionality and safety of the container.

The operator decided to consider introducing a comprehensive damage check on all similar containers before they are loaded onto aircraft.
