Accident to the PIPER - PA-46 - 350P registered F-GUYZ

on 8 February 2019
at Courchevel (Savoie)

Runway overrun during landing, collision with a mound of snow

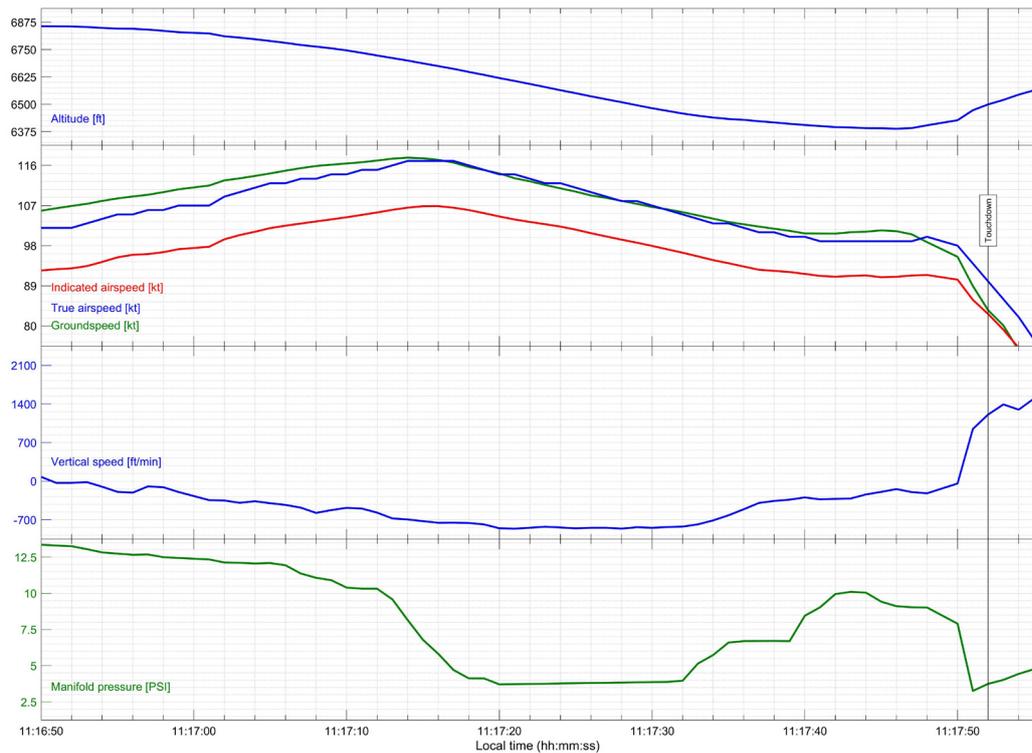
Figure 5: Parameters during final based on Garmin G1000 avionics suite

In final, at the beginning of the descent, the indicated airspeed was 85 kt which then increased up to 101 kt before re-descending to 91 kt. At the same time, the rate of descent globally increased with substantial variations until stabilizing at around -800 ft/min. It is interesting to note that during the last 20 s of the final, power was at idle. All these elements show that the approach was not stabilized.

When the aeroplane approached the upward sloping part of the runway, the pilot progressively increased power. The speed was stabilized at around 90 kt for approximately 10 s.

Two seconds after the reduction in power, the wheels touched down roughly half way along the runway. The speed was 79 kt.

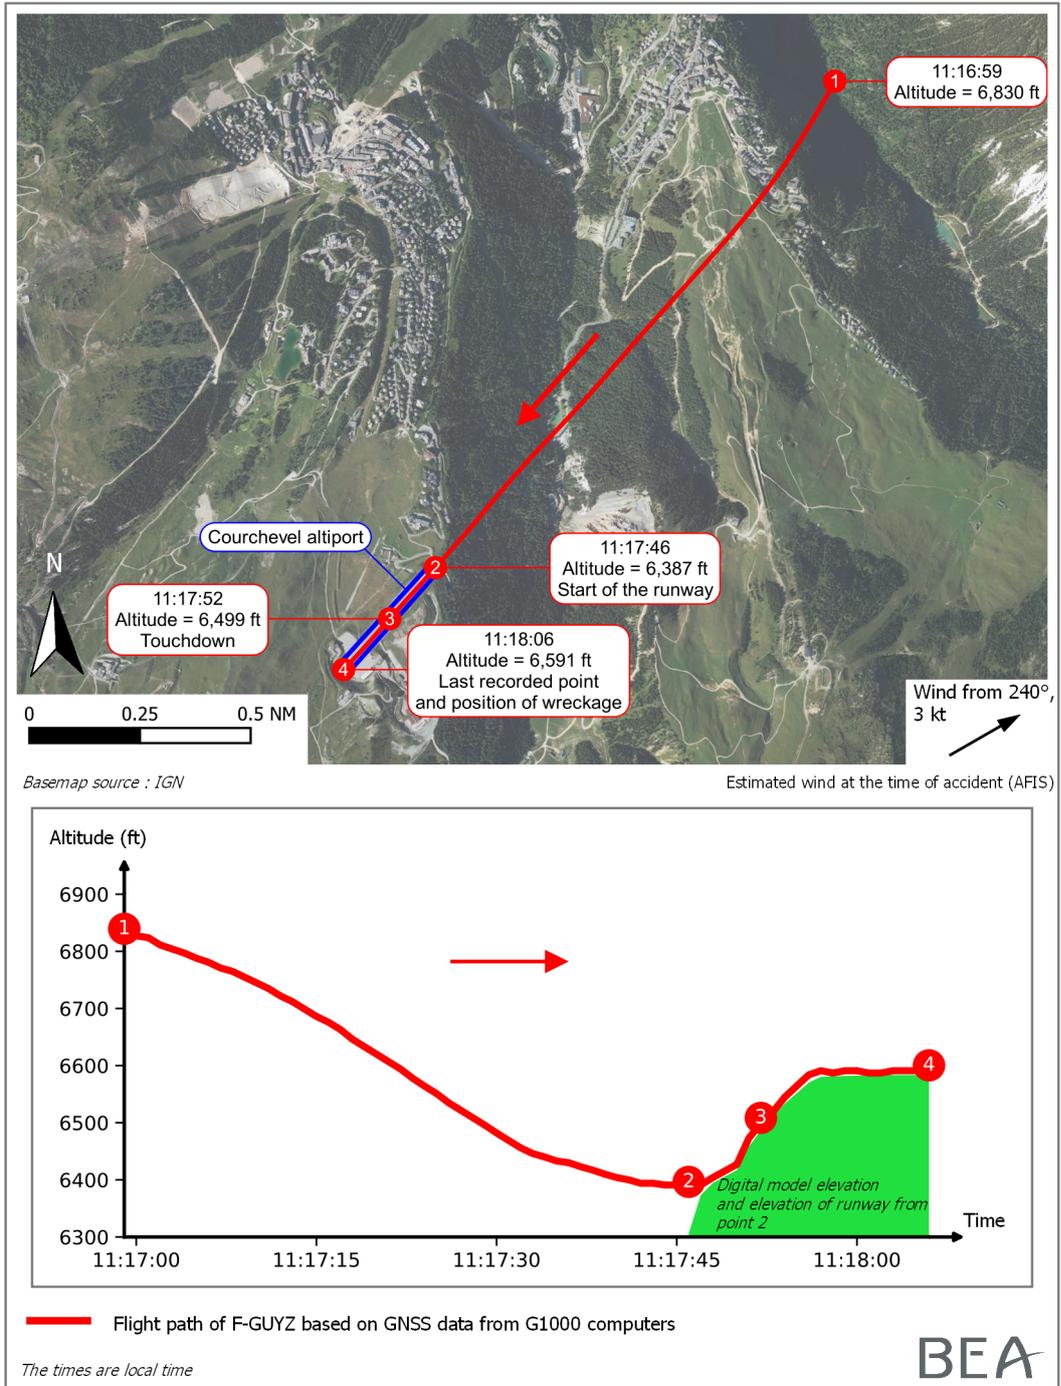
Figure 6: F-GUYZ final flight path at Courchevel

During the final to Courchevel mountain airfield, the pilot extended the flaps to the second of the three detents. The plane's parameters were not stabilized. The speed on short final was consistent with the speed suggested by the instructor during the pilot's skill-test flight carried out the day before. After flaring, when the plane was parallel with the runway, the pilot throttled back late. This power reduction took place halfway along the runway, at around 270 m after the runway threshold when the speed was still 80 kt.

The remaining distance was insufficient to safely stop the aeroplane. Despite the pilot's inputs on the brakes to try to stop the aircraft, it overran the runway and collided with a wall of snow.
