## Serious Incident –Final Report–

AAIS Case N°: AIFN/0010/2018

# Runway Confusion Takeoff from Wrong Runway

Operator:	Air Arabia
Make and Model:	Airbus A320-214
Nationality and Registration:	The United Arab Emirates, A6-ANV
Place of Occurrence:	Sharjah International Airport
State of Occurrence:	The United Arab Emirates
Date of Occurrence:	18 September 2018

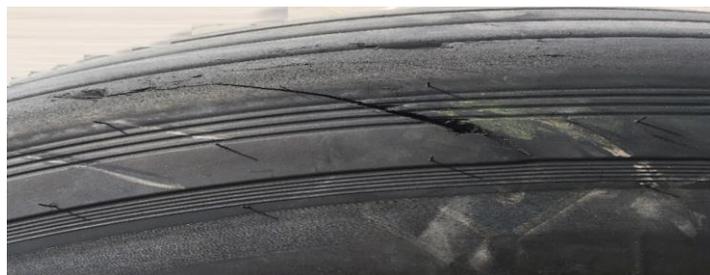
The Aircraft was intact. The No. 3 main wheel tire on the right main landing gear struck a runway approach light located at the runway-end safety area, which resulted in cuts to the inboard sidewall and tread (figure 1). The tire remained inflated during the flight. As per the Commander's statement, he could not notice any cuts on the tire as the cut was on the lower invisible part of the tire.

Figure 1. Damaged No. 3 main wheel tire

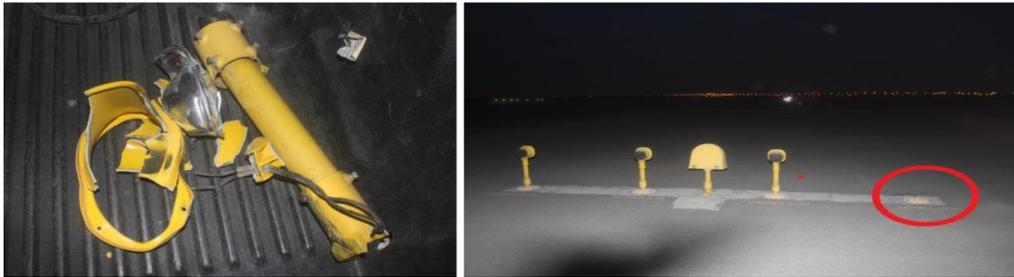
The No. 3 main wheel tire struck the runway 30 approach light. The support post of the approach light was made of steel and was bolted to the runway surface with a height of 70 centimeters. The base of the light support structure was completely detached, and the light assembly was broken (figure 2). The damaged approach light was located on the runway end safety area (RESA) (figure 3).

Figure 2. Damaged runway 30 approach light

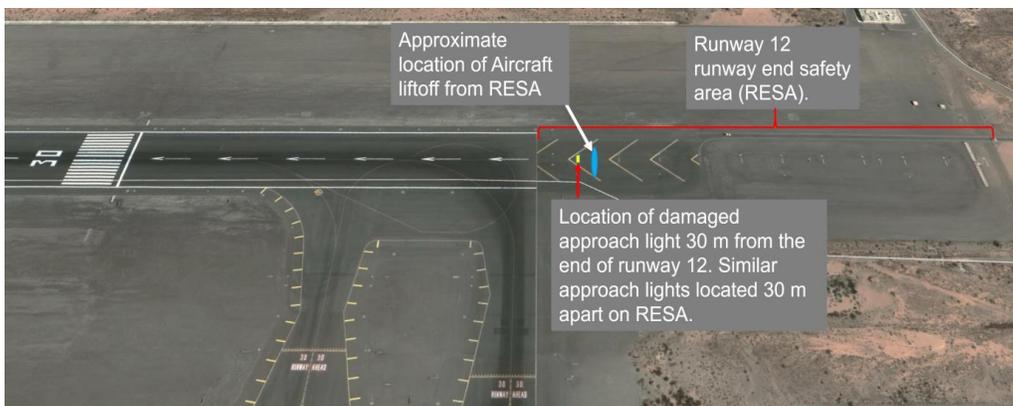
Figure 3. Location of the damaged runway 30 approach light on the runway end safety area (RESA)

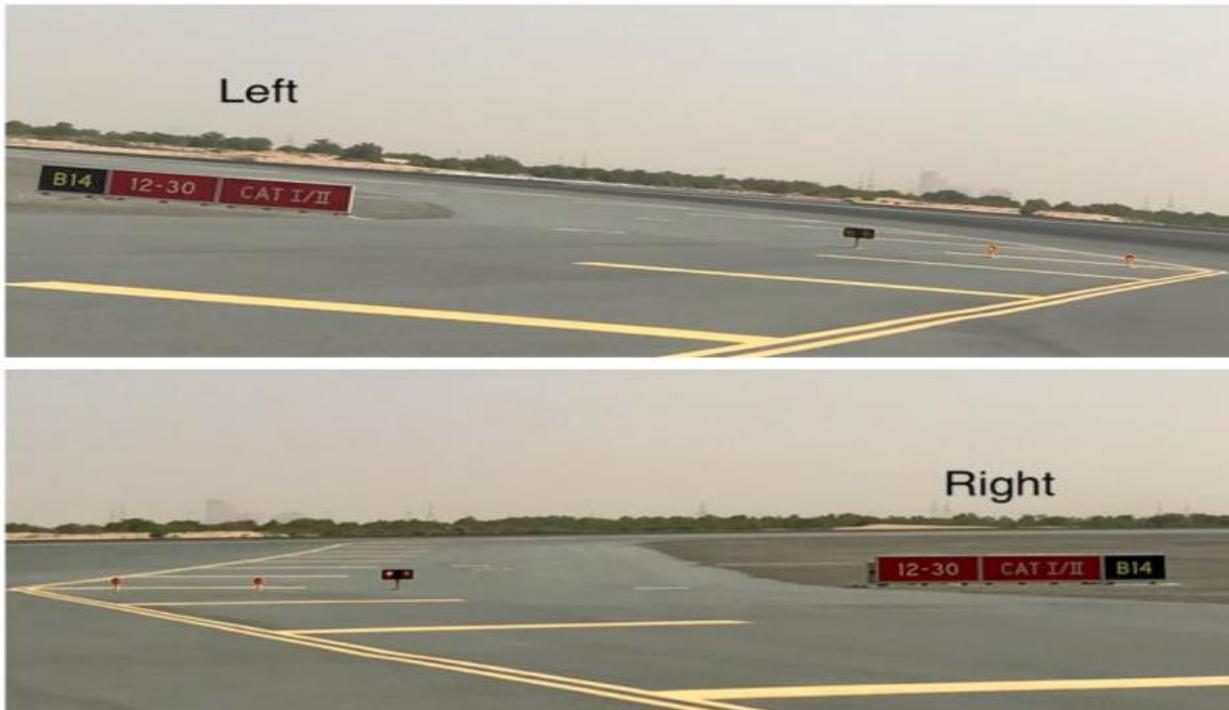
Figure 7 illustrates that when runway 30 is used for intersection takeoff at Bravo 14, a left turn is required, with a take-off distance available of 3052 meters. The taxiway centerline that leads to runway 12 and runway 30 is marked with a continuous 150 millimeter wide yellow line in accordance with the requirements of the Civil Aviation Regulations *CAR Part IX - Aerodromes*. In case a right turn is made, the aircraft will be on runway 12 with the runway available of 1006 meters,

Figure 7. Taxiway Bravo 14 runway 12/30 holding point information signage

Although the Investigation could not confirm that whether or not the existence of TORA information at the intersection could have prevented entering the wrong runway, the Investigation believes that such information would have enhanced the flight crew situation awareness of the remaining runway available. Therefore, the Investigation recommends that the airport operator performs a risk assessment for fixing a sign illustrating the TORA at the intersection takeoff as stated in *CAR Part IX*.

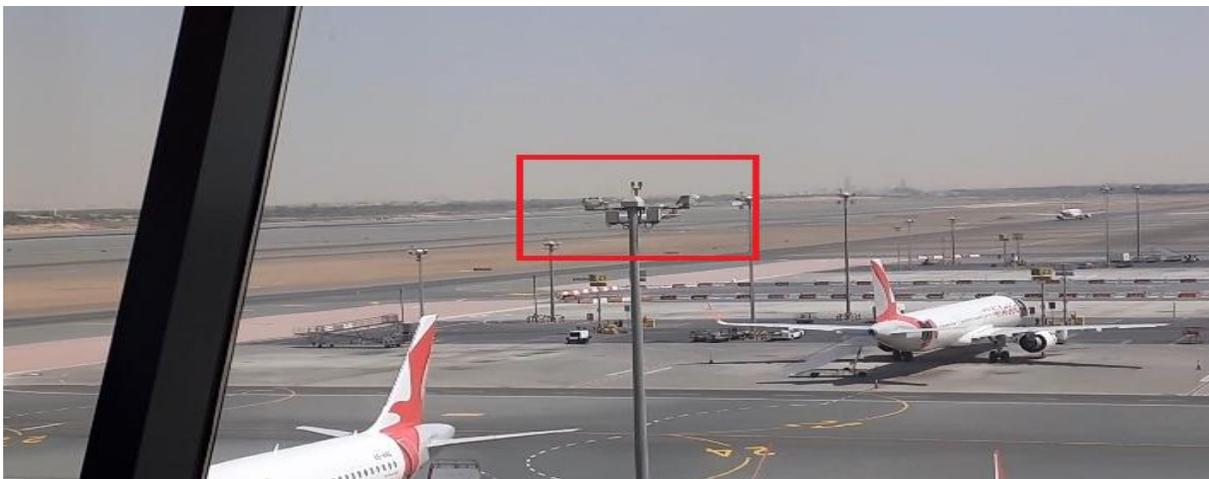
**Figure 8.** Standby tower obstructed view of an Airbus A320 aircraft at Bravo 14 holding point

The Investigation noted that monitoring of aircraft taxiing to Bravo 14 intersection and onto runway 12/30 was obstructed by a light pole which was located at the aircraft parking stand at a short distance from the tower. As Bravo 14 intersection with runway 12/30 was not covered by the CCTV, and Bravo 14 was about 1 kilometer from the tower, the controllers needed to physically move and sometimes use binoculars to visually watch a movement of aircraft or vehicle.

The Investigation noted that sighting the direction of an aircraft holding at Bravo 14 intersection was obstructed by a light pole located at the aircraft parking stand a short distance away from the standby tower. As the airport was not equipped with ground movement radar, the only means for monitoring Bravo 14 intersection was the visual watch. However, because of the obstruction of sighting Bravo 14 by the lighting pole, the controllers should change their body position in order to see an aircraft holding at Bravo 14. The controllers could also use binoculars because Bravo 14 was located about 1 km from Tower.

SANS is recommended to explore the possibility of re-evaluating the risks surrounding intersection takeoffs post this Incident, and prepare a safety case study, if needed, to prevent similar incidents from occurring.
