Incident to the AIRBUS - A318 - 100 registered F-GUGD on 20 December 2019 close to Hyères-Le Palyvestre airport (Le Var)

This is a courtesy translation by the BEA of the Final Report on the Safety Investigation published in September 2021. As accurate as the translation may be, the original text in French is the work of reference.

Acquisition of a false glide slope signal on approach, increase in pitch attitude with autopilot engaged, activation of the flight envelope protections

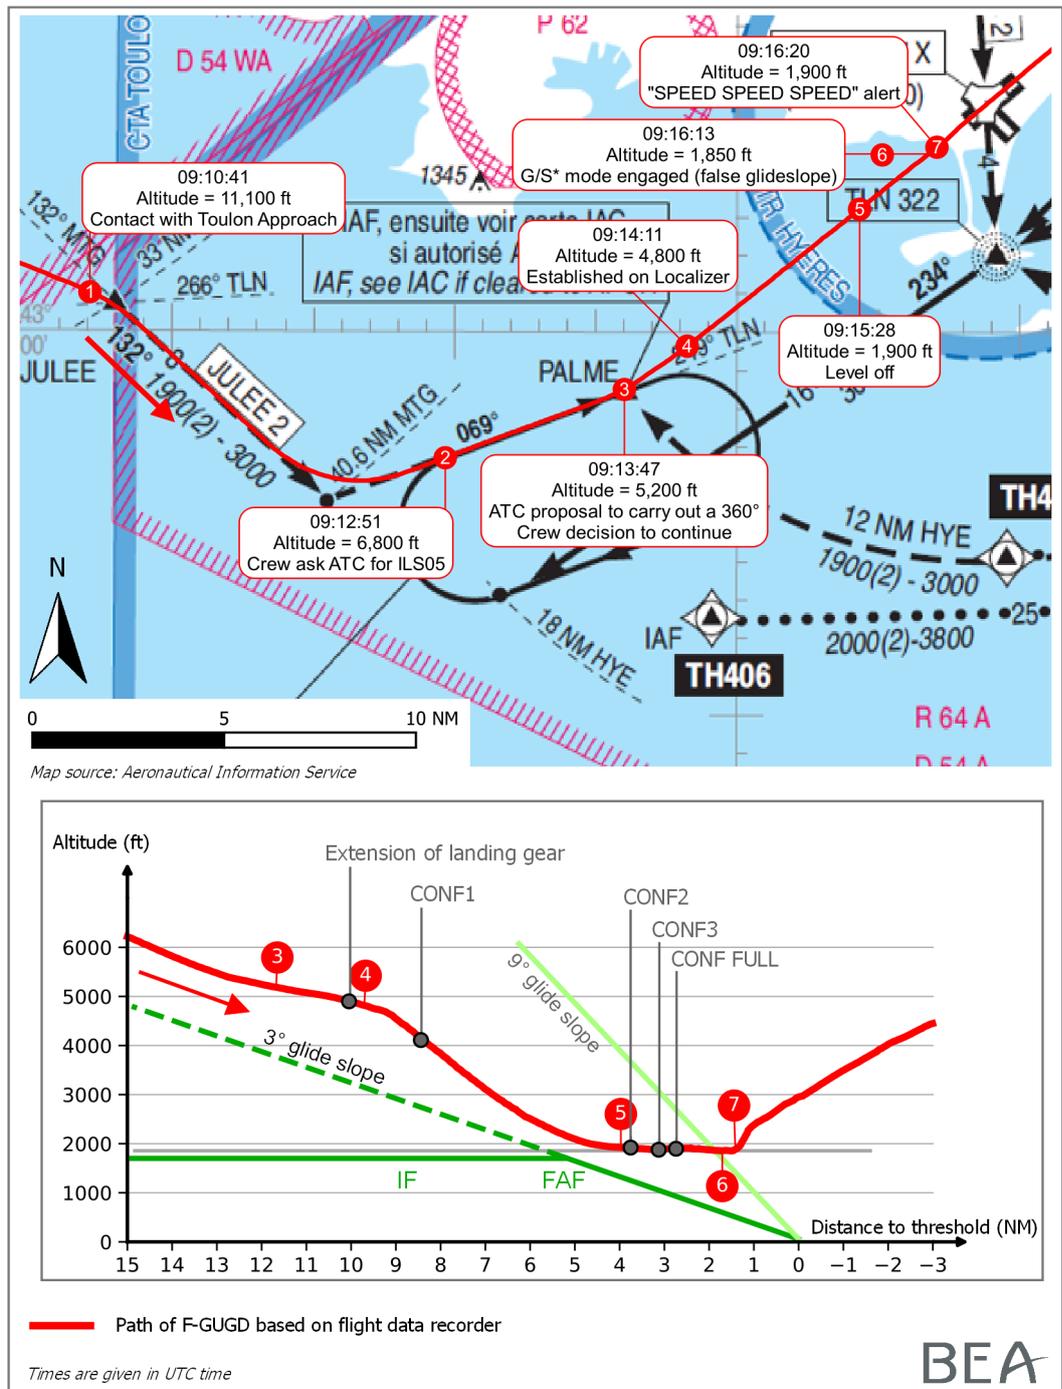
Figure 1: F-GUGD's flight path

During the left turn to join the Initial Approach Fix (IAF) (PALME waypoint), the tailwind component recorded by the aeroplane went from 0 to 50 kt in around 40 s. It remained higher than 40 kt during the descent to roughly 3,000 ft.

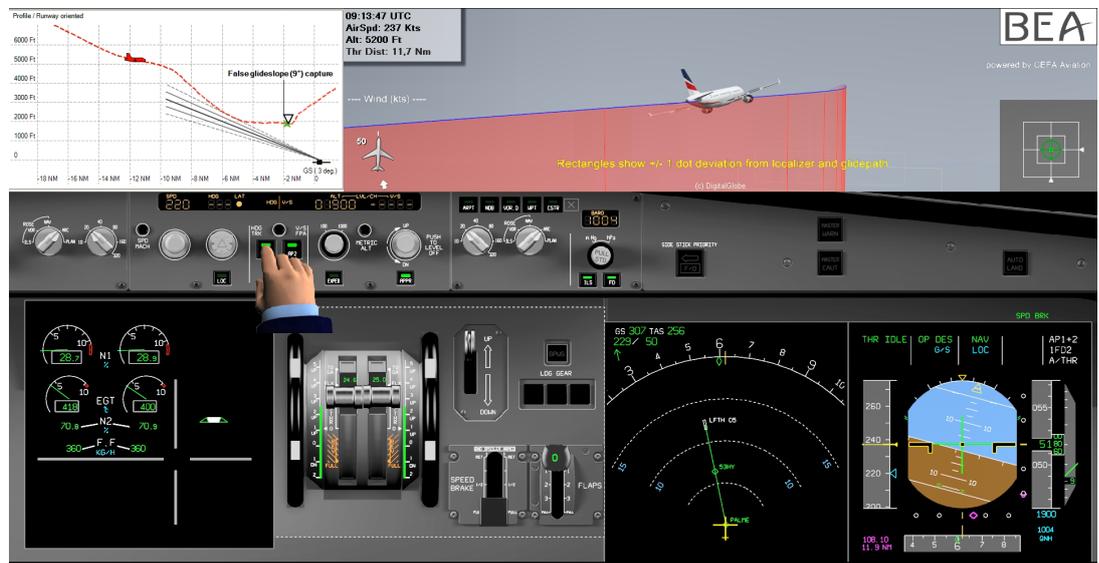
Around one minute later, the crew passed the IAF. The controller asked the crew if they wanted to make a direct approach or to carry out a holding pattern in order to descend. The crew replied that they wanted to make a direct approach for runway 05. The controller cleared them for the approach. At the same time, the APPR mode and AP 1 were engaged. At this point, the aeroplane was 12 NM from the runway threshold at an altitude of 5,170 ft, i.e. approximately 1,350 ft above a 3° glide slope, with an indicated airspeed of 237 kt and decreasing, and a ground speed of 307 kt (see [Figure 1](#) point ③ and Figure 2).

Figure 2: Reconstruction of flight path and main flight instruments at 09:13:47 on passing the IAF. The left window shows the vertical profile of the flight path and the 3° Instrument Landing System (ILS) glide slope; the main view shows the flight path in 3D.

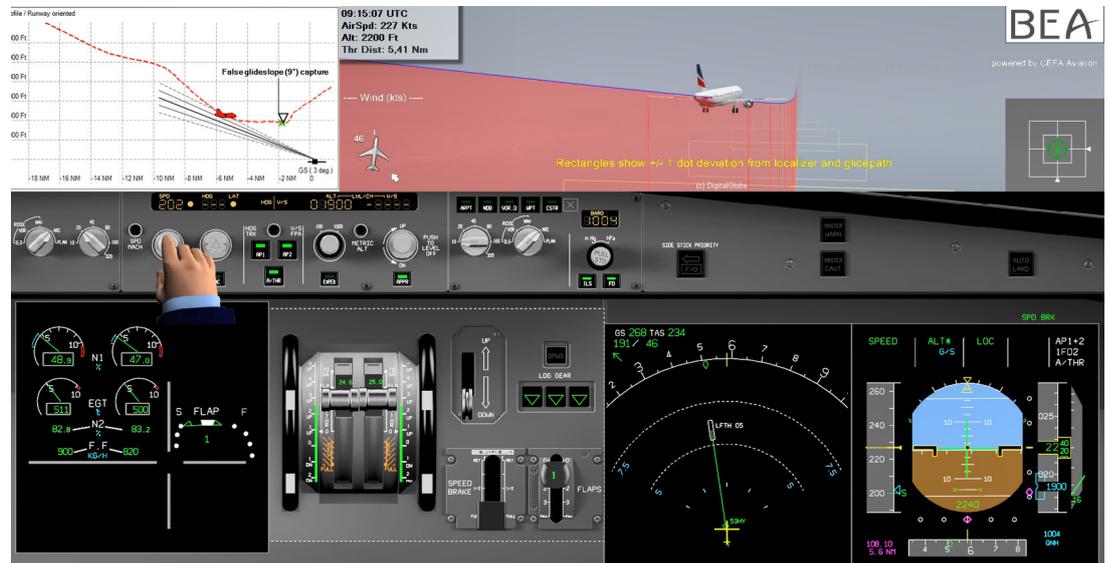
Shortly after, at 09:15:07, the crew passed the Final Approach Fix (FAF) situated at 5.3 NM from the runway threshold. At this point, the altitude was 2,200 ft and decreasing, i.e. 500 ft above the published altitude of the FAF (1,700 ft). The crew engaged the managed speed mode. The position of the glide index on the Primary Flight Display (PFD) was close to the lower limit indicating that the aeroplane was above the glide slope (see Figure 3).

Figure 3: Situation at 09:15:07 on passing FAF

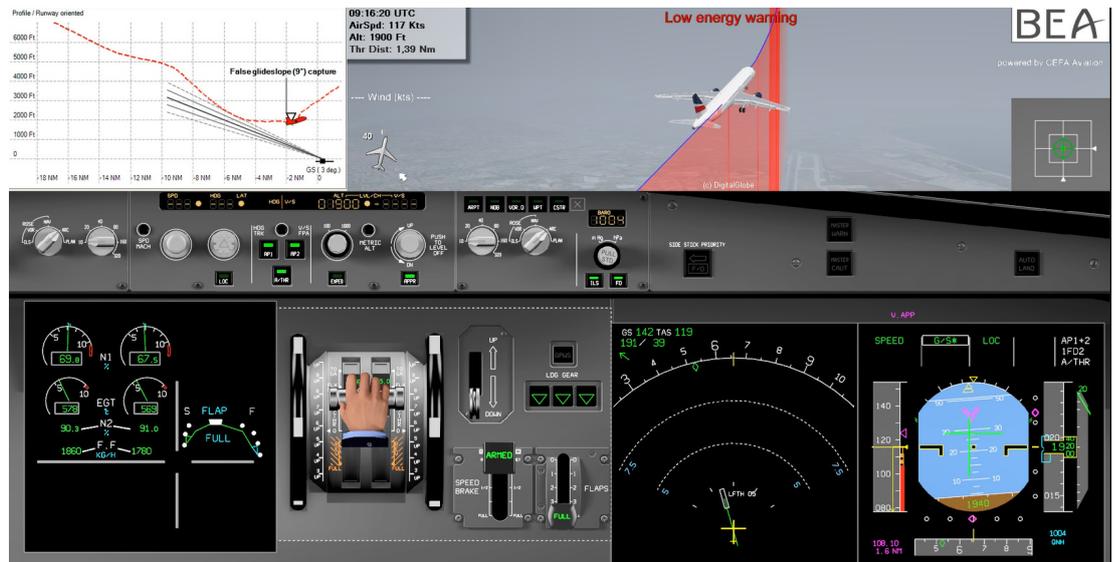
Figure 4: Situation at 09:16:20 on triggering of LOW ENERGY alert

When the pitch reached 30°, the angle of attack reached 16° and exceeded the Alpha Max (15°) for one second before decreasing under the combined effect of the triggering of the ALPHA PROT protection and the nose-down inputs made by the PF. The indicated airspeed also decreased and reached a minimum of 96 kt, i.e. 20 kt below the VLS⁽⁶⁾ and 2 kt above the VS1G⁽⁷⁾.

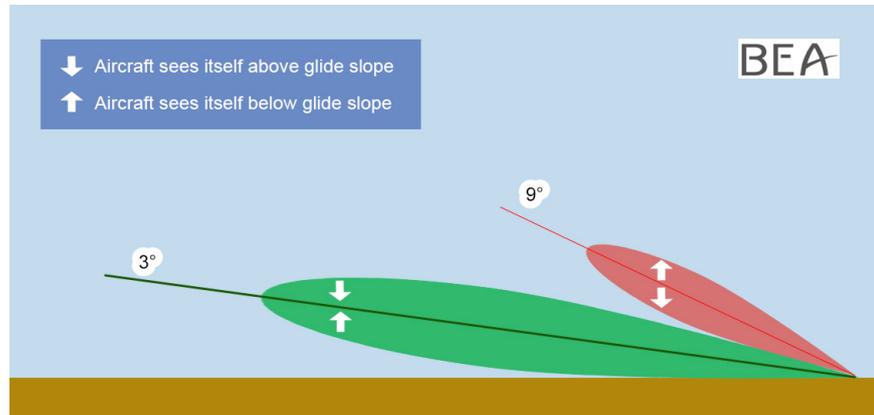
The main lobe, centred on 3°, concentrates the majority of the transmission energy and corresponds to the published glide path. An unwanted secondary lobe is present at around 9° due to the nature of the glide antenna radiation. In this lobe, the glide signal is inverted (see [Figure 5](#)).

Figure 5: Schematic diagram of ILS

In particular, when the aircraft is situated above the 9° glide slope, in the secondary lobe, it sees itself below the nominal approach slope and the AP commands nose-up orders.
