**FINAL REPORT ON SERIOUS INCIDENT TO M/s AIR ASIA
(INDIA) LTD, A320 AIRCRAFT, VT-CCU AND M/s INDIGO, A320
AIRCRAFT, VT-IAR IN DELHI AIRSPACE, ON 29/02/2020**

**FINAL REPORT ON SERIOUS INCIDENT TO M/s AIR ASIA (India) LTD, A320 ,
VT-CCU AIRCRAFT AND M/s INDIGO, A320, VT-IAR AIRCRAFT AT DELHI
AIRSPACE, ON 29/02/2020**

On 29.02.2020, a Serious Incident occurred between M/s Air Asia (India) Ltd (Call Sign- IAD776, Type- A320, Registration- VT-CCU) and M/s Go Indigo (Call Sign- IGO2124, Type- A320, Registration- VT-IAR) in Delhi Approach at 1259 UTC.

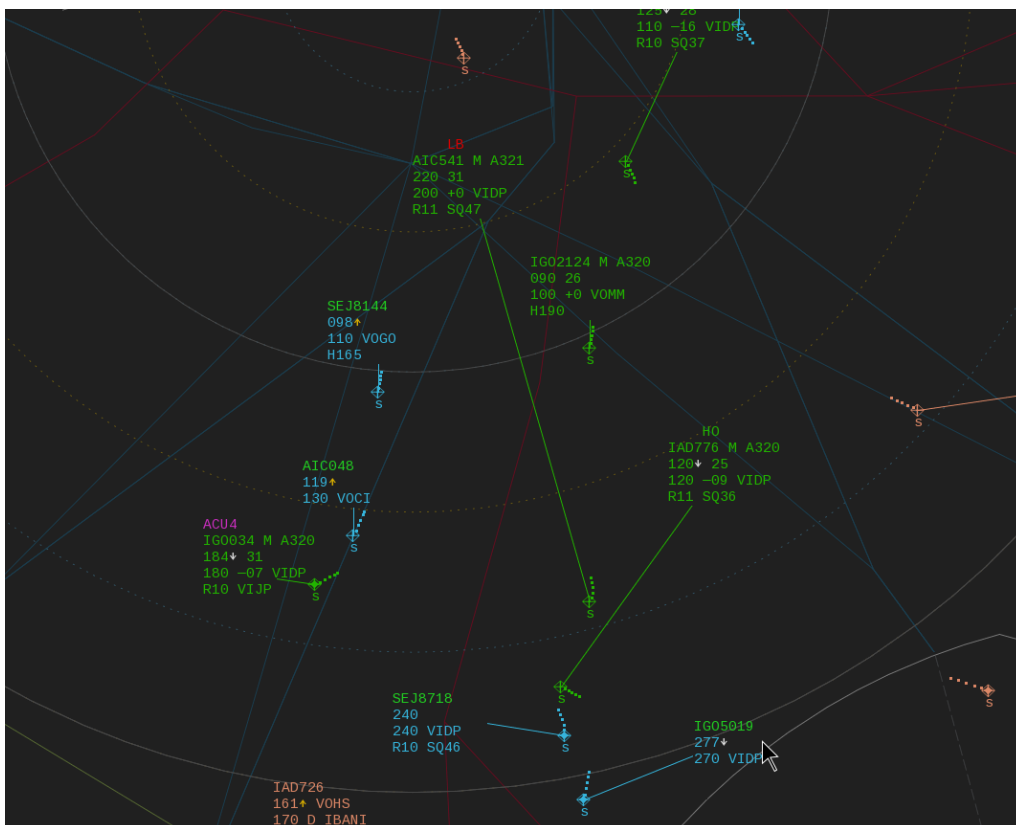
Due to bad weather, aircraft were diverting from their assigned tracks. Due to which IAD776 and IGO2124 came on reciprocal track. IGO2124 was maintaining F100 and IAD776 was descending to FL110.

Figure: Initial position of IAD776 arriving Delhi and IGO2124 departing from Delhi

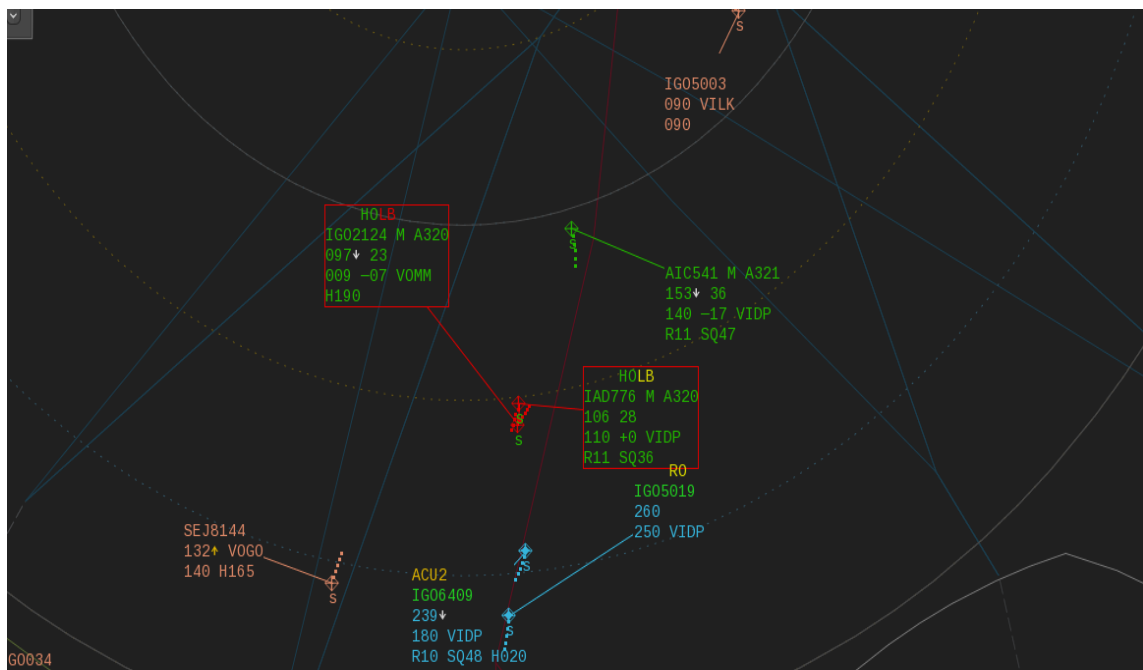
Figure: Showing minimum separation between IAD776 AND IGO2124

The standard separation reduced to 0.5 NM laterally and 600 Feet vertically. Standard separation was restored in 26 sec.

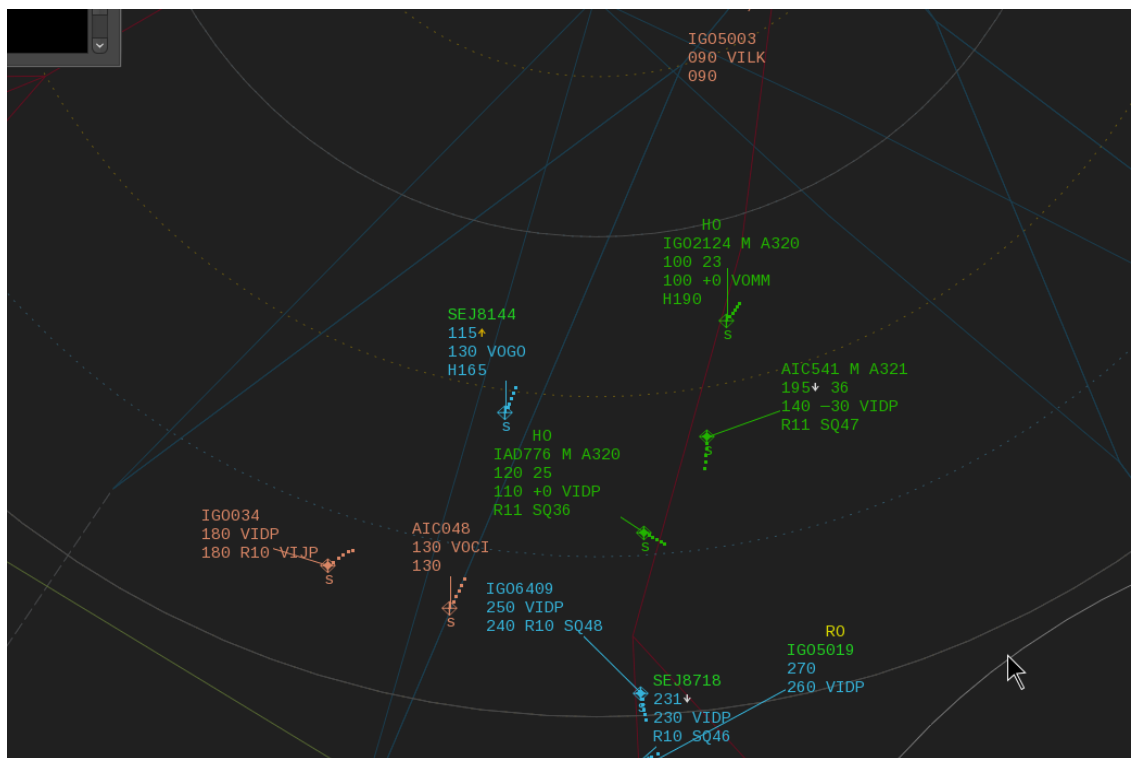
At 12:57:27 UTC, IAD776 was instructed to descend to FL110. This instruction was readback correctly by flight crew of IAD776. In CVR, there were no conversation of descending to FL100 nor the flight crew crossed checked the Assigned level. Flight crew did not use the standard phraseology for leaving flight level or descending to flight level.

Figure: at 12:57:30 UTC, IAD776 given descent to FL110 and IGO2124 maintaining FL100

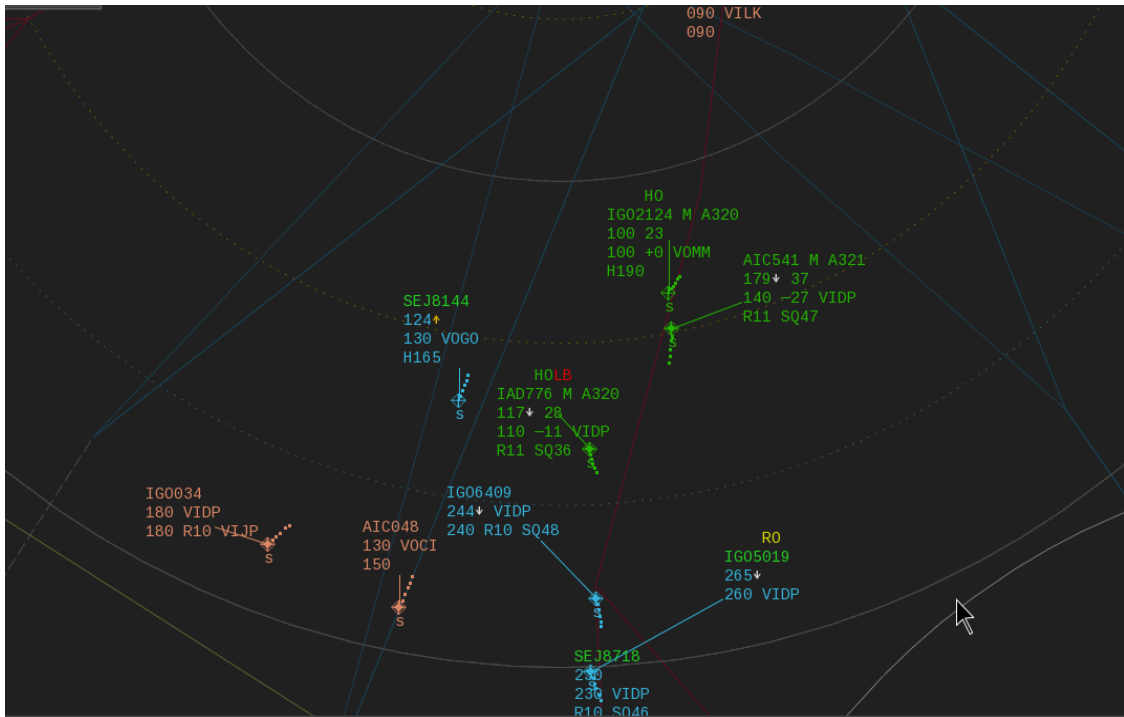
An indication of level burst alert is generated by the Indra Automation System which indicates that the level feed in aircraft by Flight crew is different to what is entered by the controller in its automation system. It is indicated as "LB" in red colour.

After giving descent, it was found that level burst alert had generated by the system which was neglected by the controller.

Figure: At 1258 UTC, Level burst (LB) was generated

ii. Airports Authority of India may advise its controllers to be more cautious for system generated alerts.

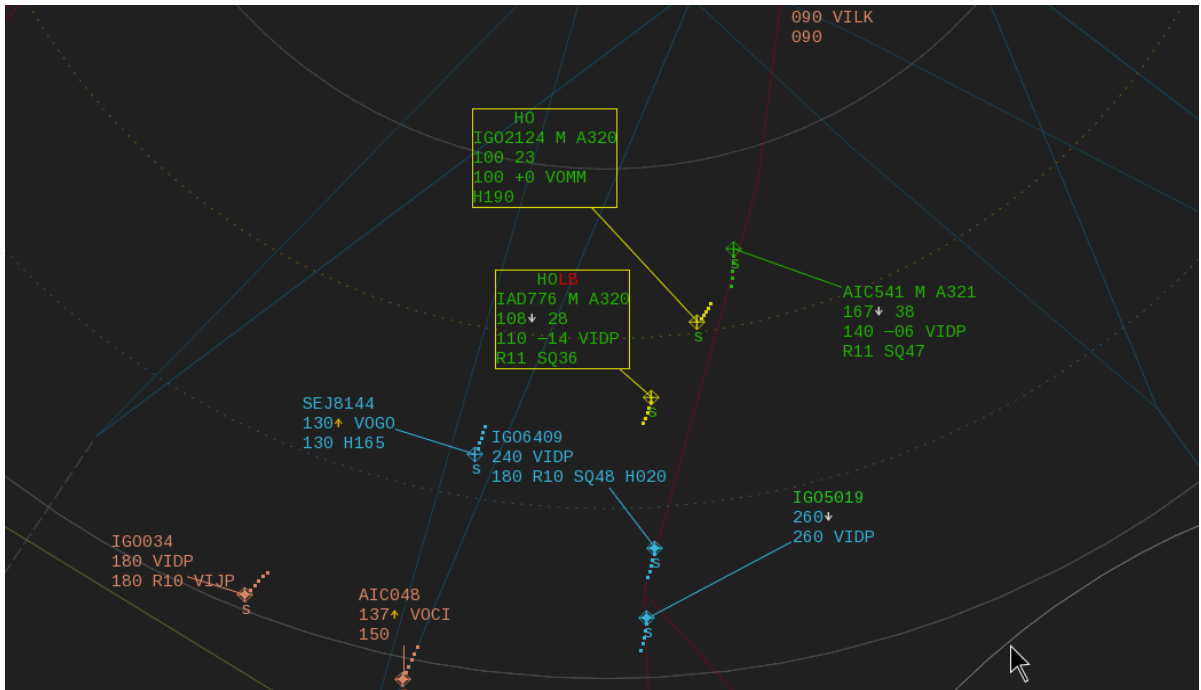
After sometime, it was observed by controller that IAD776 is descending below its assigned level i.e. FL110. Controller gave avoiding action by instructing IAD776 to climb to FL110 and IGO2124 to descend to FL90, but at 12:58:43 UTC a Short Term Conflict Alert (STCA) was generated by the ATM automation system for a likely conflict between IGO2124 and IAD776.

Figure: STCA (Predicted) generated on Automation Screen

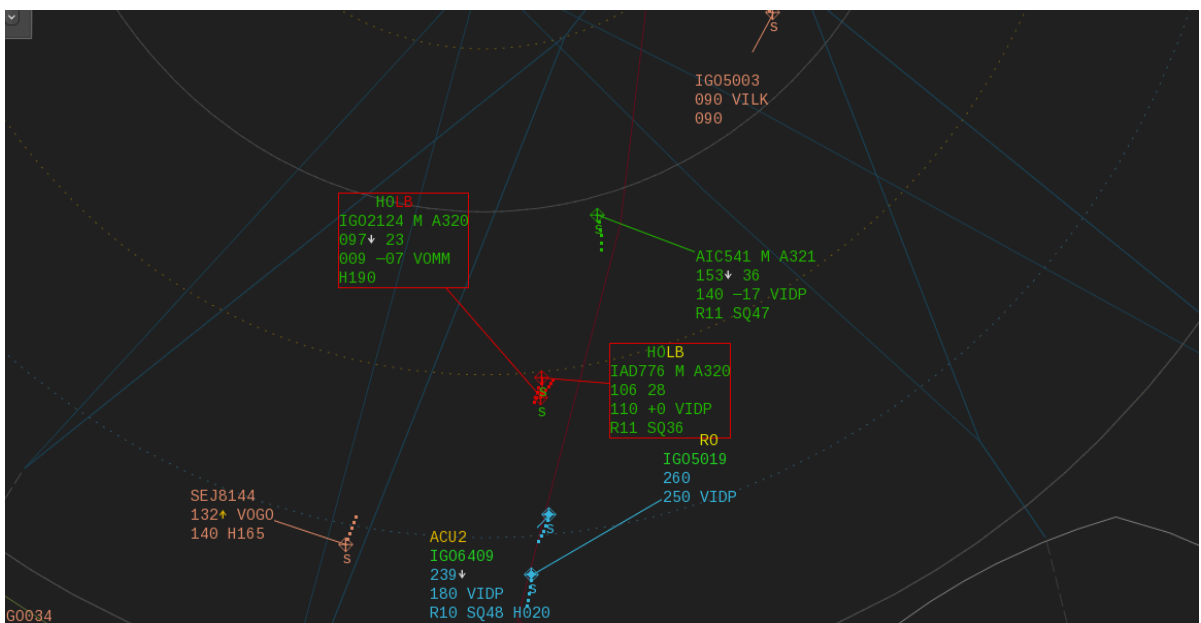
At 1259 UTC, IAD776 reported getting TCAS-RA. At the same time, Automation system also notified separation breach (i.e. Alert violation). Both aircraft executed RA manoeuvre. IGO2124 descended as per RA manoeuvre while IAD776 maintained FL106. As per the system at 12:59:28 UTC, both aircraft were clear of conflict.

Figure: STCA (violation) generated on Automation System Screen

The standard separation was reduced to 0.5 NM lateral and 600 feet vertical. The standard separation was restored in 26 sec.

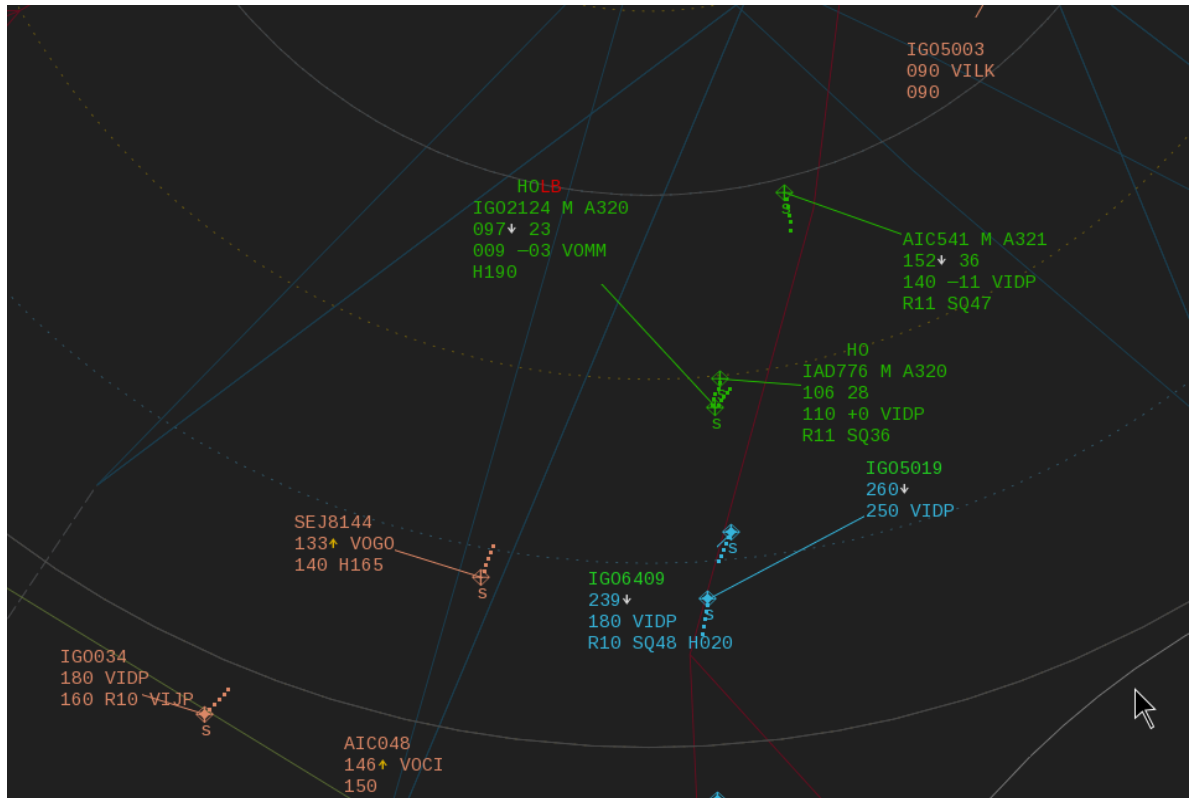
Figure: Showing Clear of conflict, IAD776 maintaining FL106 and IGO2124 descending

After both aircraft were cleared of conflict, controller enquired the reason of decent with IAD776. IAD776 replied that they descended to FL100 as it was instructed by ATC. However, in tape transcript, Flight crew of IAD776 readback descent to FL110.
