SERIOUS INCIDENT

Aircraft Type and Registration:	Boeing 737-4Y0F, EC-MIE
No & Type of Engines:	2 CFM CFM-56-2CI turbofan engines
Year of Manufacture:	1992 (Serial no: 26069)
Date & Time (UTC):	16 June 2021 at 0104 hrs
Location:	East Midlands Airport
Type of Flight:	Commercial Air Transport (Cargo)
Persons on Board:	Crew - 2 Passengers - None
Injuries:	Crew - None Passengers - N/A
Nature of Damage:	Damage to towbar and two landing gear tyres
Commander's Licence:	Airline Transport Pilot's Licence
Commander's Age:	54 years
Commander's Flying Experience:	11,750 hours (of which 9,570 were on type) Last 90 days - 120 hours Last 28 days - 11 hours
Information Source:	Aircraft Accident Report Form submitted by the pilot and further enquiries by the AAIB

Synopsis

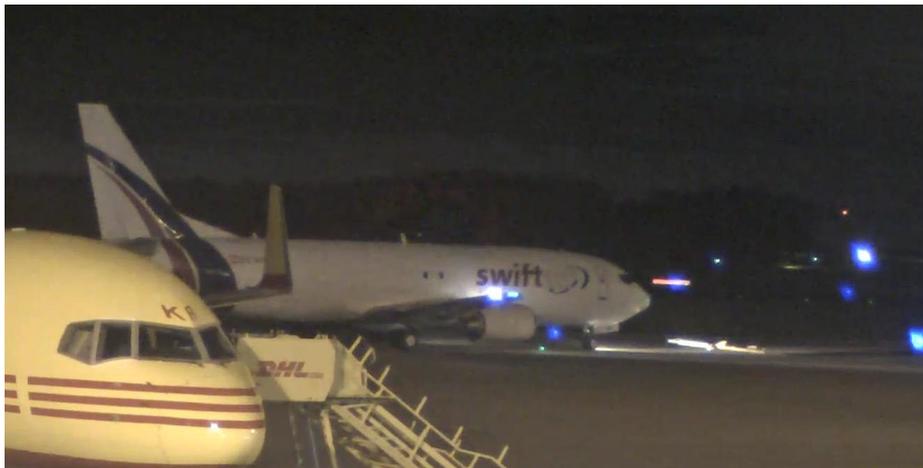
Figure 1

The crew received clearance from ATC to taxi towards Runway 27. Soon after the aircraft started to move, the co-pilot felt something similar to the toe brakes being applied momentarily. Upon asking the commander if he had checked the brakes, the commander said he had not. They did not see the towbar under the aircraft's nose prior to commencing the taxi, Figure 1.

EC-MIE and towbar just prior to taxiing

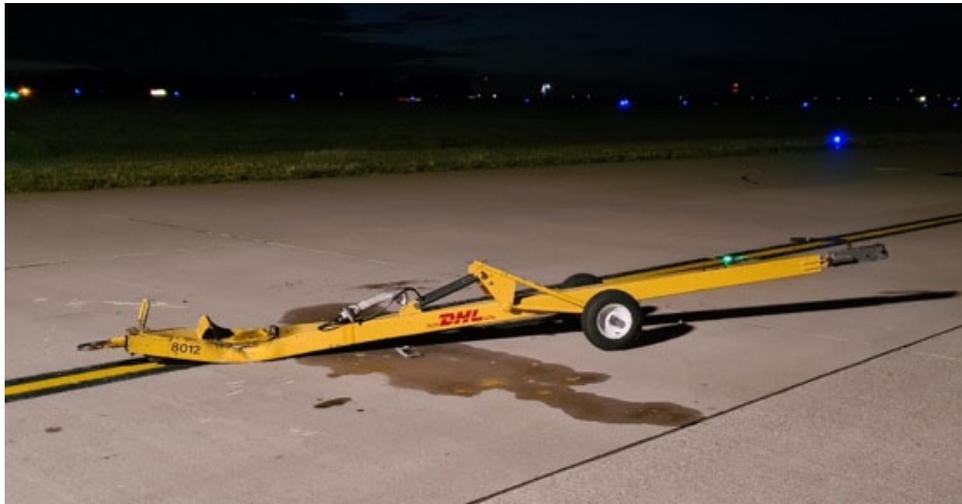
in the taxiway with damage indicating that the aircraft had taxied over it, Figure 2. The TD immediately informed ATC and his supervisor, who informed airfield operations.

Figure 2
Towbar showing damage

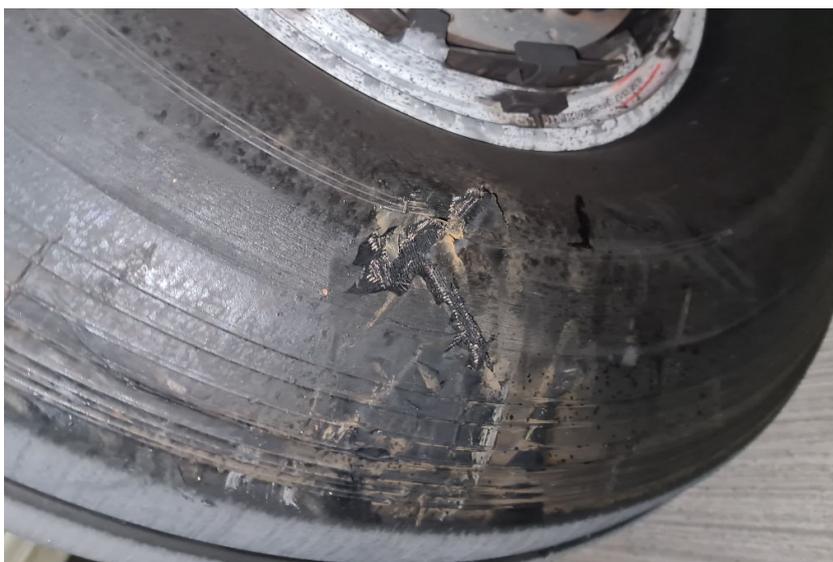
Whilst the aircraft was waiting to depart at the holding point for Runway 27, ATC informed the crew that there had been an incident during the pushback and an inspection of the aircraft was required. Subsequently, they were informed by the handling agent that the aircraft had struck something and they should return to a stand for an inspection. The aircraft was subsequently taxied back towards the East Apron, stopped, shutdown and towed onto a stand, where it was inspected. Upon inspection, damage was discovered to the two tyres on the left landing gear, Figure 3. The damaged tyres were replaced before the aircraft departed after a delay of nearly four hours.

Figure 3
Damage to one of the landing gear tyres
