Investigation Report

Type of Occurrence:	Accident
Date:	23 June 2014
Location:	Near Olsberg-Elpe
Type of aircraft:	1.) Airplane 2.) Airplane
Manufacturer / Model:	1.) Learjet Corporation / Learjet 35 A 2.) Eurofighter GmbH / Eurofighter
Injuries to Persons:	1.) Pilot and co-pilot fatally injured 2.) None
Damage:	1.) Aircraft destroyed 2.) Aircraft severely damaged
Other Damage:	Crop damage
Information Source:	Investigation by BFU
State File Number:	BFU 1X002-14

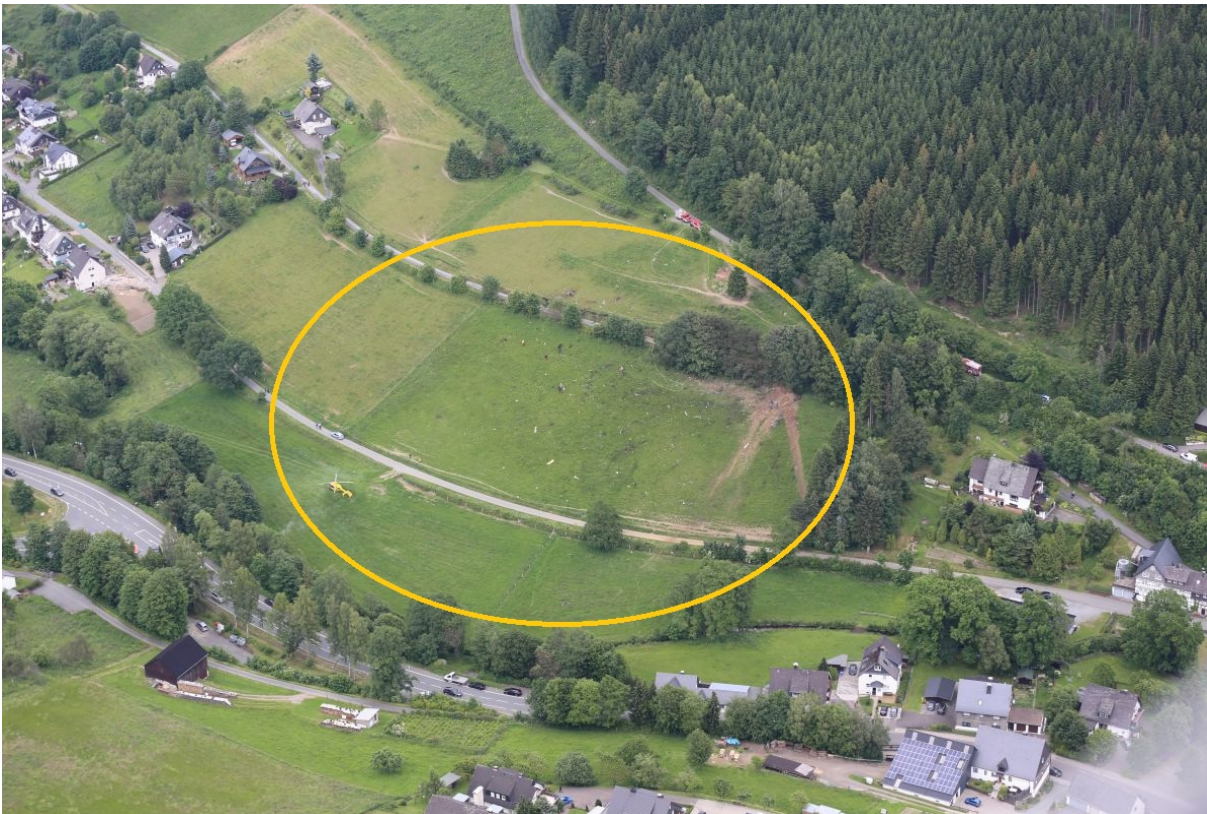
At the impact site the left wingtip tank stuck in the ground. In the area surrounding the impact site the elevator and the vertical tail of the airplane were found. The FDR was found about 20 m and the CVR about 30 m to the north.

The right engine had fractured between compressor and turbine and was found about 75 m downslope from the impact site. In this area the right wingtip tank was found.

Dimension of the accident site of the Learjet 35 A

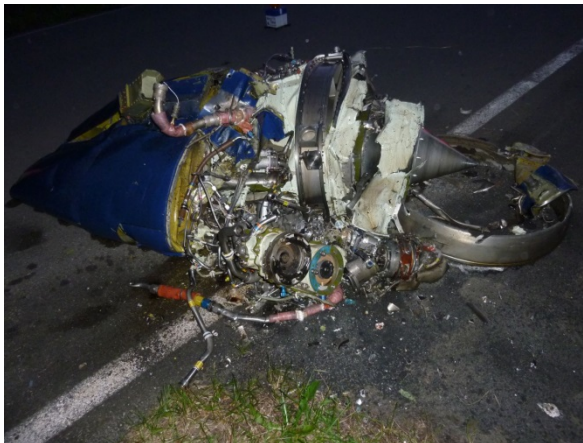
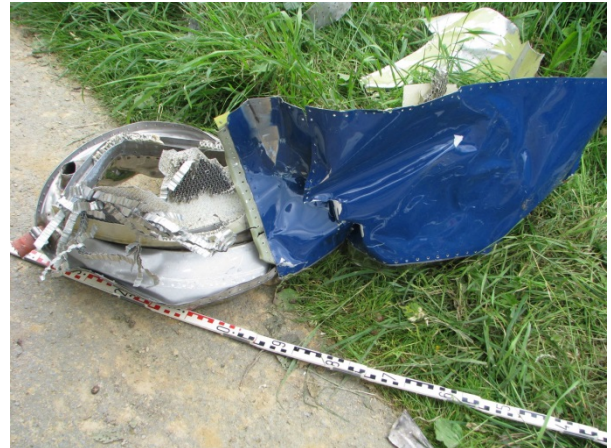
The left engine was found about 1.3 km south of the main wreckage. Parts of the cowlings of the right engine and pieces of luggage of the two Learjet pilots were found about 2.7 km south of the main wreckage.

Left engine (left) and the cowling of the right engine (right)

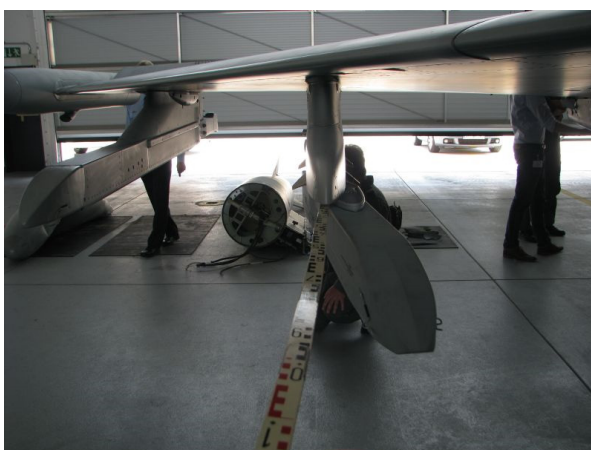
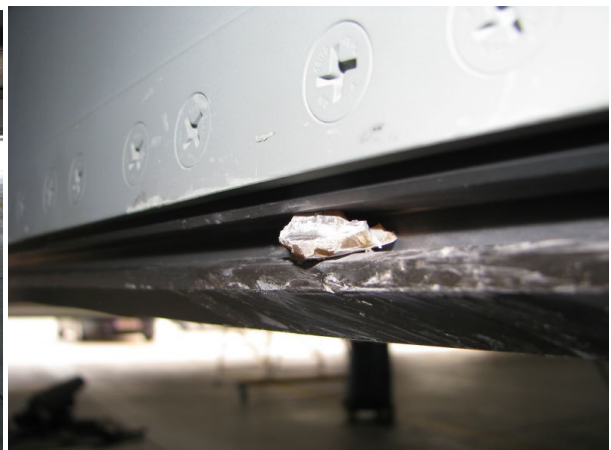
The Eurofighter was examined at Nörvenich Air Base. It was determined that the rail launcher at the outboard wing pylon below the right wing was fractured in the front third and bent towards the fuselage. In the rail a white part of the Learjet's fuselage was found. At the aft part of the rail launcher, parts of the insulating material from the Learjet's fuselage were found.

Deformed rail launcher (left). Fragment of the Learjet's fuselage (right)

The damages found on the two airplanes show that the initial contact occurred between the rail launcher of the outboard wing station and the front fuselage upper surface of the Learjet. Subsequently, the Learjet fuselage collided with the outboard tank of the Eurofighter. The impact forces affected the Eurofighter's right-hand wing rail launcher and the outboard tank sideways and resulted in the deformation of the rail launcher and the outboard tank being torn off. The dark-blue paint transfer on the Eurofighter's lower surface of the inner flaperon, and parts of the right engine nozzle

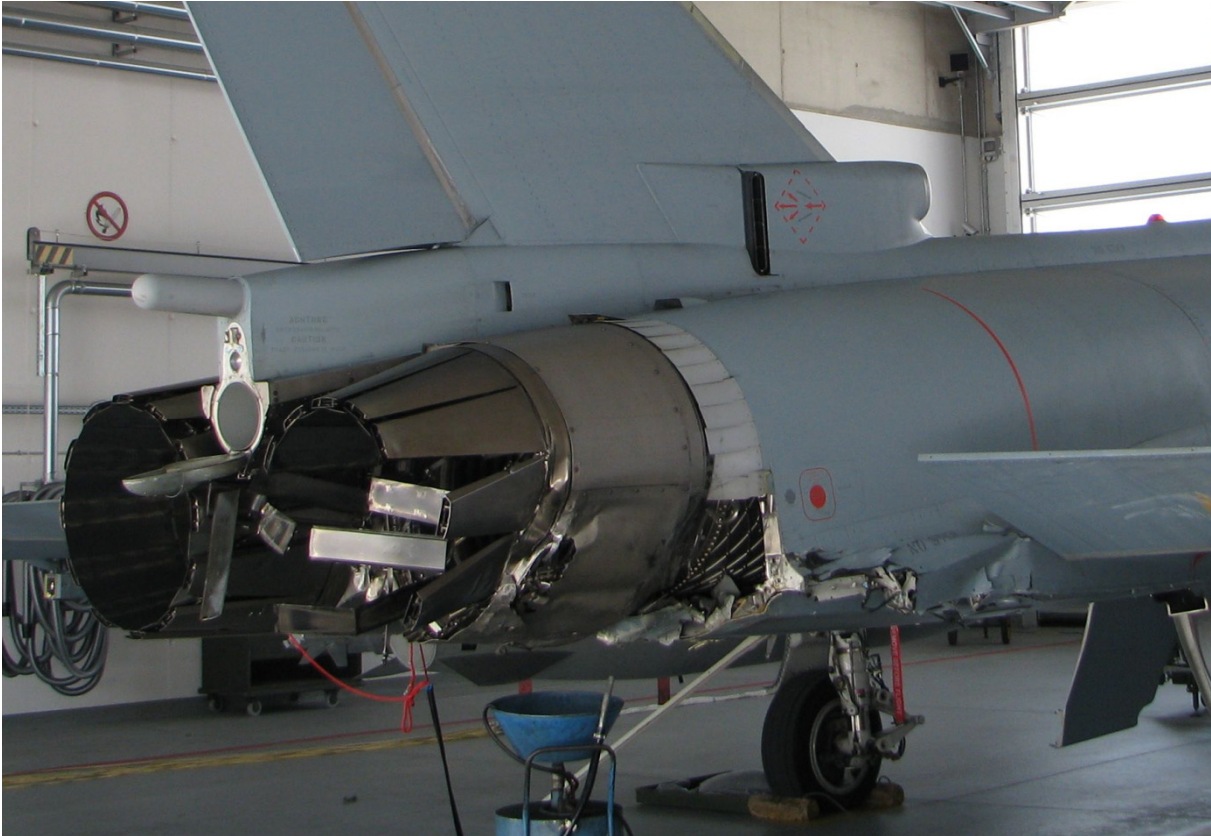
The lower surface of the inner flaperon and parts of the nozzle of the right engine showed blue paint transfer.

The entire right engine was deformed towards the longitudinal axis of the airplane.

Damages on the tail of the Eurofighter

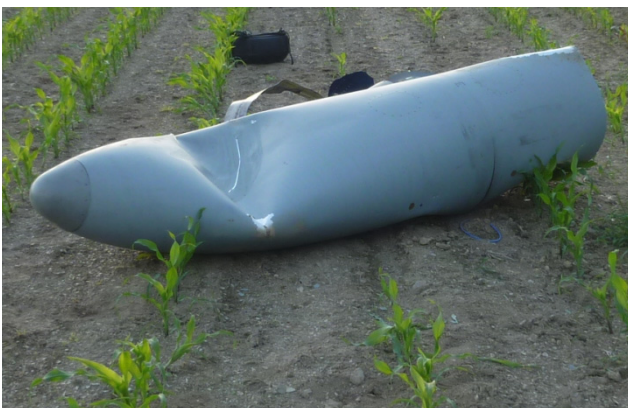
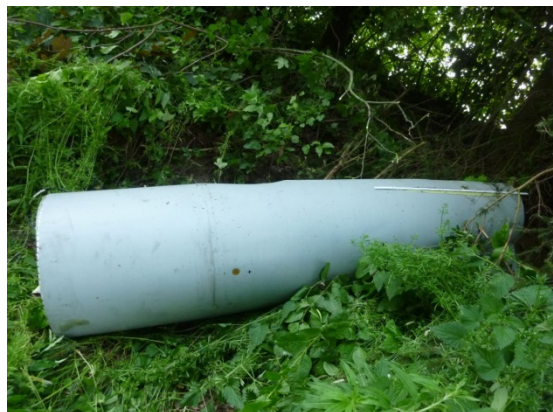
The outboard tank of the Eurofighter had been torn off and was found in two pieces. One of the pieces still carried the jettison and was found 2.1 km and the other 2.3 km south of the main wreckage of the Learjet.

Parts of the outboard tank of the Eurofighter

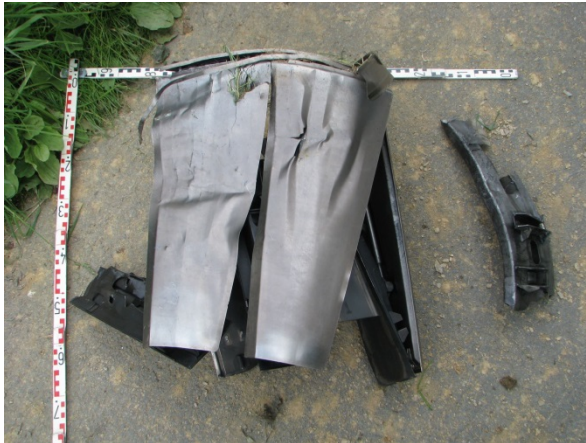
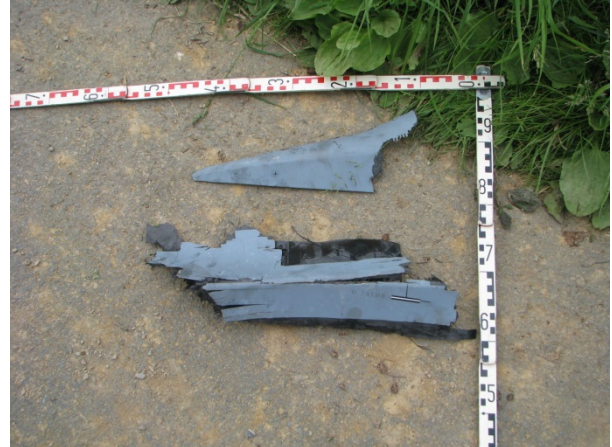
Approximately 2.4 km south of the Learjet's main wreckage the following parts of the Eurofighter were found: pieces of the nozzle of the right engine, carbon composite pieces of the aft fuselage, and the cowling of the inner flaperon track and carriage of the right wing.

Parts of the nozzle (left); carbon composite structure of the Eurofighter

originated from the Learjet's right engine cowling. During the collision the following parts of the Eurofighter were severed: Right engine nozzle, parts of the carbon fibre structure of the aft fuselage and the cowling of the inner flaperon track and carriage of the right wing, and the braking parachute. The Learjet lost parts of the right engine cowling during the collision. The fact that parts of the interior cabin panelling, the luggage of the pilots, and the emergency exit door were found in great distances from the main wreckage shows that the fuselage was heavily damaged during the collision. The fire traces found on the inside of the emergency exit door correspond with the fire observed by the two Eurofighter pilots and the video recording of the head-up display.

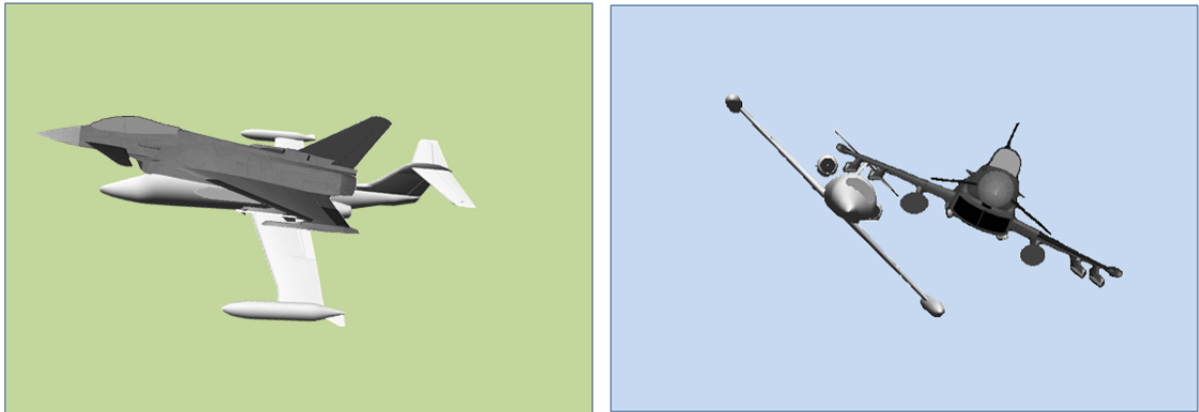
At the time of the collision, at 1438:28 hrs, the CVR recorded dull sounds. The Learjet had a heading of 358° and a bank angle of 46° to the left. The Eurofighter had a heading of 001° and a bank angle of 26° to the left.

Reconstruction of the collision in side view (left image) and front view (right image)

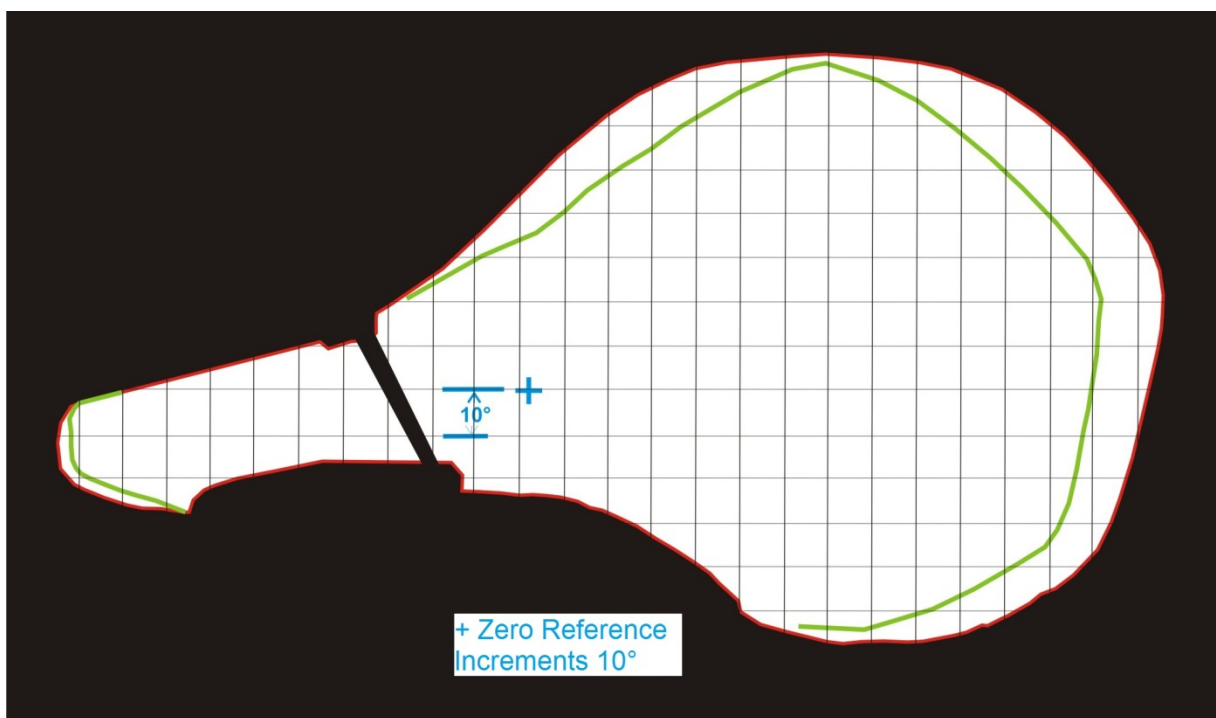
The co-pilot's remark ten seconds prior to the collision "Kannst du mal nehmen, ich kann den nicht mehr sehen (can you take over, I can no longer see it)" shows that he had lost visual contact with the Eurofighter shortly before and asked the PIC to take over controls. At the time of this remark the Learjet had a bank angle of 4° to the left.

The following graph shows that the field of vision from the right-hand pilot's seat towards the left and upward was clearly limited. It is highly likely that for the co-pilot in the right-hand seat the Eurofighter flying at that time slightly above and to the left of the Learjet was hidden by the fuselage structure (cockpit roof) even at the low bank angle to the left. In this phase the Learjet's bank angle increased and the obstruction of the field of vision did too.

Field of vision from the co-pilot's seat

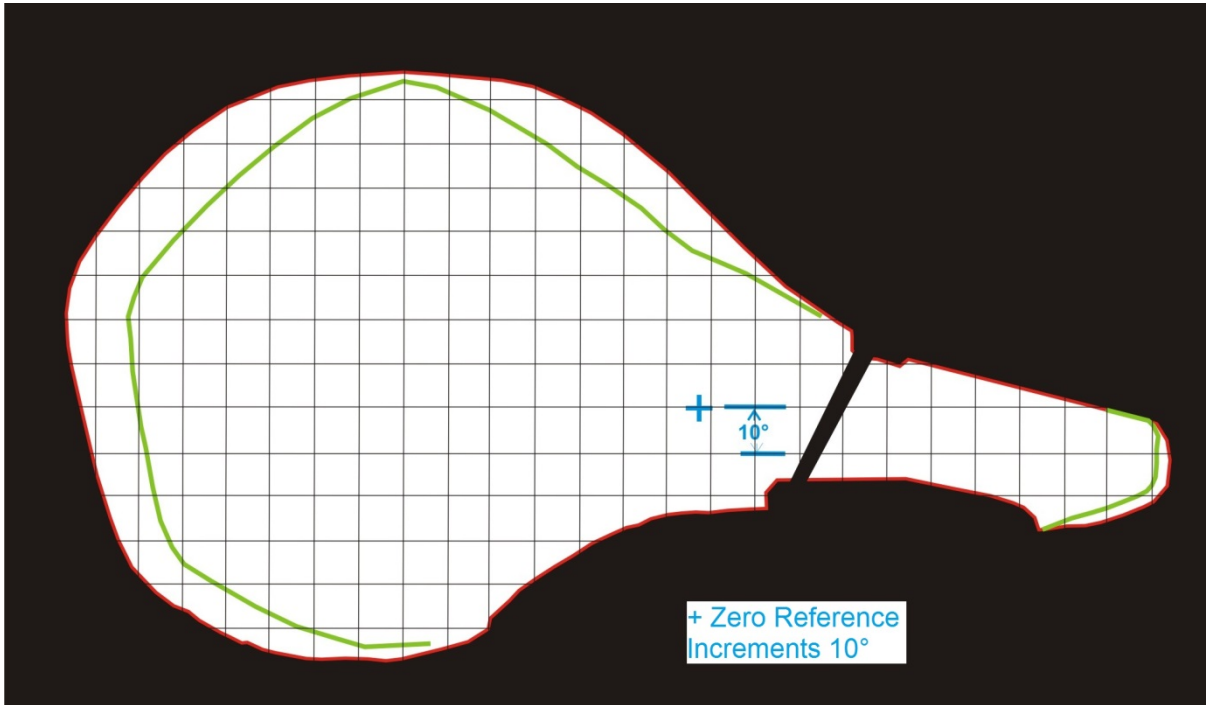
Within the last one and a half seconds the Learjet's bank angle decreased by about 7°. The BFU views this as a probable consequence of a respective control input by the PIC. It is likely that the Eurofighter was in the upper left part of the left cockpit window and therefore at the edge of the PIC's field of vision.

Field of vision from the PIC's seat

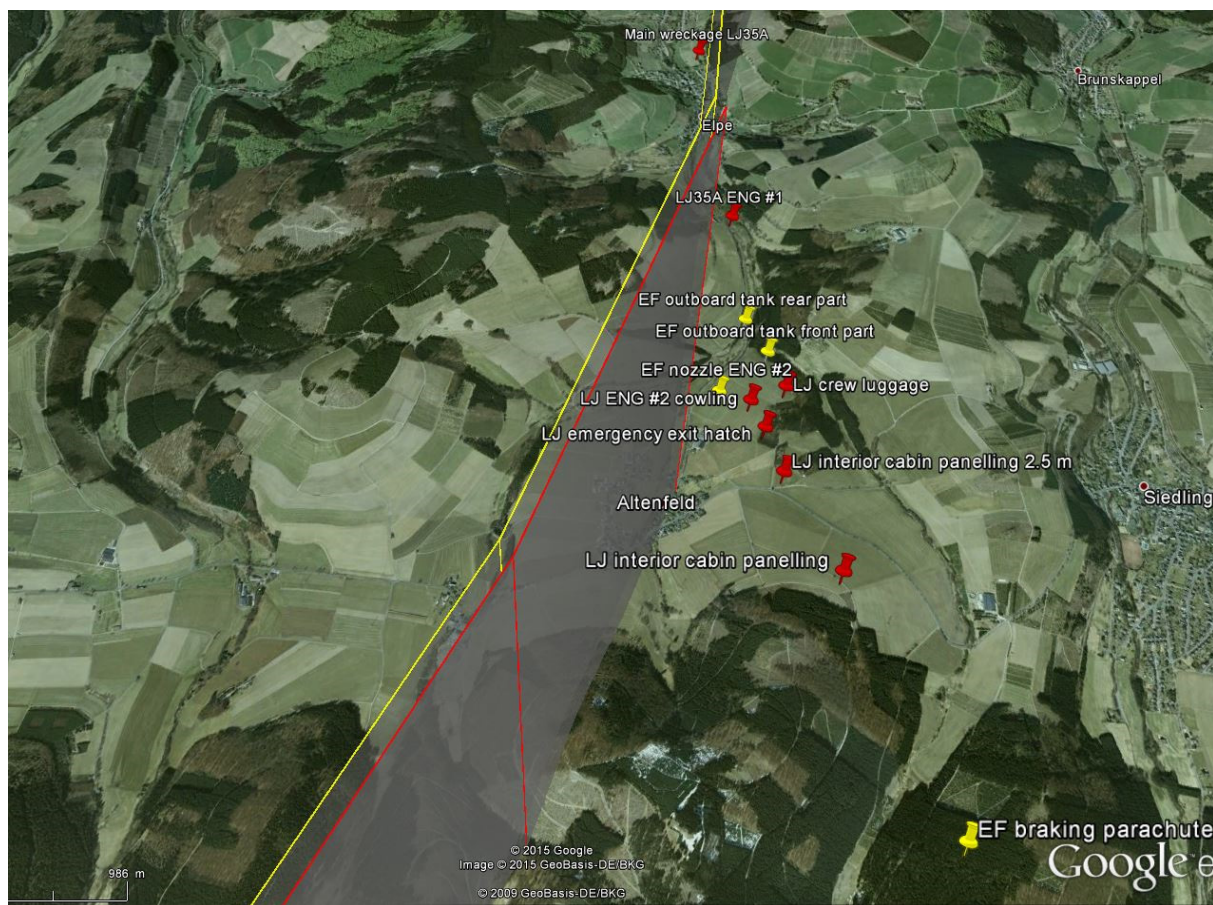
Flight path reconstruction and distribution of the wreckage Learjet (red) and Eurofighter (yellow)
