# Final Report

## IN-038/2019

Incident involving an Airbus A321 operated by British Airways PLC, registration G-MEDN, on 05 August 2019 at Valencia Airport (Valencia, Spain)

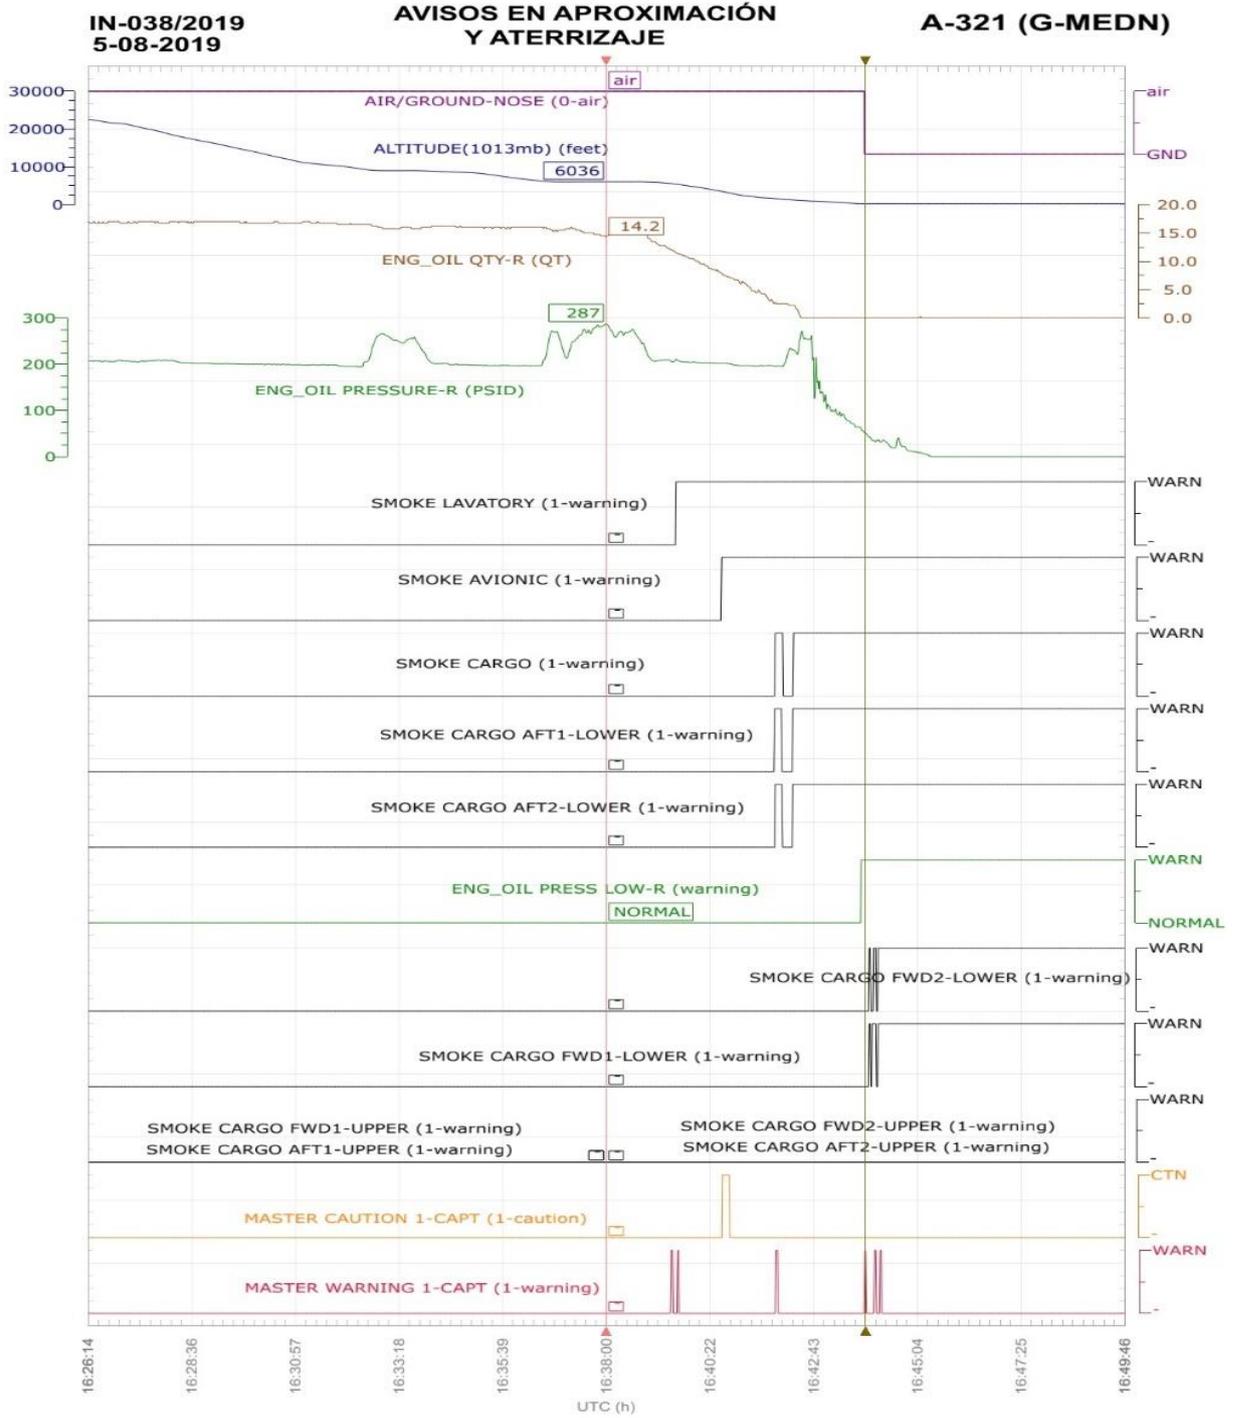
Fig. 12: Relevant parameters during the approach and landing phases

- The graph indicates that at 16:38:55, the oil level in the right engine began to drop rapidly, just before the smoke alerts were activated. The oil level indicator showed 0 (zero) 3 minutes and 31 seconds later, at 16:42:26.
- The right engine oil pressure then began to decrease rapidly, falling below 80 psi at 16:43:28 and below 60 psi at 16:43:48 a few moments before touching down at 16:43:51.

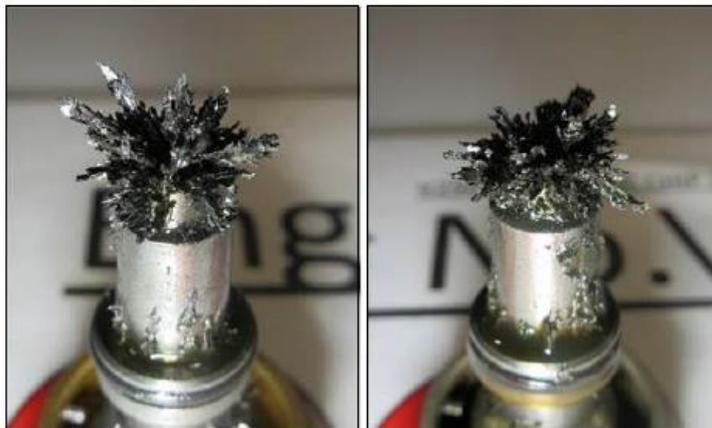
Figs. 15 & 16: Magnetic chip detectors MMCD and FBC MCD<sup>25</sup>

- Before the engine was disassembled, large amounts of metallic (ferrous) debris were found in the magnetic chip detectors. The analysis of the particles found they were composed of materials used in the bearings of the V2500 engines.

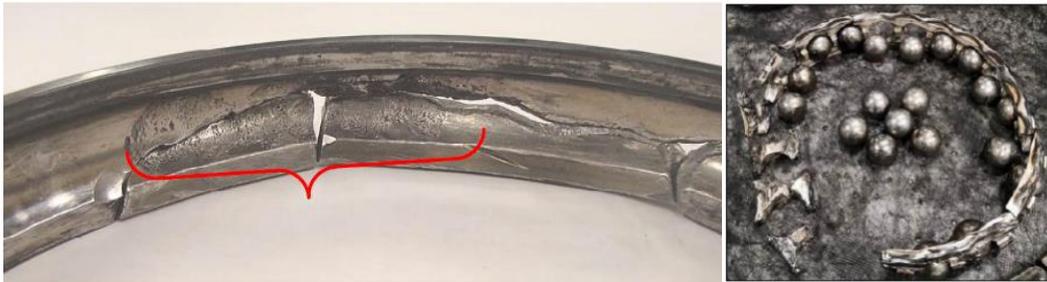
Figs. 17 & 18: Condition and remains of the cage and outer race of bearing no.3

- Bearing 3: A 125° arc had come out of the outer cage, and there was significant spalling on the running surface. 15 of the balls were in the cage, and 5 had popped out. The balls exhibited severe mechanical damage and wear, the cage had multiple fractures, and there was flaking in the inner race and a fracture in the outer race.

- The spalling of bearing 3 started between the outer race and the bearing balls.
- Operating with the spalling on the outer race caused wear as a result of the friction and contact between the outer race and the number 3 bearing housing due to the increased vibration.
- The outer race began to crack, with parts of it coming loose and damaging the bearing cage.

- The balls caused surface damage as they rolled over the flakes, cracks and gaps in the outer race and also affected the cage housings. This damage caused the cage to crack.

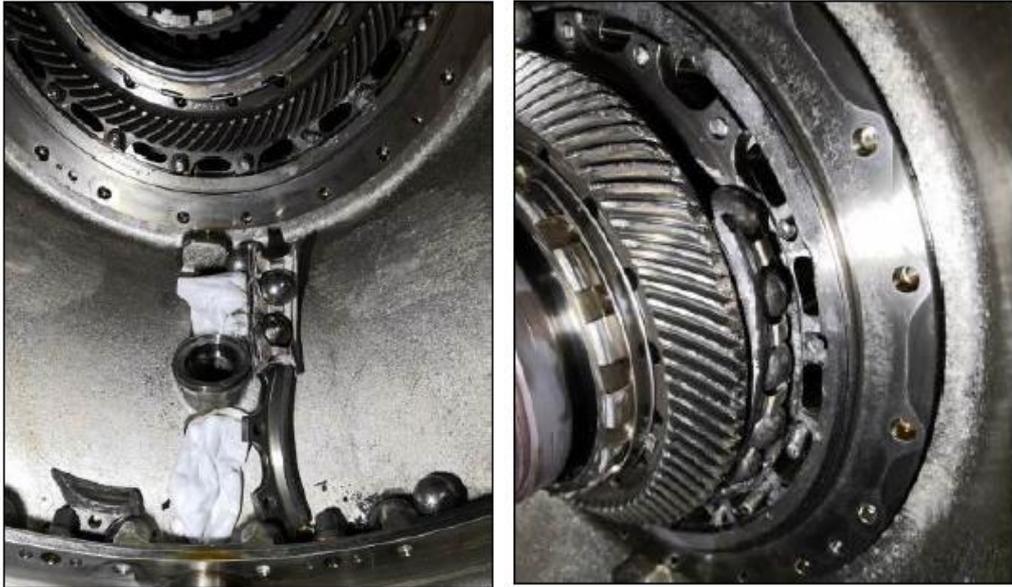
Figs. 19 & 20: Condition and remains of bearing no. 3 in situ

- Bearing 1: neither the bearing, housing, or carbon seal had any visible signs of damage or abnormalities.
- Bearing 2: No visible damage.
- Internal gearbox (IGB): internal damage from impacts. It was evident that bearing 3 had been displaced axially. After disassembling the IGB, it was confirmed that the outer race of bearing 3 had fractured from the 2 o'clock to the 5 o'clock position. Five of the number 3 bearing balls had popped out of the bearing cage and were found inside the IGB. The bearing cage was deformed, and part of it was out of position. Nine of the damper rod nuts that hold the outer race of bearing 3 were broken.

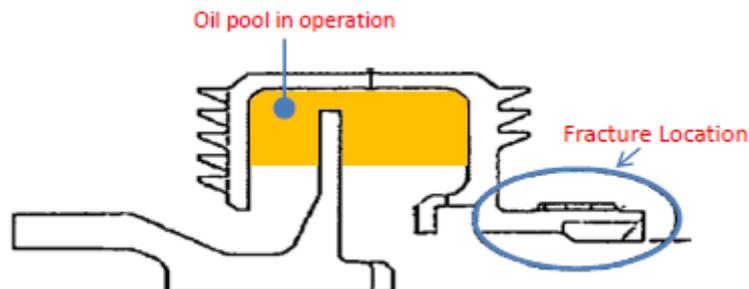
Fig. 21: Section of the hydraulic seal

- Hydraulic seal: was found fractured at the point where it threads with the high-pressure compressor stub shaft.
- Bearing 3 support: No visual abnormalities. The 18 rods holding the outer race of bearing 3 were in place, with 9 of the nuts broken. The shaft was twisted, and the carbon seal was misaligned. This misalignment could have caused uneven contact, allowing oil to drip from the FBC onto the HPC.

- The outer race and the number 3 bearing cage continued to fracture and possibly release sections of the outer-ring race.
- As the turning shaft lost its alignment, the hydraulic seal fractured, allowing air from the 8th stage of the compressor (HPC) to enter the front bearing compartment (FBC).
