ACCIDENT

Aircraft Type and Registration:	DJI Matrice M210 Version 1 (UAS, registration n/a)
No & Type of Engines:	4 electric motors
Year of Manufacture:	2017 (Serial no: 0G0DECG0230007)
Date & Time (UTC):	19 November 2020 at 1150 hrs
Location:	Poole, Dorset
Type of Flight:	Emergency services operations
Persons on Board:	Crew - None Passengers - None
Injuries:	Crew - N/A Passengers - N/A
Nature of Damage:	Damage to right leg and propeller blades
Commander's Licence:	Other
Commander's Age:	38 years
Commander's Flying Experience:	14 hours (of which 5 were on type) Last 90 days - 2 hours Last 28 days - 1 hours
Information Source:	AAIB Field Investigation

Synopsis

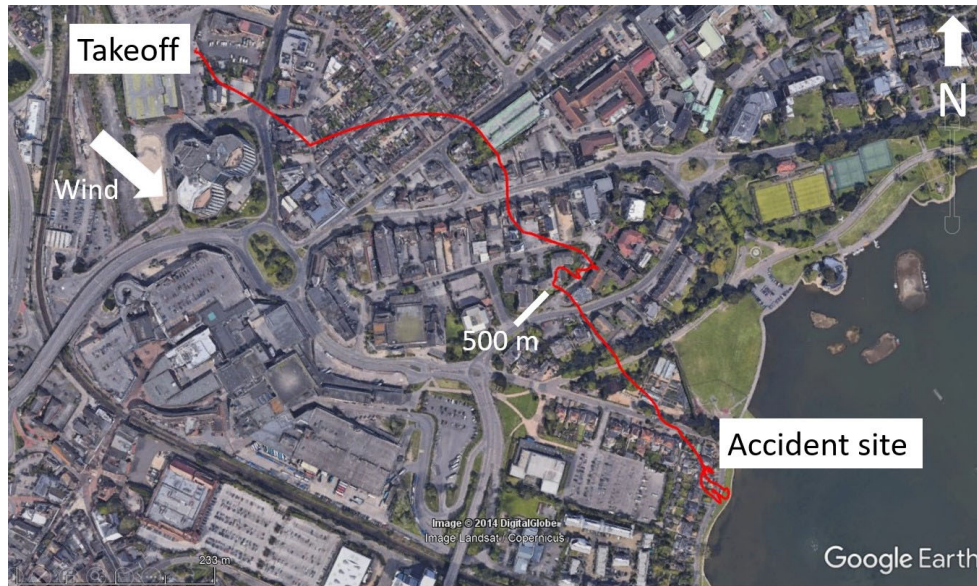
Figure 1

The pilot was now very concerned and activated the '*Return to home (RTH)*' feature on the controller, but it did not appear to engage despite being operated multiple times. RTH then appeared to activate but the aircraft did not move any closer. The pilot then switched to '*Sport Mode*' as per their emergency procedure which he expected would give him a top speed of 51 mph, allowing a greater ability to overcome the headwind. This cancelled the RTH feature so he pressed RTH again, but it would not re-engage. The remote pilot asked the observer to try engaging it using his slave controller, but this did not work either. At this stage neither the pilot nor the observer could see the aircraft, but they could see it on the moving map heading slowly towards Poole Park boating lake in a south-easterly direction (Figure 1). Both controllers then lost communication with the aircraft.

Accident flight ground track
Underlying image © Google Earth™

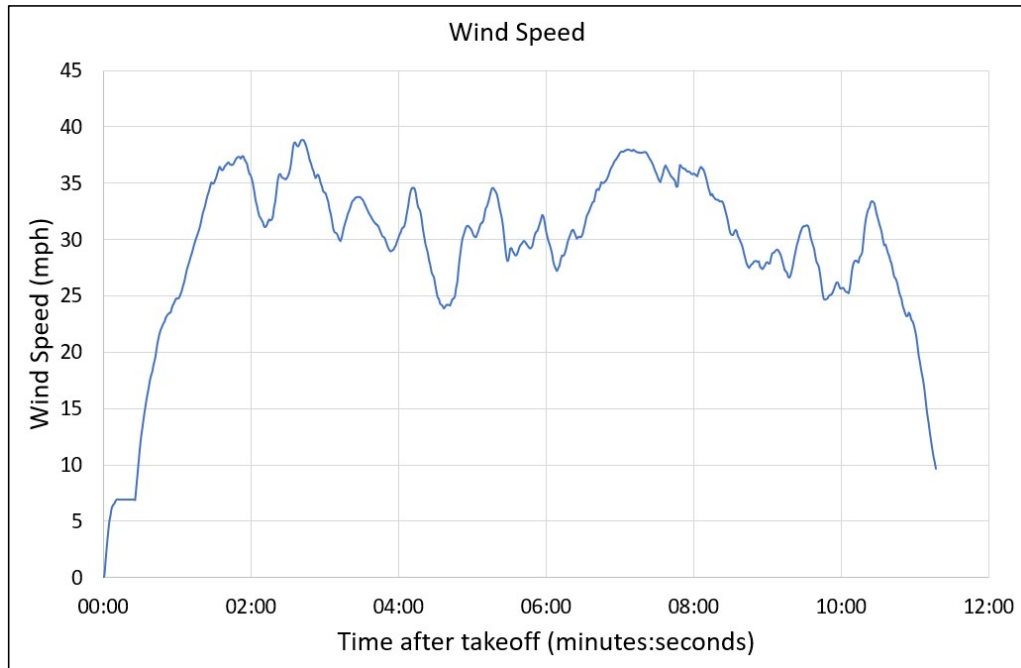
**Figure 3**

Calculated Wind Speed recorded by UAS (mph)
Peak wind is 39 mph at time 02:41

The wind at 400 ft increased beyond the 24 mph speed forecast by the pilot's UAS weather forecast app. The wind reached a calculated peak of 39 mph, but varied mainly between 25 mph and 35 mph. The UA's top speed in P-mode was either 35.8 or 38 mph. If it had been able to achieve 38 mph then it would not have drifted away in the wind. Even at a top speed of 35.8 mph there were periods when it would have made progress back towards the home point. However, with the restricted pitch attitude that was about 10° less than normal, this was not possible. The pilot's attempt to use S-mode as per the operator's emergency procedure did not allow an increase in speed as the restricted pitch limit also applied in S-mode.

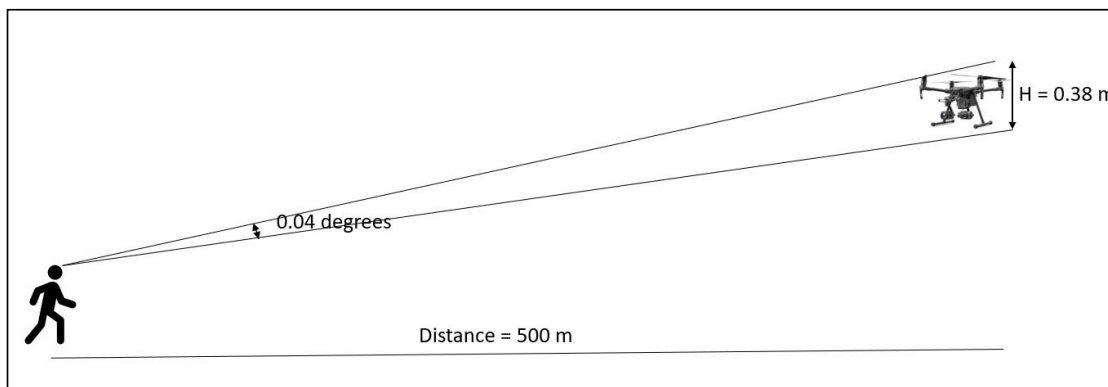
Figure 4

The Matrice M210 has dimensions of 0.51 x 0.51 x 0.38 m without the propellers. Its height is 0.38 m so when it is flying level and viewed from a distance, it presents a profile of 0.51 m by 0.38 m. At a horizontal distance of 500 m this dimension would present an angular size of 0.06° by 0.04°⁷. On a piece of paper held at a normal reading distance⁸ of 35 cm, the size of the Matrice can be represented by a small square of dimensions 0.4 by 0.3 mm.

Angular height of Matrice M210 at a distance of 500 m

It is not clear why the CAA considers 500 m as a normally acceptable distance. A distance cannot be considered normally acceptable without specifying what a normal size is, which CAP 722 does not do. CAP 722 emphasises the importance of being able to avoid collisions but does not state anything about the importance of being able to recover the UA from that distance following a loss of position holding or telemetry. The smaller the

It is recommended that the Civil Aviation Authority review the Visual Line of Sight distance figures in CAP 722 and amend the guidance to make it clear that just being able to see an unmanned aircraft is not sufficient for Visual Line of Sight operations and that pilots need to be able to demonstrate that at the distance they are flying, they can manoeuvre it rapidly to avoid a collision and can also land the unmanned aircraft safely following a loss of position-holding without reference to video or telemetry.
