Separation occurrence involving Airbus A320-232, VH-VGP and Jabiru J230D, 24-7456

Near Ballina Byron Gateway Airport, New South Wales, 28 November 2020

ATSB Transport Safety Report

AO-2020-062

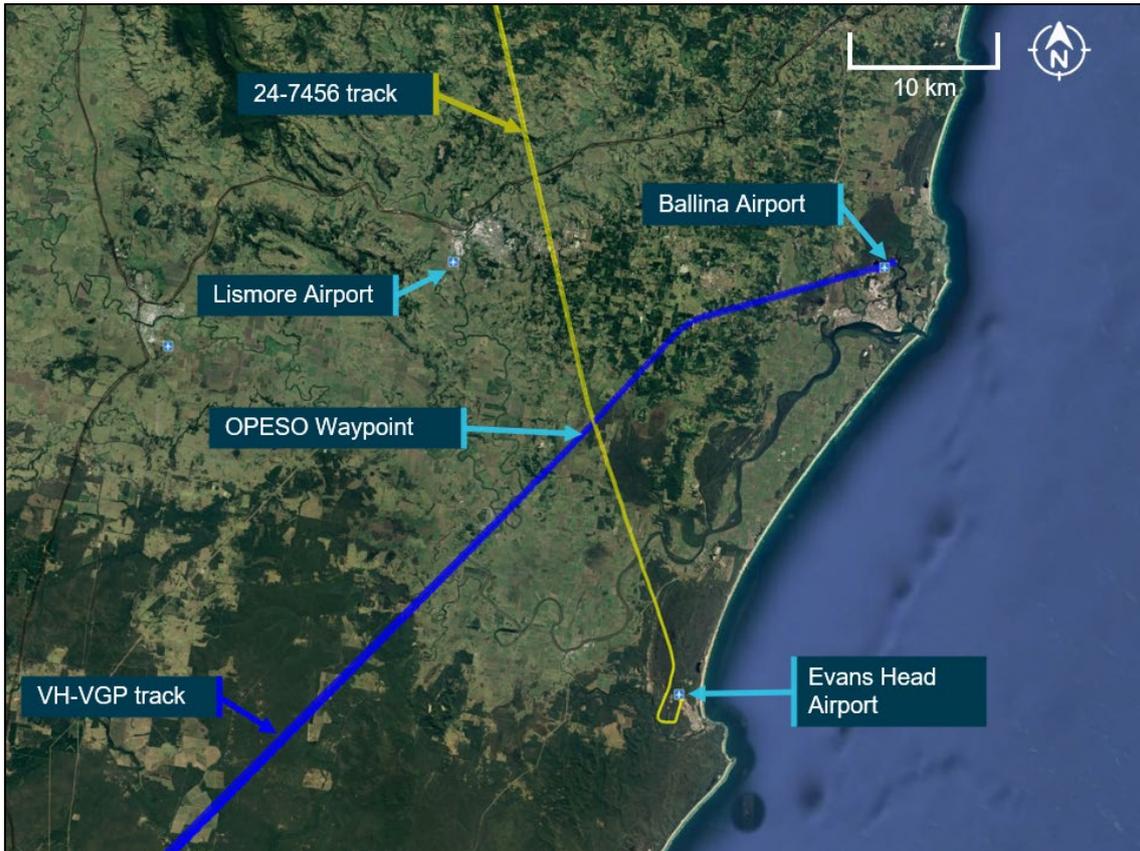
Figure 3: VH-VGP and 24-7456 tracks

Meanwhile, VGP continued tracking towards Ballina Airport via the waypoint⁴ OPESO, descending to an altitude of about 3,200 feet in preparation for the required navigation performance⁵ approach for runway 06. Prior to crossing the OPESO waypoint, the flight crew of VGP received a traffic collision avoidance system (TCAS) proximate traffic alert for an unidentified aircraft at an unspecified altitude in the 11 o'clock⁶ position relative to VGP (see the section titled *Traffic collision avoidance system*). Unbeknown to the flight crew of VGP, the proximate traffic was 7456 tracking in a southerly direction towards Evans Head (Figure 3).

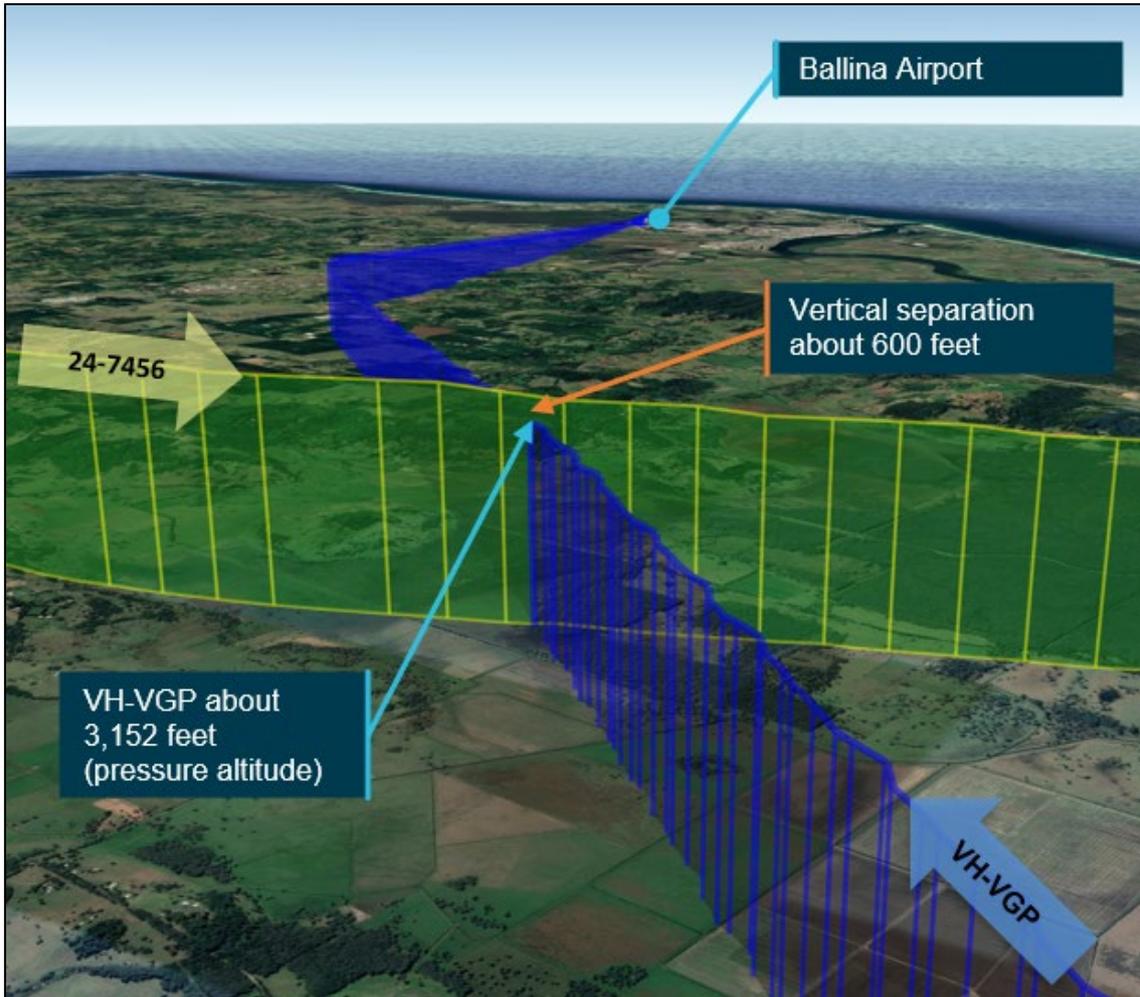
Figure 4: : Recorded flight paths of VH-VGP and 24-7456

The data obtained from VGP's quick access recorder and the OzRunways program used by the pilot of 7456, indicated that, at 11:28:41 and 12 NM south west of Ballina Airport, the tracks of VGP and 7456 intersected, with vertical separation between the two aircraft reducing to about 600 ft. The flight crew of VGP sighted 7456 just prior to passing below the aircraft. The pilot of 7456 sighted VGP shortly after passing above the aircraft. Both the pilot of 7456 and the flight crew of VGP observed no lateral separation between the two aircraft (Figure 4).

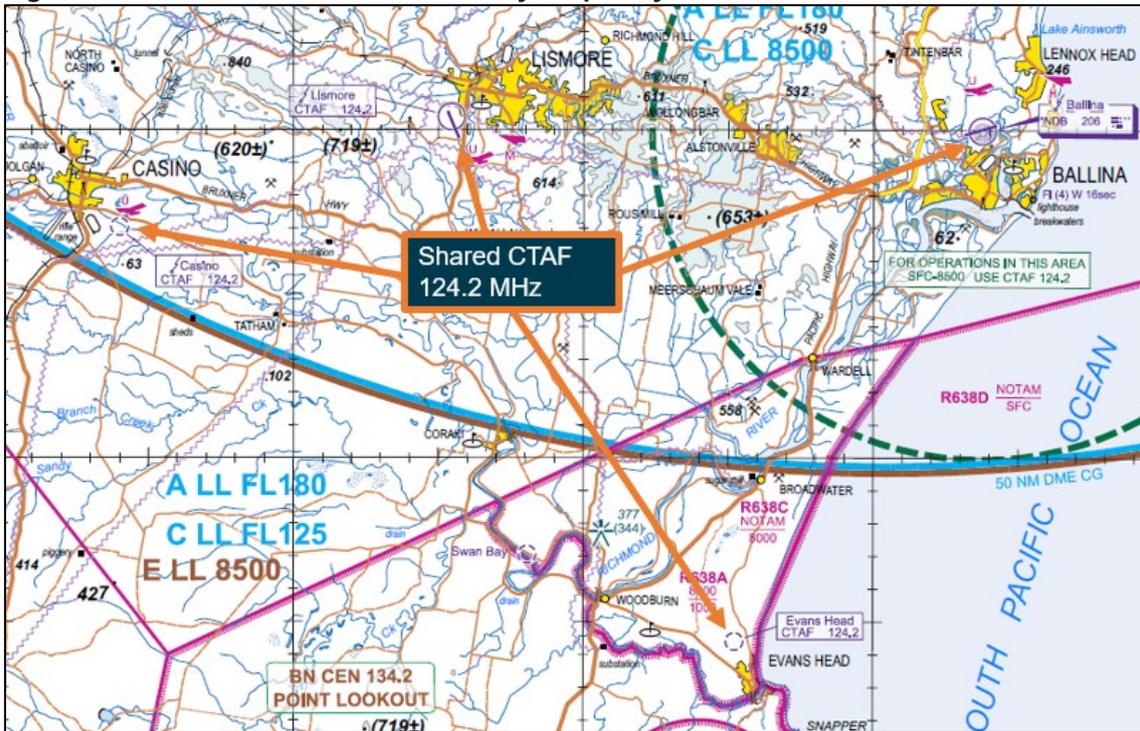
Figure 6: Shared common traffic advisory frequency

The Ballina Airport CTAF was a designated frequency on which pilots made positional broadcasts when operating in the vicinity of the airport. The Ballina Airport CTAF was shared with neighbouring airports and ALAs Casino, Lismore and Evans Head to assist traffic coordination and enhance the situational awareness of pilots operating within the surrounding airspace (Figure 6).
