Hydraulic system malfunction, return and evacuation, involving Airbus A330, VH-EBC

94 km west-north-west of Sydney Airport, New South Wales, on 15 December 2019

ATSB Transport Safety Report
Aviation Occurrence Investigation (Defined)
AO-2019-073
Final – 21 June 2022

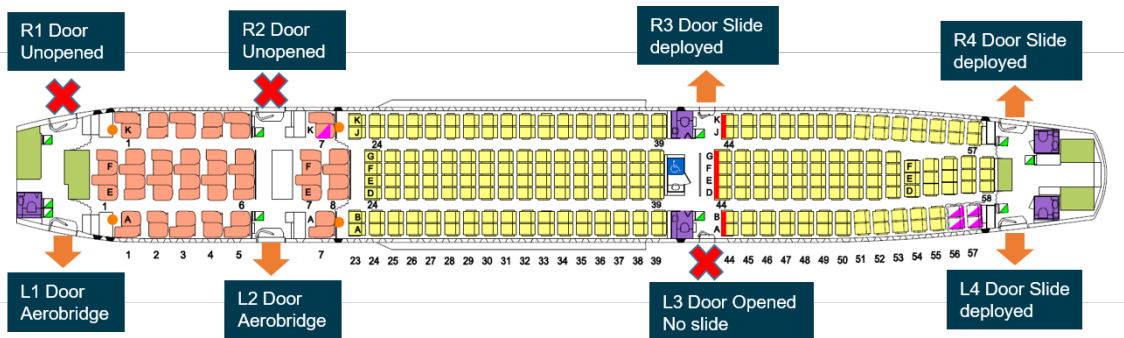
Figure 1: Cabin layout showing doors used during the evacuation

Figure 1 shows the 8 exits on the A330 aircraft. Five exits were used during the evacuation; 2 exits connected to the aerobridges (L1 and L2), and 3 other exits which had escape slides deployed (R3, L4 and R4).

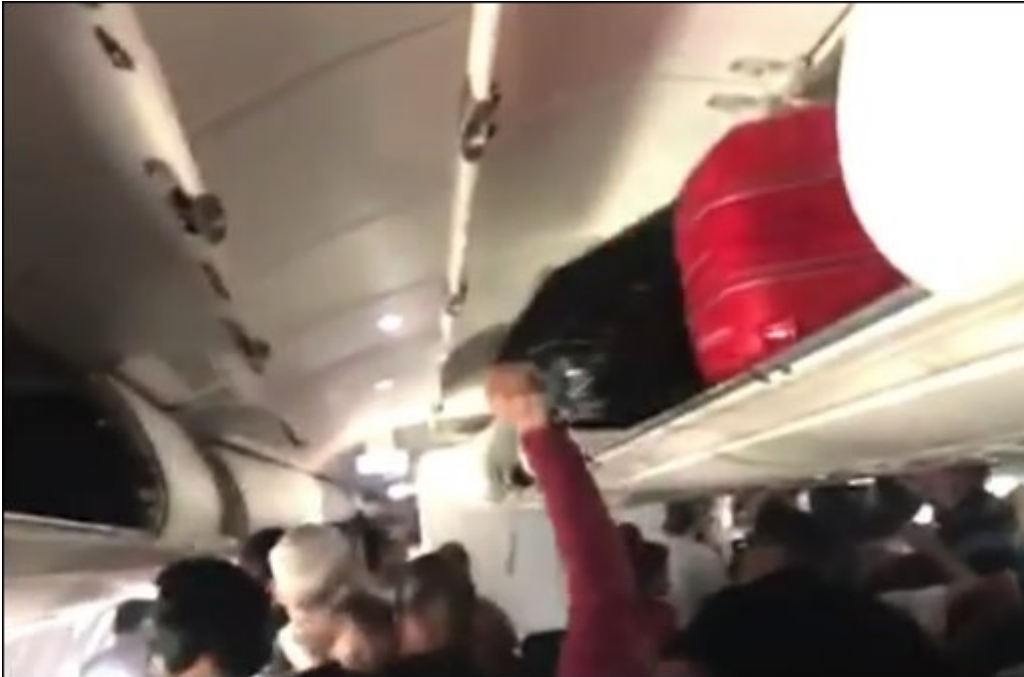
Figure 2: Still image of passenger video taken during the evacuation

As the evacuation occurred at the terminal, some passengers had already retrieved, or started to retrieve, bags prior to the evacuation command. Video footage captured by passengers after the evacuation command showed passengers retrieving cabin baggage from overhead baggage compartments (Figure 2).

Passengers collecting cabin baggage from overhead lockers during the evacuation.
Source: Channel 7

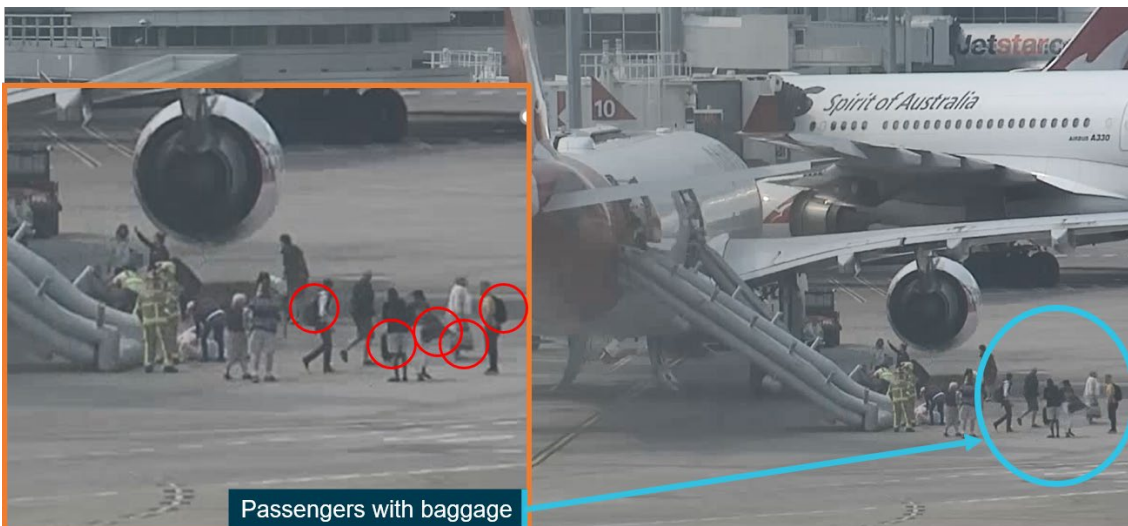
Figure 3: Still image showing passengers evacuating with cabin baggage

Cabin crew at doors with escape slides deployed reported that some passengers arrived at the doors carrying bags. The cabin crew stated that they advised those passengers to leave their bags and, when they did, the passengers were generally compliant, with a number of passengers leaving their bags in the galley area on the way to their exit. However, video footage showed several passengers taking bags down the escape slides (Figure 3). CCTV and video footage taken by passengers also showed that at least 40 of the 129 passengers who exited via the 2 aerobridges were carrying cabin baggage (such as a small suitcase or backpack).

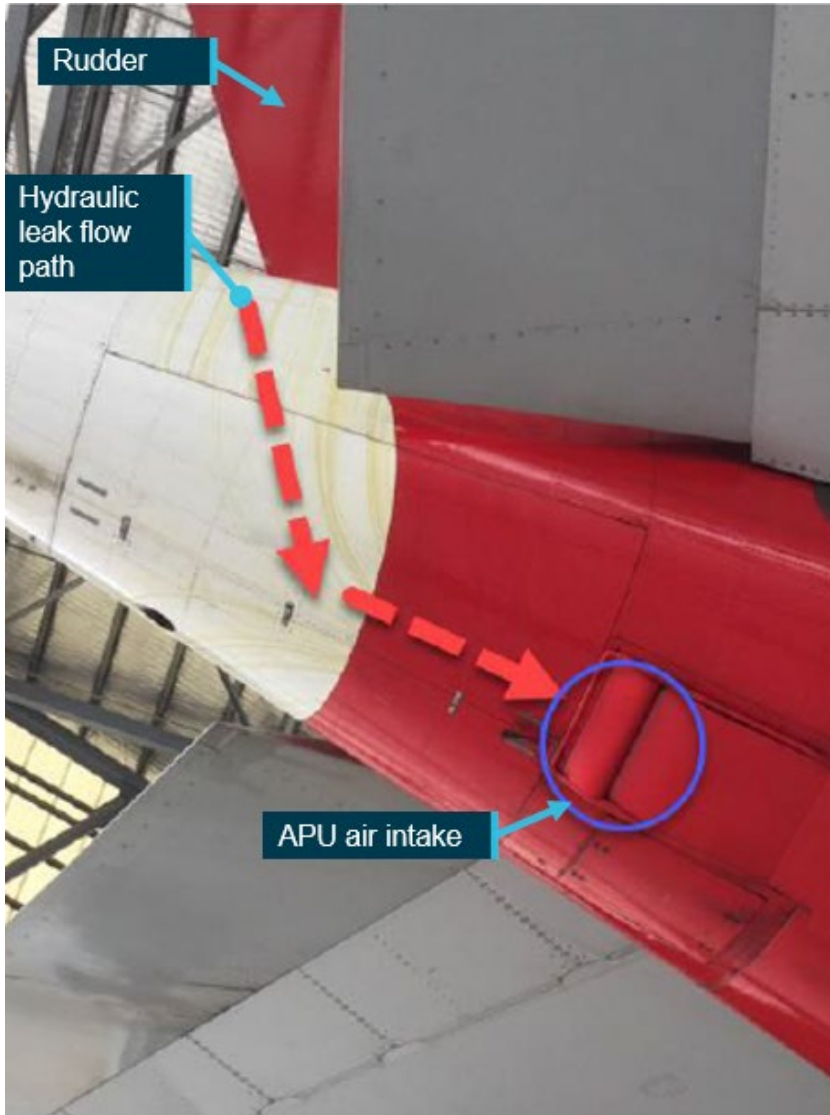
Figure 4: Tail of VH-EBC showing hydraulic fluid leak towards APU air intake

The aircraft was inspected by the operator's engineers after the evacuation to identify the source of the hydraulic leak. There was evidence of residual hydraulic fluid on the tail flowing down towards the auxiliary power unit (APU) air intake (Figure 4).

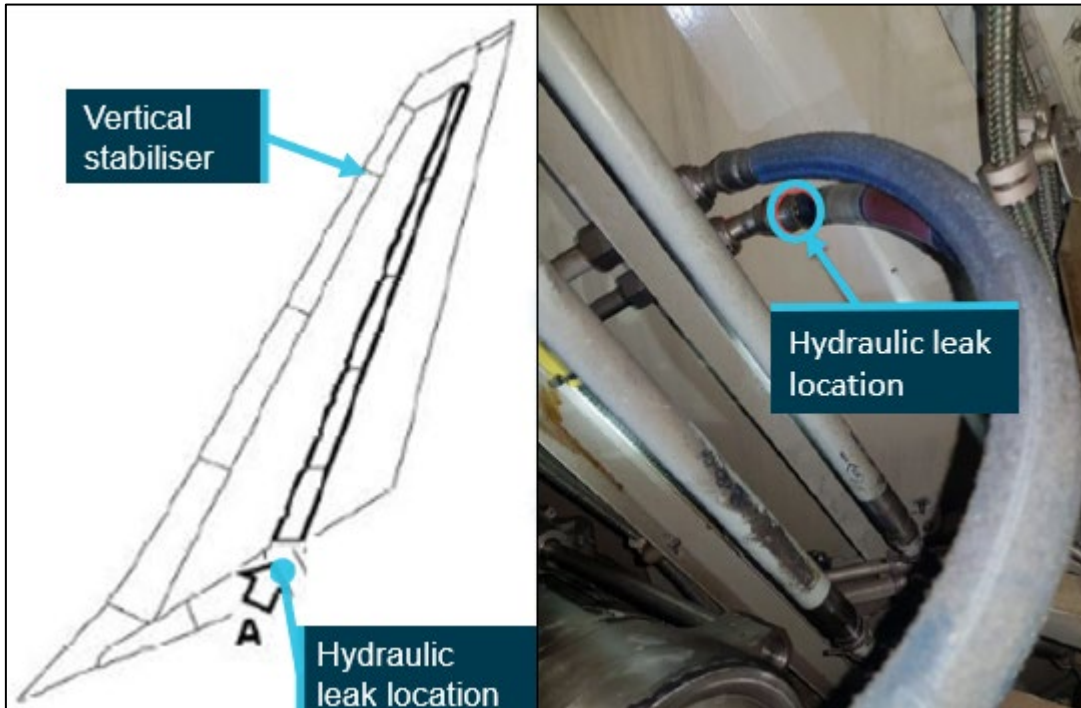
Figure 5: Location and position of green system rudder servo hoses and position of leak

The operator's engineers examined the internal sections of the vertical stabiliser and identified the hydraulic leak emanating from a flexible hose connected to the centre rudder hydraulic servo, which was powered by the green hydraulic system rudder servo pressure hose. The leak occurred near where the hose joined a 45° end fitting (Figure 5). Apart from this leak, there was no discernible visual defects.

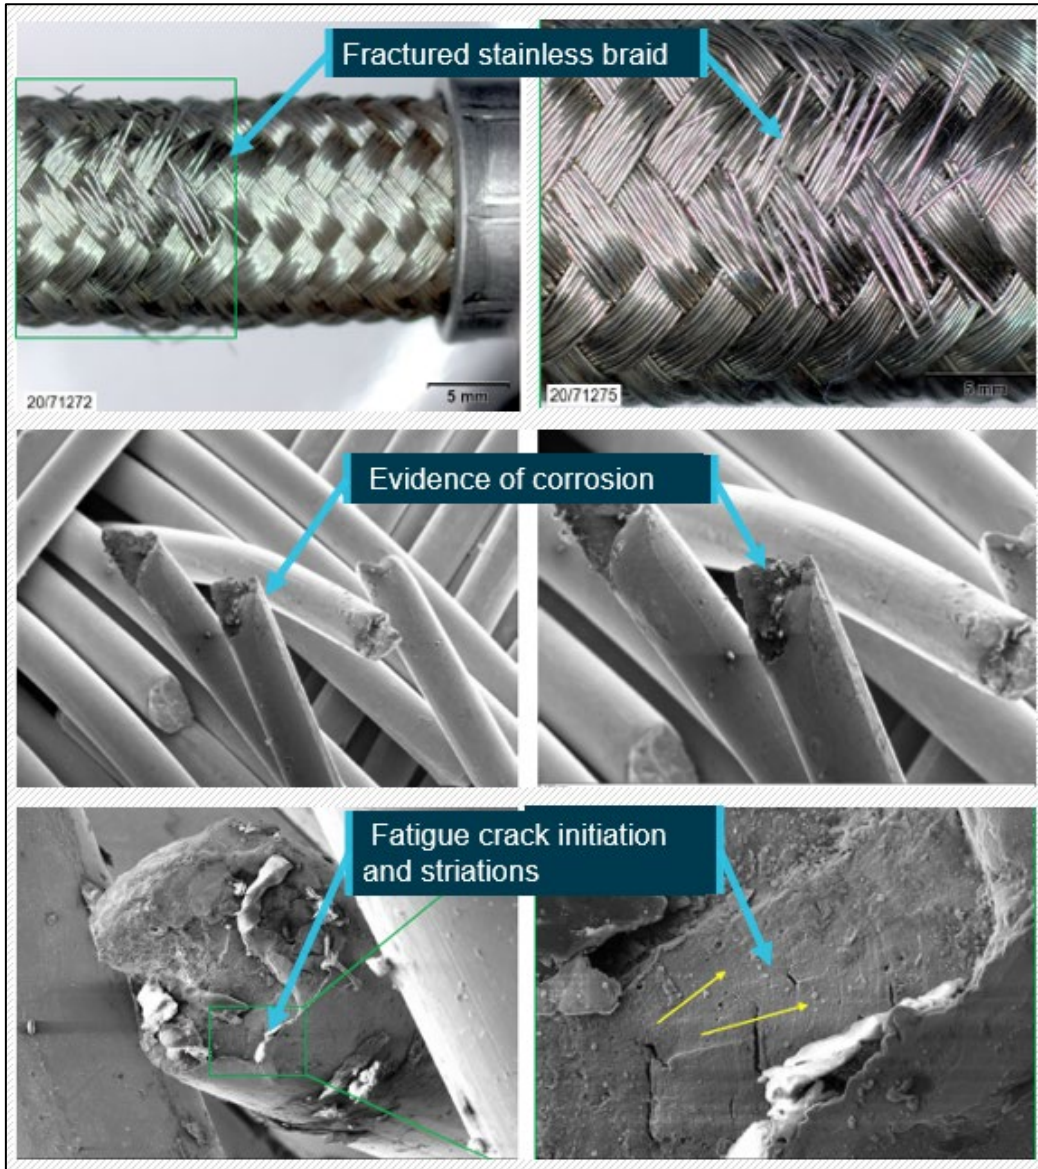
Figure 6: Hydraulic hose steel braid fracture surface showing corrosion and fatigue cracks

The leakage was confirmed between 45° fitting and metallic label. The outer steel braid of the hose was found damaged. The fractured wires of the steel braid exhibit corrosion attack and corrosion products. Fatigue striations were detected indicating a fatigue fracture. The fractures of the wire originated from corrosion attack and fails due to fatigue load and corrosion. No other mechanical damage could be identified which could act as crack starting points.

Figure 6 shows the hydraulic hose stainless steel braid fractures, with evidence of corrosion and fatigue cracking at varying degrees of magnification.

Qantas introduced a procedure for A330 flight crew to refrain from turning the APU bleed on until an engineering inspection had occurred following a hydraulic system leak. The operator also introduced a periodic replacement program for the pressure supply line to the hydraulic servo for all 3 hydraulic systems.

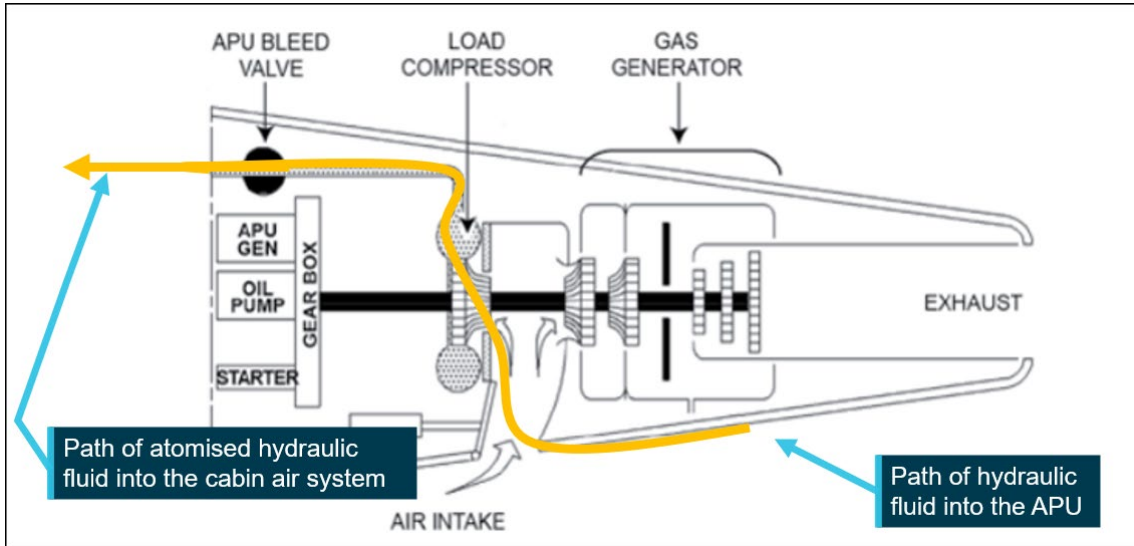
Figure 7: A330 APU schematic showing air intake and path of the atomised hydraulic fluid contamination into the cabin

Figure 7 is a schematic of the APU showing the air intake that was the entry point for the hydraulic fluid ingress. The air intake provides inlet air to the APU gas generator and also the load compressor. The load compressor provides pressurised air to the cabin air conditioning system when the aircraft is on the ground and the APU bleed air valve is open.

intake. However, when the aircraft is on the ground some fluid may bypass the frame due to the lack of airflow.
