# REPORT AVIATION 2022/02

***Air accident in the Skoddevarre mountains, Alta municipality, Troms og Finnmark county, Norway on 31 August 2019 with Airbus Helicopters AS350 B3, LN-OFU, operated by Helitrans AS***

# Report on air accident

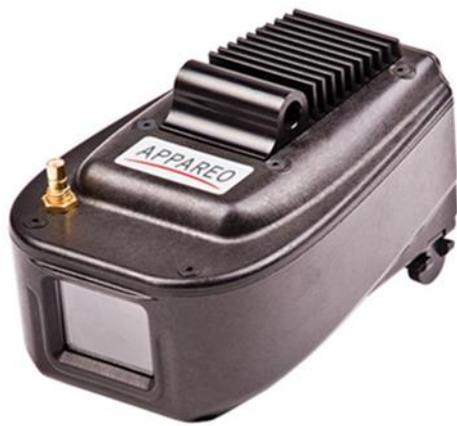
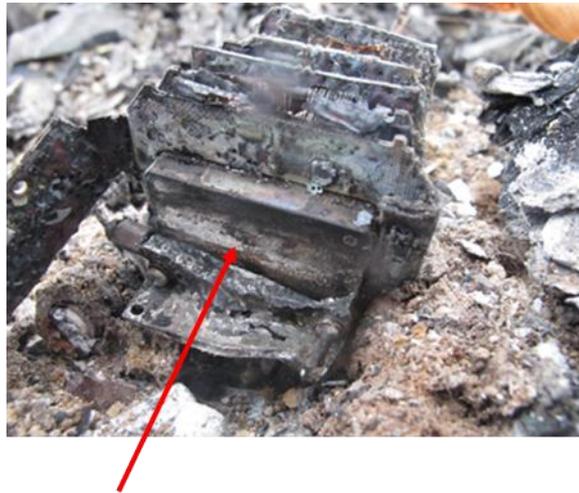
Figure 21: Appareo Vision 1000 in undamaged condition, and in severely fire-damaged condition as found in LN-OFU. The arrow points to the casing around the built-in memory module. Source: Appareo Systems, LLC and Airbus Helicopters

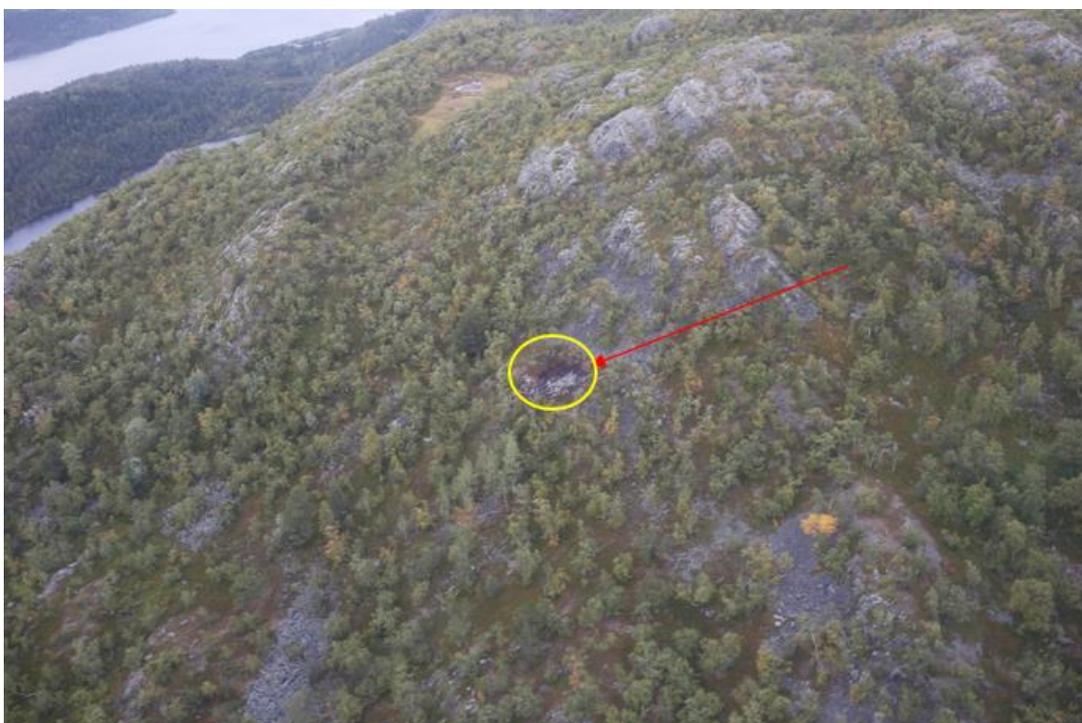
Figure 24: The accident site. The photo was taken looking north-west. Photo: The police/NSIA

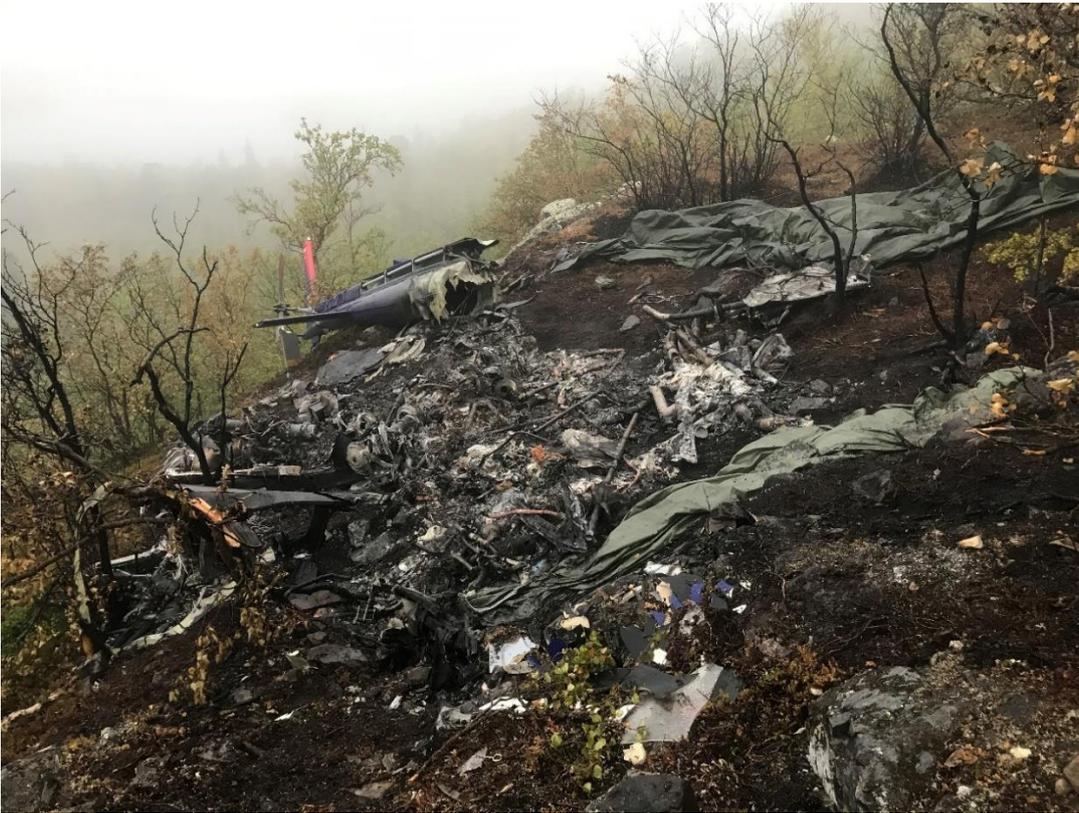
*Figure 25: The accident site near Skoddevarre, viewed from an easterly direction, with the front of the helicopter in the foreground. The bushes on the far right in the photo had not been damaged by the main rotor. Tarpaulins have been deployed to protect the wreckage. The photo was taken after removal of the deceased. Photo: NSIA*

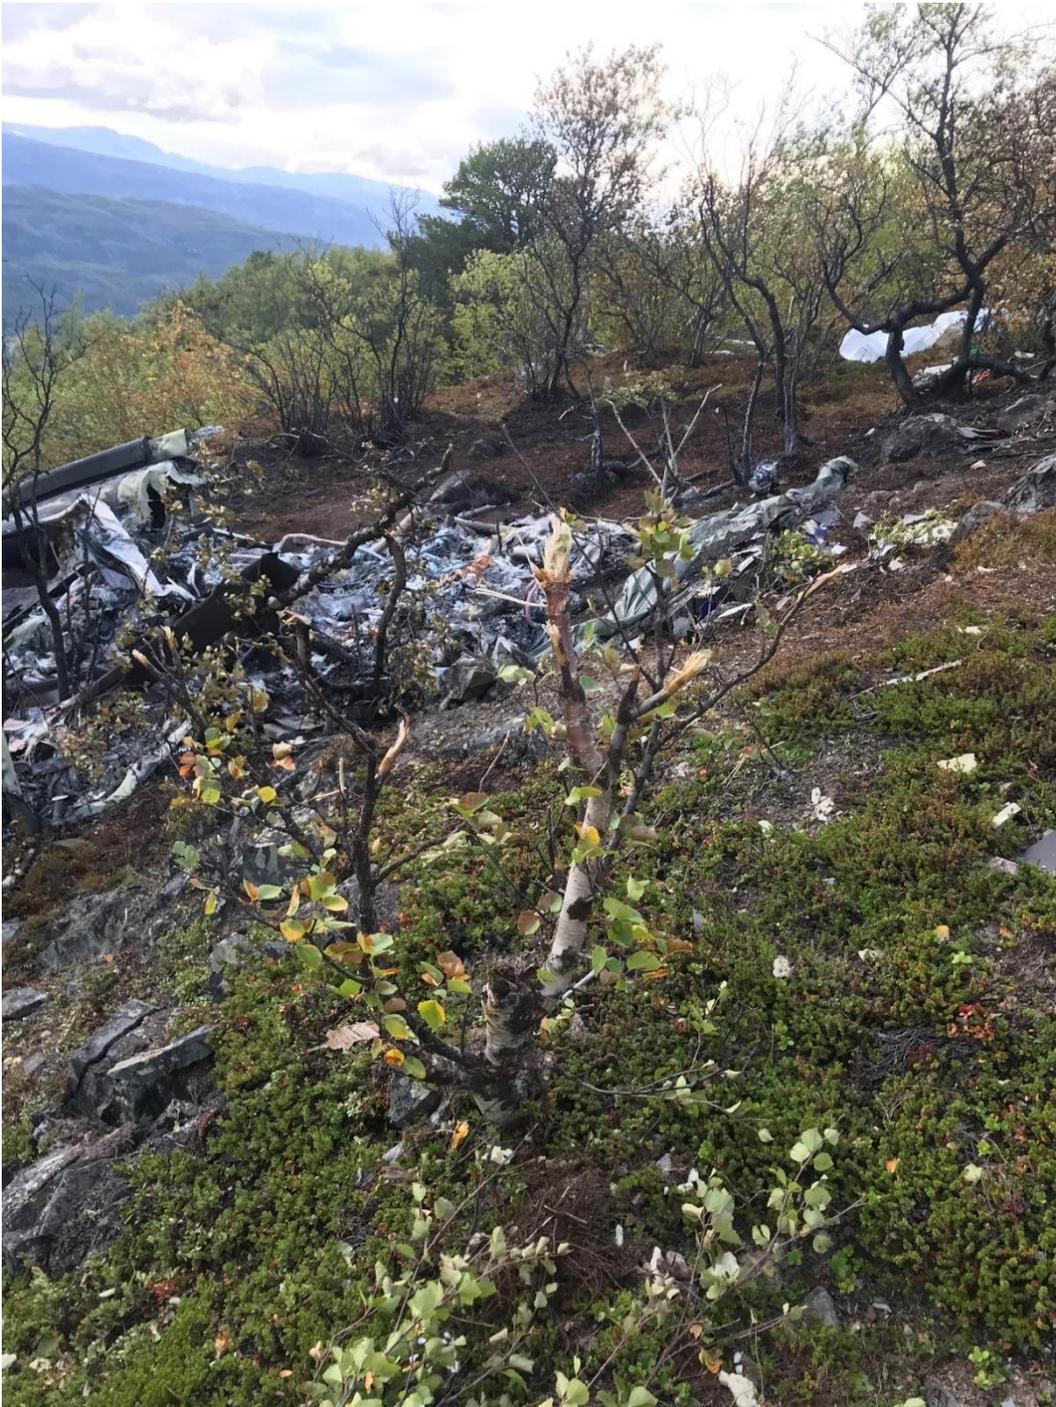
*Figure 26: The accident site, viewed from the south-east. The birch in the foreground was in front of and to the right of the wreckage. The tree on the upper right was damaged by fire only. Photo: NSIA*

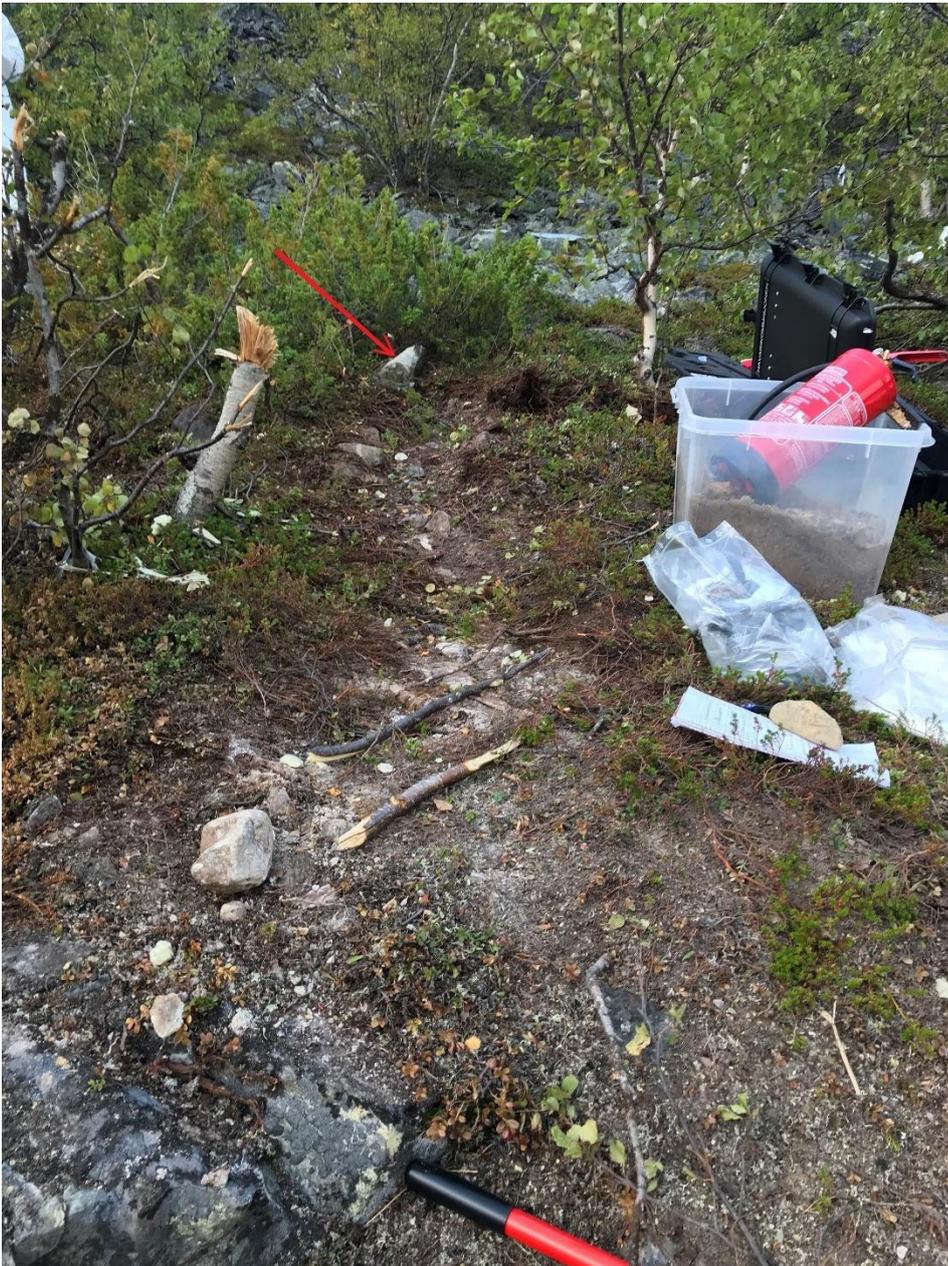
Figure 27: Photograph showing the most visible mark after a rotor blade to the front and to the left of the wreckage. The birches to the left in the photo have been cut by rotor blades. The red arrow shows where the tip of a rotor blade has hit a rock. Photo: NSIA

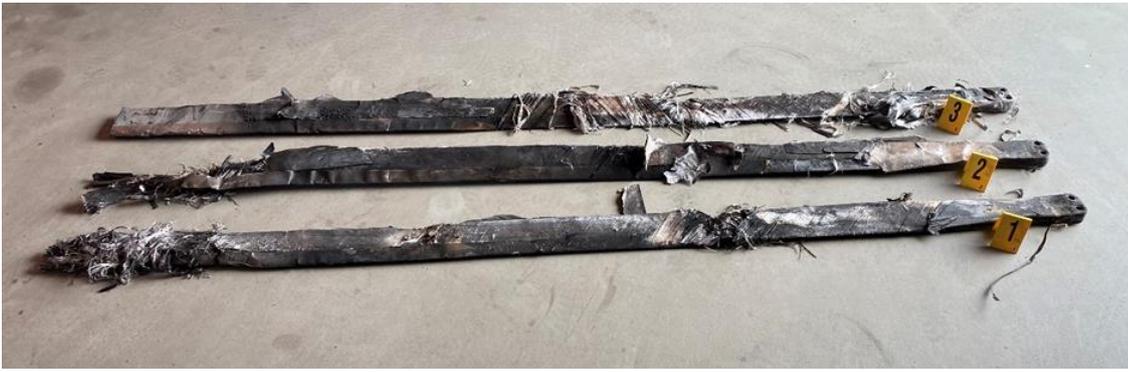
Figure 28: The three rotor blades. The blade tips are to the left in the photo. Photo: NSIA

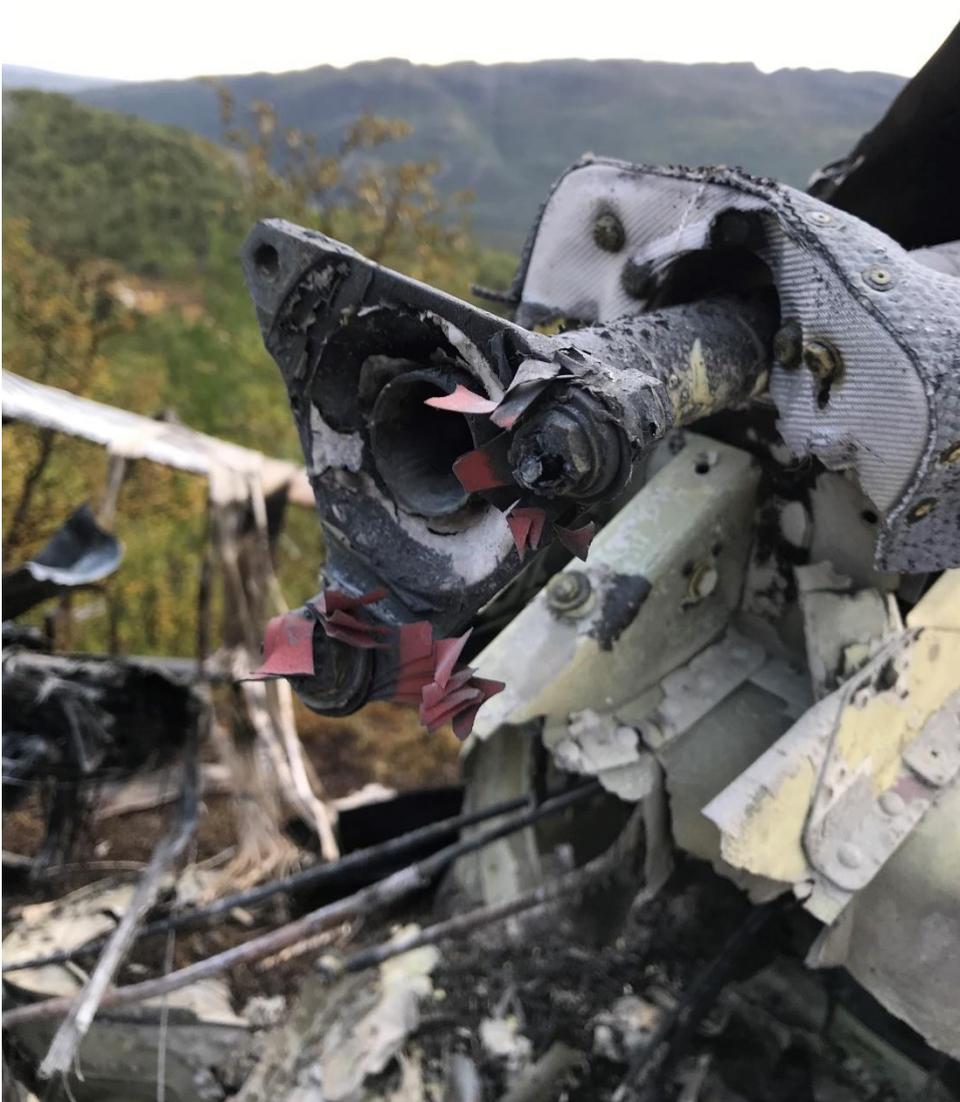
Figure 29: The broken drive shaft for the tail rotor between the fuselage and tail boom, with typical rupturing of the flexible coupling. Photo: NSIA

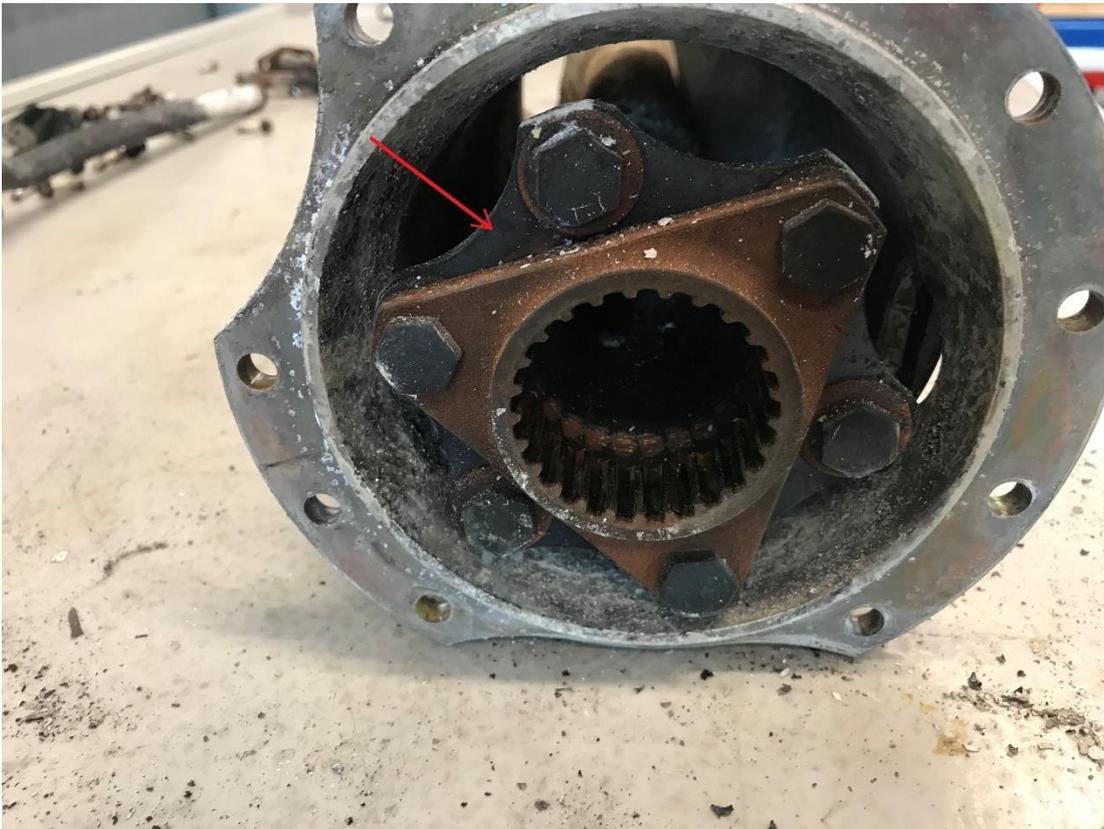
Figure 48: The drive shaft between the engine and main gearbox seen from the engine side. The flexible coupling, see red arrow, appears to be undamaged. Photo: NSIA

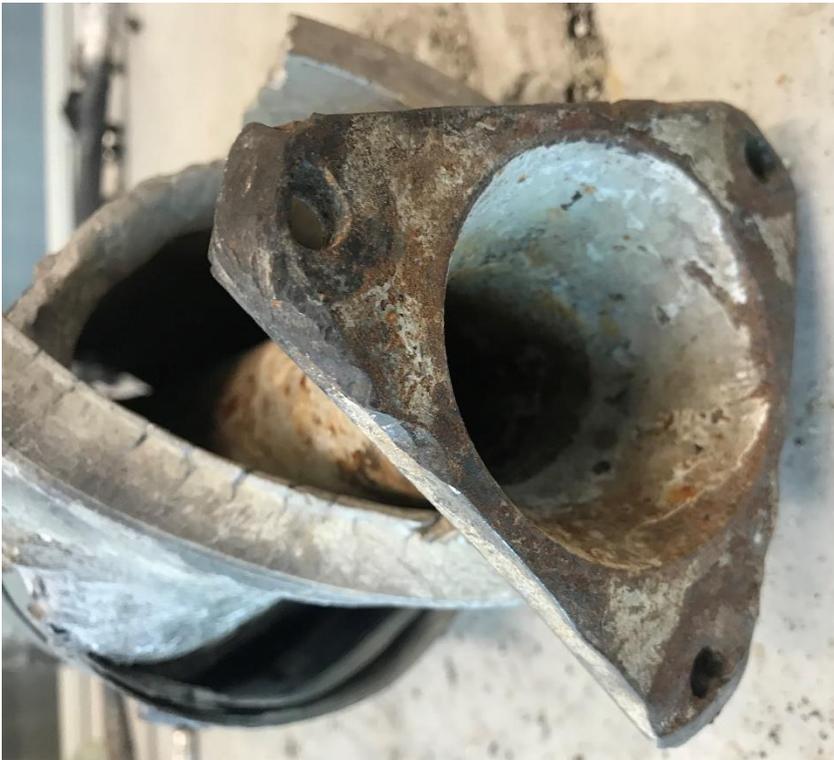
*Figure 49: Drive shaft between engine and main gearbox with flange for connection to the gearbox. The flange shows rotation damage in several places and no remains of the flexible coupling. The gimbal coupling in the background is severely damaged by heat and also shows signs of rotation damage. Photo: NSIA*

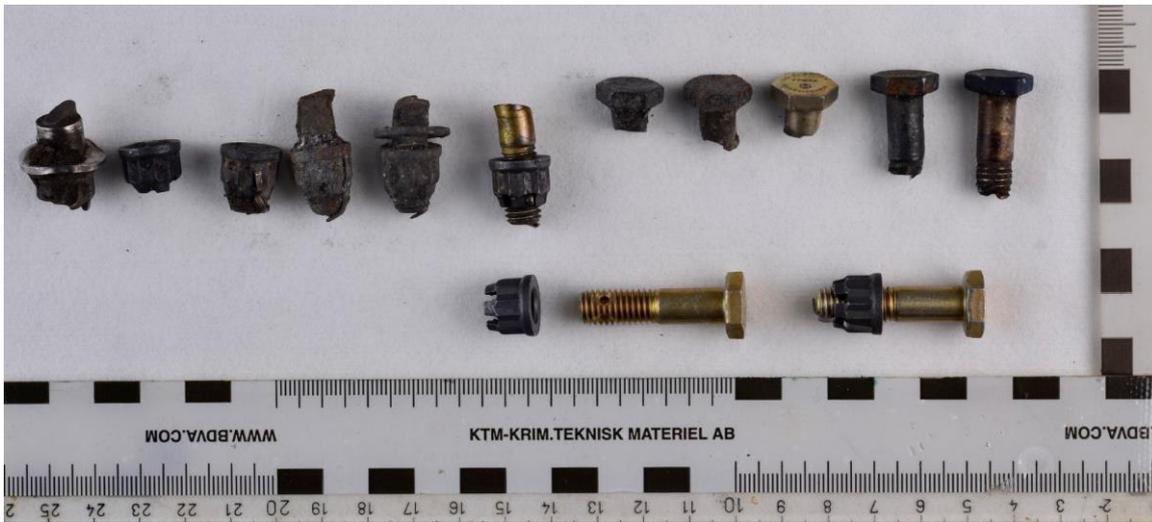
Figure 50: All the bolt halves that were found. For reference purposes, two unbroken bolts with nuts are shown in the lower part of the photo. Photo: DNV GL/NSIA

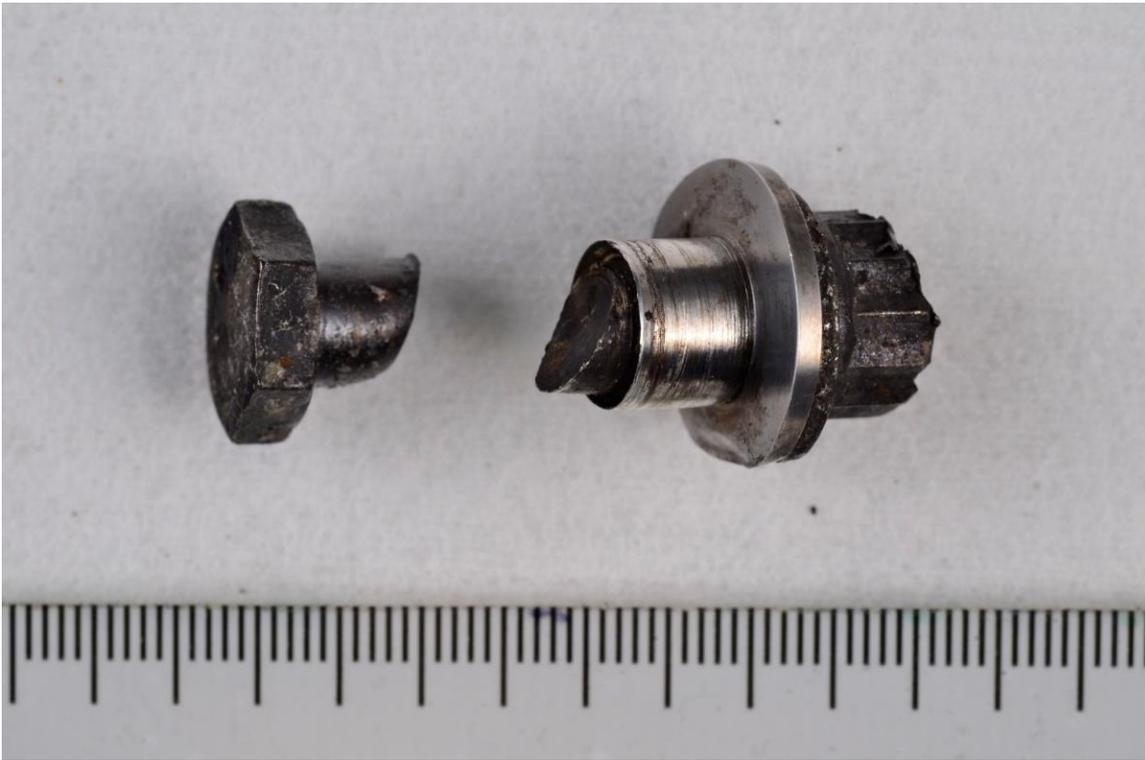
Figure 51: The fracture surfaces of one of the bolts. The sleeve that is inserted through the discs can be seen on the right by the nut. Photo: DNV GL/NSIA

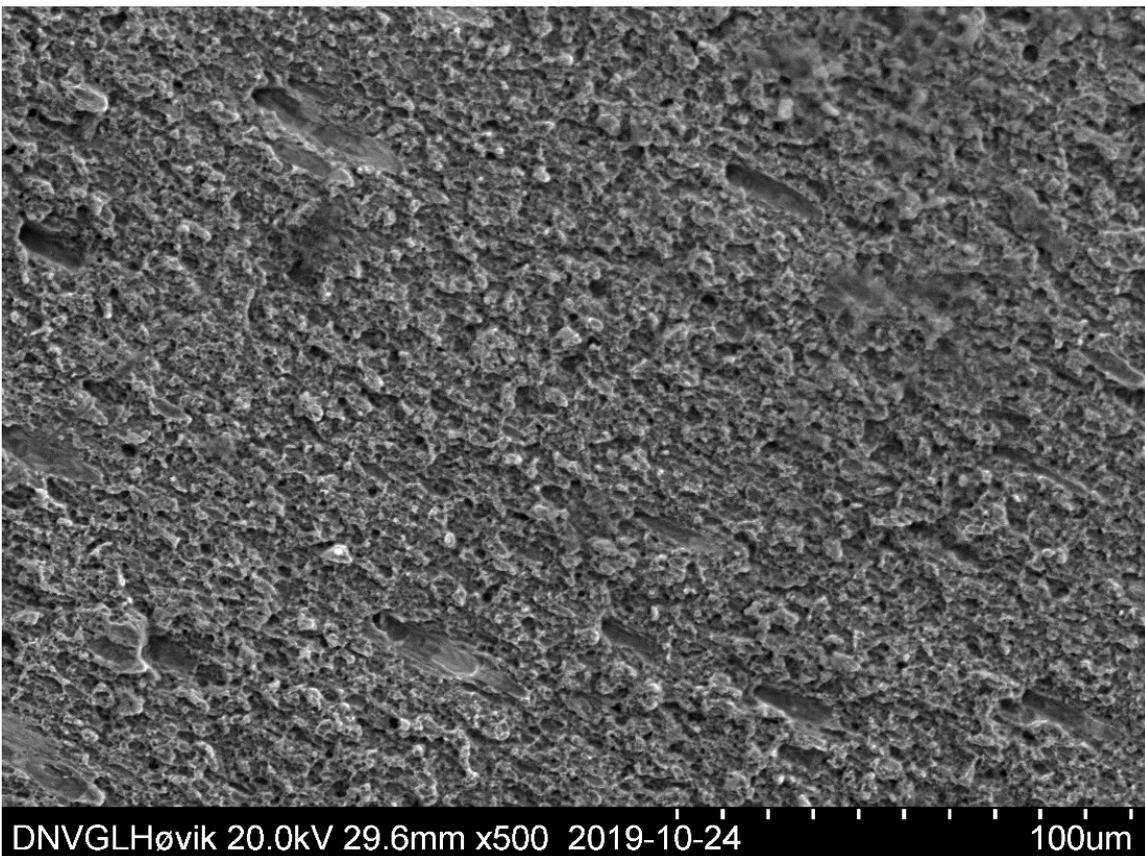
Figure 52: The fracture surface of the bolt in the previous figure, magnified 500 times. The dimples in the fracture surface are evidence of a ductile overload fracture. Photo: DNV GL/NSIA

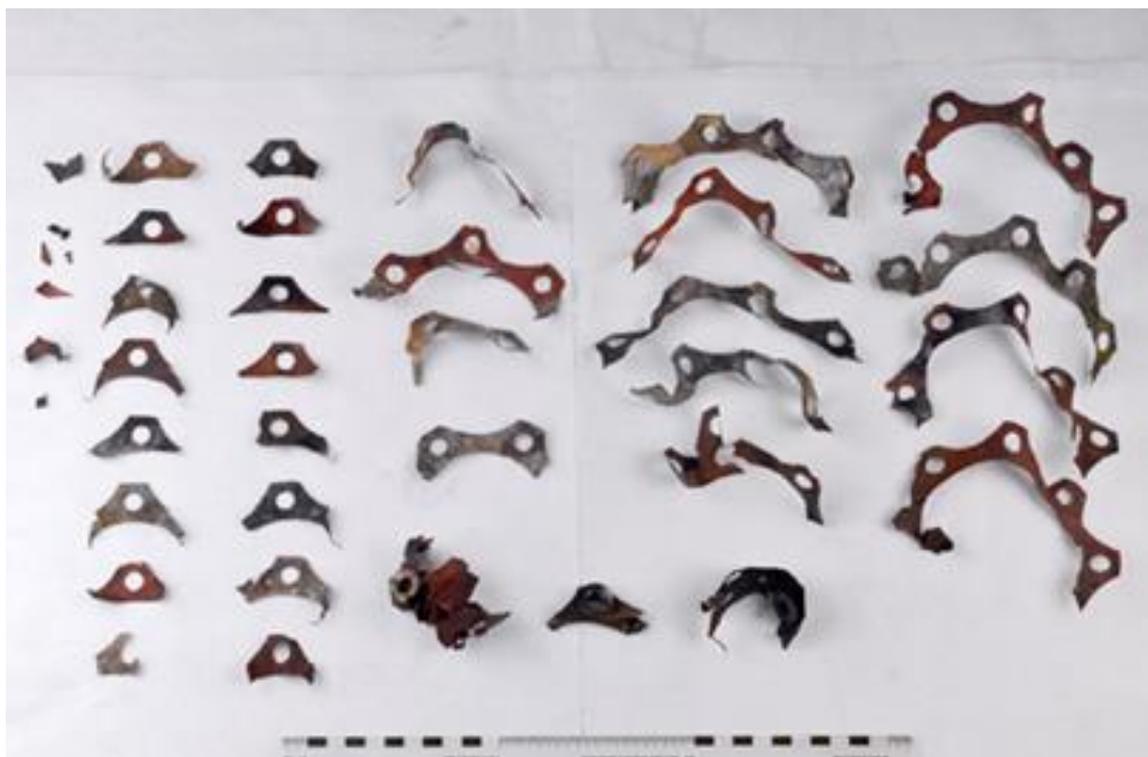
Figure 53: Disc segments from the flexible coupling. Photo: DNV GL and NSIA

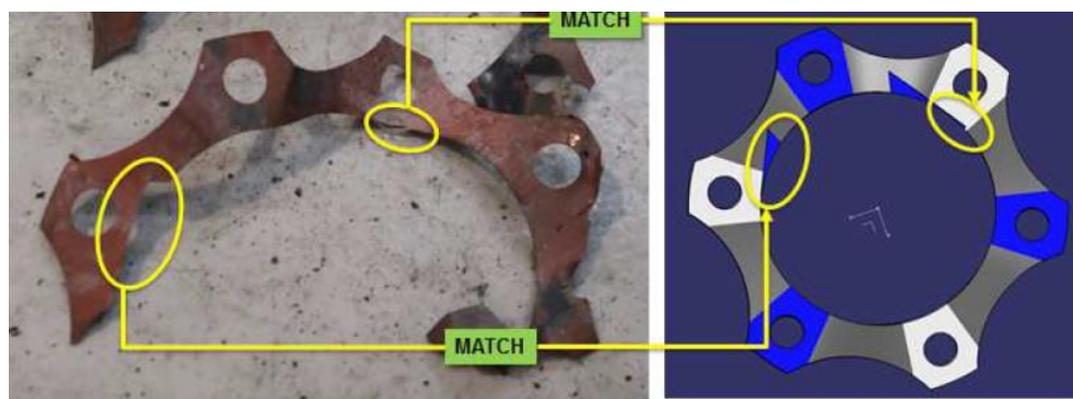
Figure 55: Comparing the damages to the actual disc segments of LN-OFU and typical damages to the disc segments due to misalignment of the driveshaft it was found that they were close to identical. Source: Airbus Helicopters/NSIA

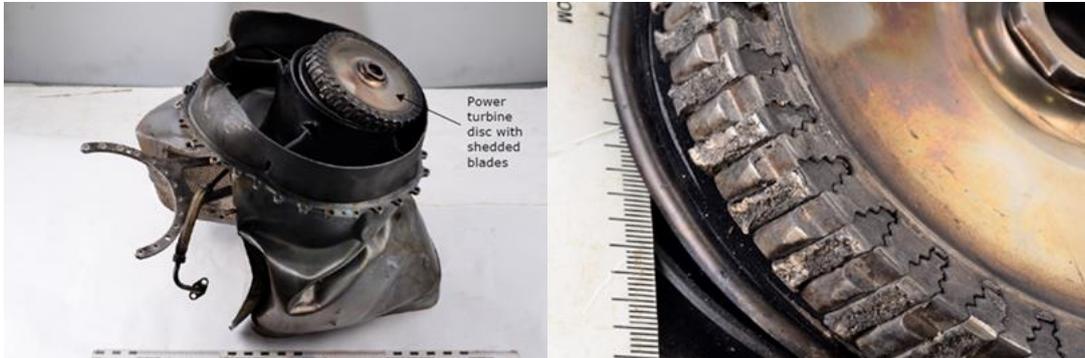
Figure 59: All 37 blades on the free turbine had just about identical fracture surfaces at the root of the blade. Photo: DNV GL/NSIA

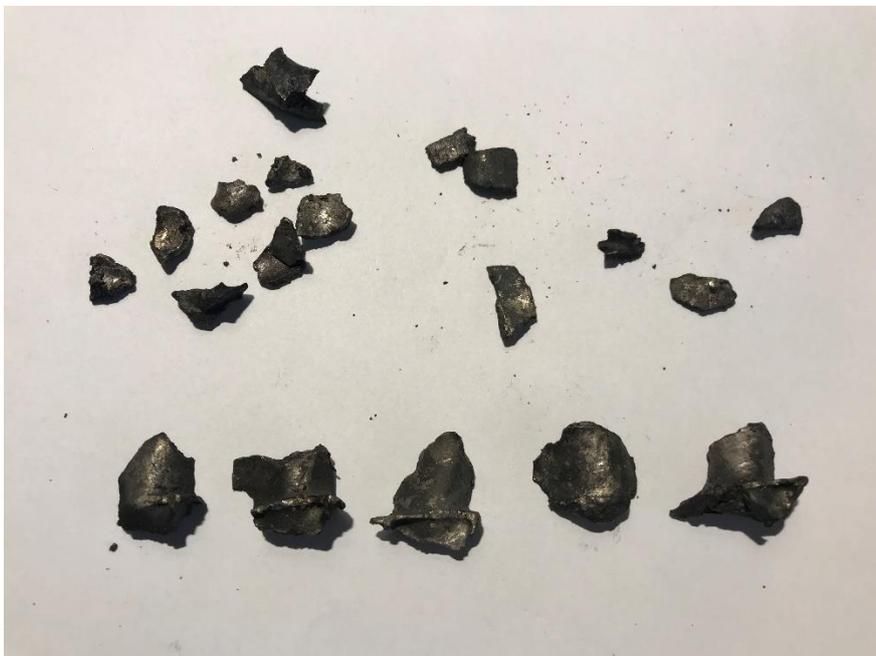
Figure 60: Turbine blade fragments found during engine disassembly. Photo: NSIA

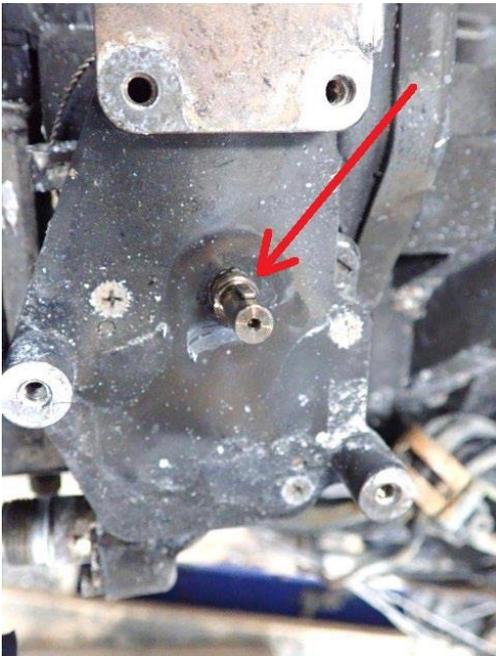
Figure 61: The arrow points to the locking finger on the shaft between the HMU and the EBCAU. When it points straight upwards, the EBCAU has not taken over control of the engine. Photo: Safran Helicopter Engines

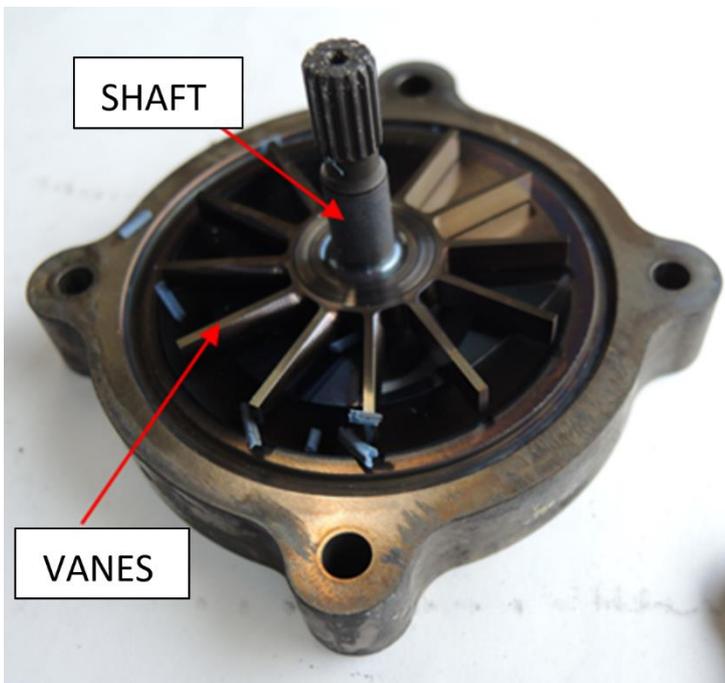
Figure 62: The vanes and shaft in the low-pressure part of the fuel pump. Small bits of the interior blue gasket were further fragmented and fell off during disassembly. Photo: NSIA

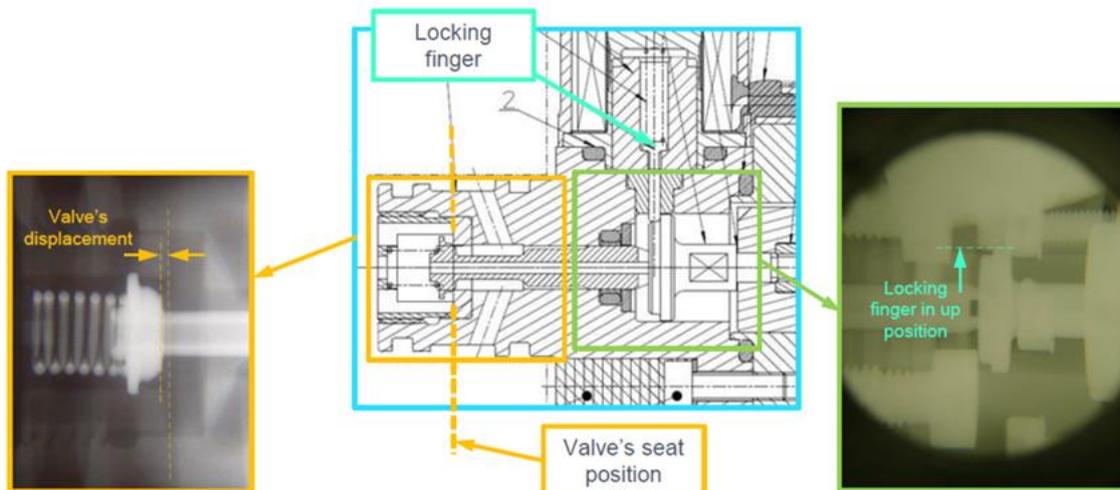
Figure 63: X-ray images of the SEV showed that it was found in the open position and had not been activated. Illustration: Safran Helicopter Engines. X-ray images: AIM/NSIA

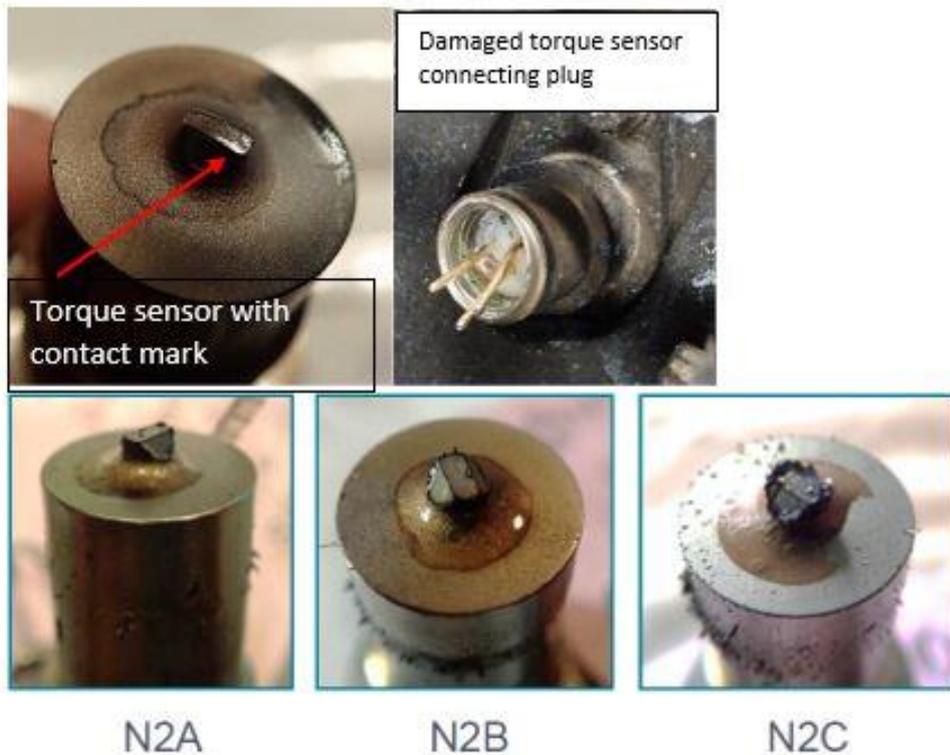
Figure 64: The torque sensor with contact mark on the pick-up part, the damaged connecting plug and the three undamaged N2 sensors. Photo: Safran Helicopter Engines/NSIA

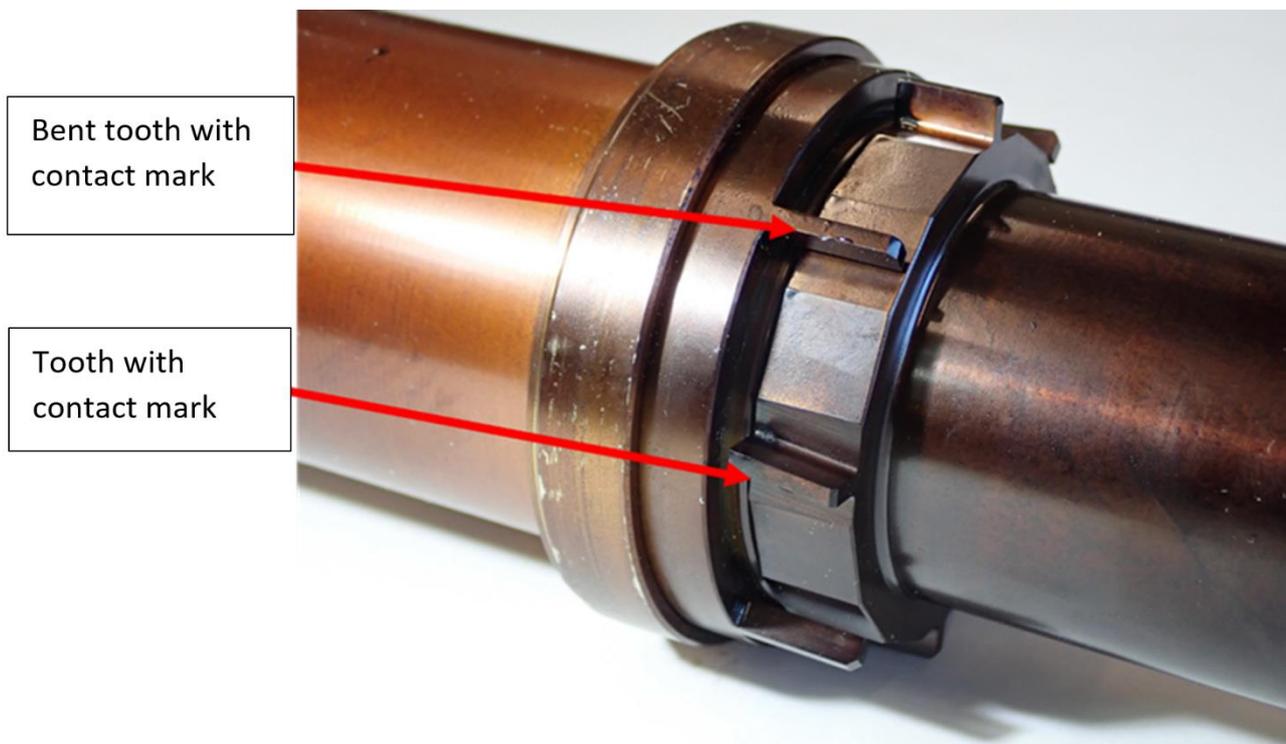
Figure 65: The engine's transmission shaft with contact mark and bent tooth. Photo: NSIA

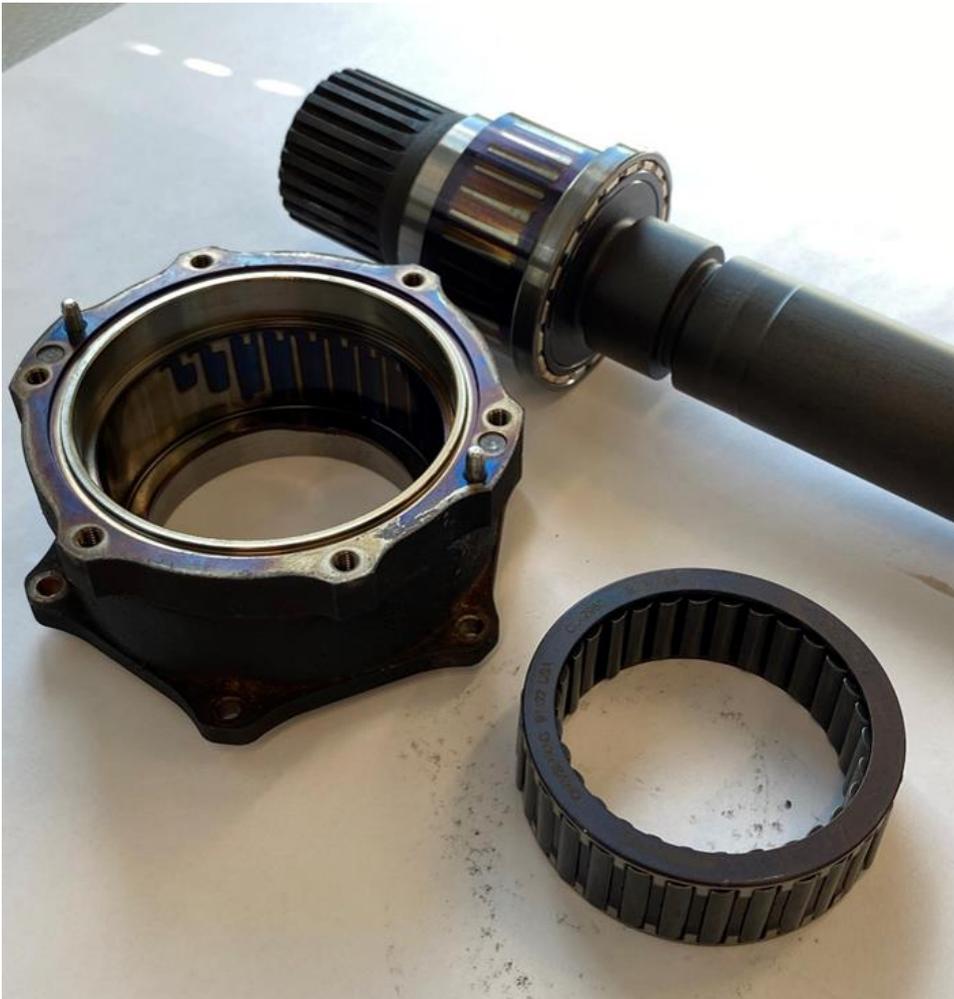
Figure 66: The freewheel clutch. From left to right: the outer ring with blue oxidation marks, the inner shaft with oxidation marks from the sprags and the ring with sprags on the bottom right. Photo: NSIA

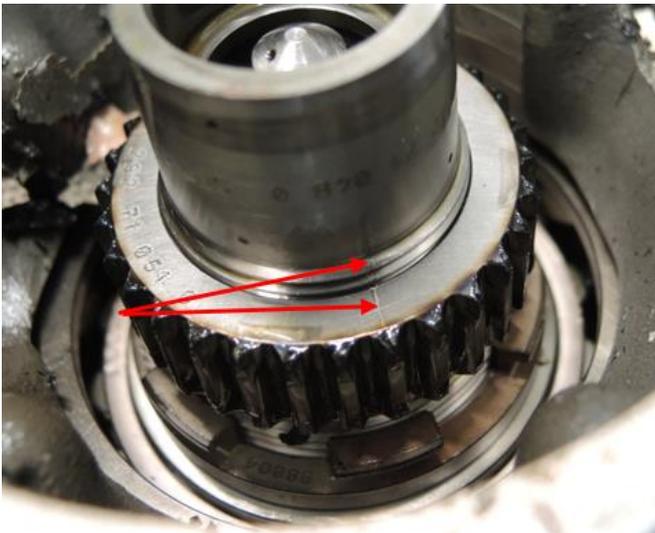
Figure 67: The alignment marks on LN-OFU. The blue discolouration of the nut was caused by the heat that developed after the crash. Photo: Safran Helicopter Engines/NSIA
