AIRCRAFT ACCIDENT REPORT

AASL/2019/01/03/F

**Final Report on the serious incident involving
Boeing 737-500 Aircraft with nationality and
registration marks 5N-AIS, operated by Azman Air
Services Limited, which occurred at Port-Harcourt;
Nigeria on 3rd January, 2019**

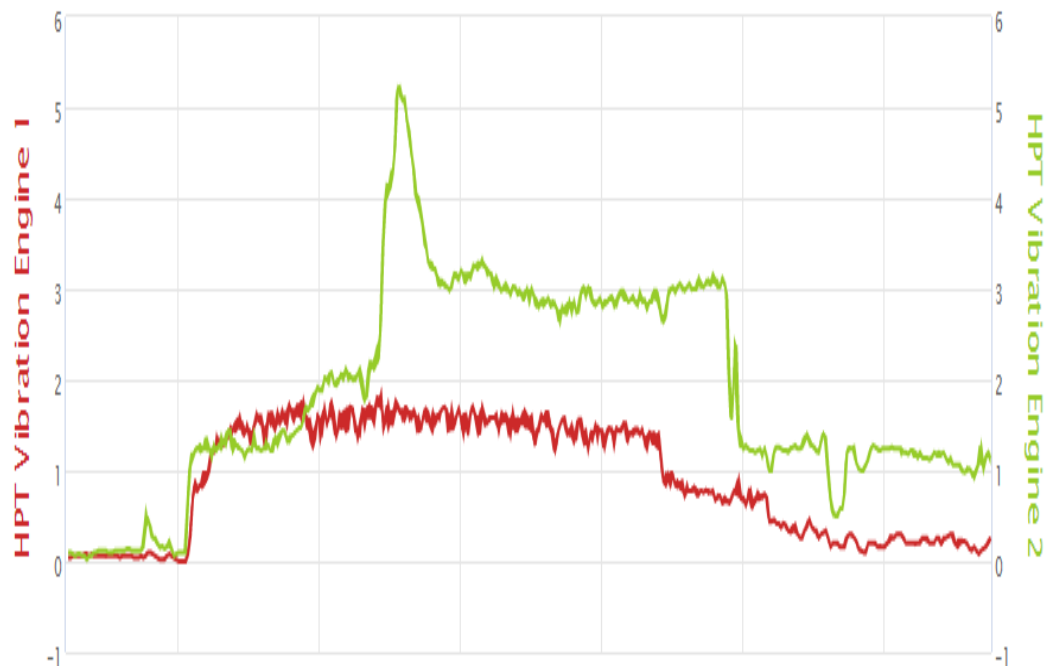
At 10:10 h, AZM2316 took-off from DNMM for a commercial flight heading to DNPO. At 10:15:36 h, Engine 2 turbine vibration started to increase gradually over a period of 40 seconds reaching a peak of 5.26 units (*typically, vibration >3 is considered abnormal and >4 is considered critical*).

Figure 6: High pressure turbine vibration of number two engine

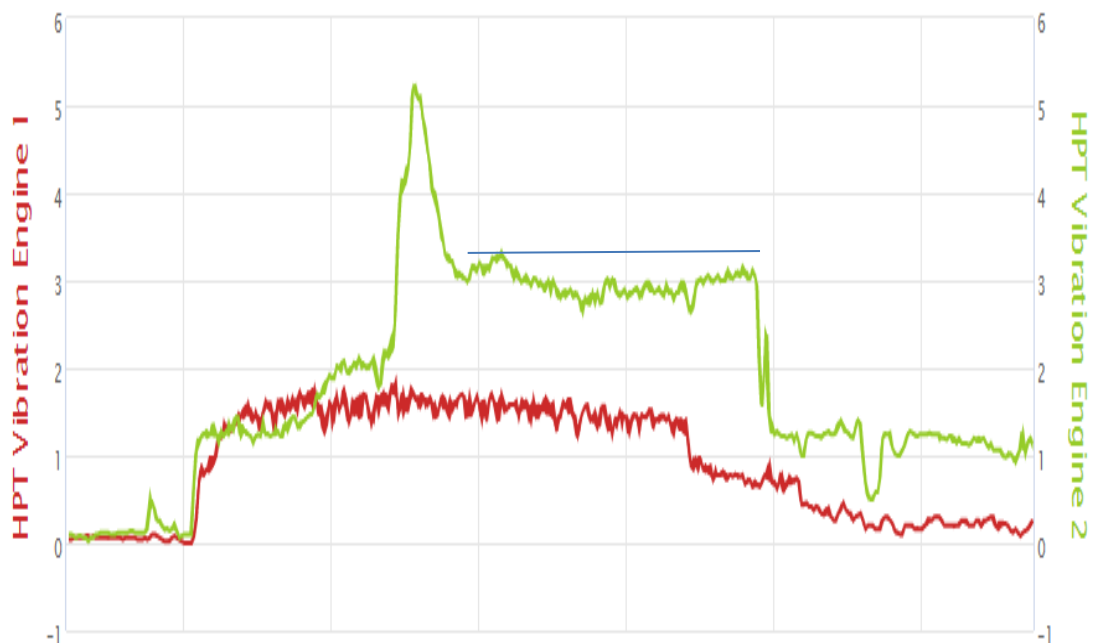
At 10:17 h, the Engine 2 turbine vibration gradually decreased over a period of 90 seconds stabilizing at approximately 3.0 units.

Figure 7: The Engine 2 High pressure turbine vibration gradually decreased over a period of 90 seconds

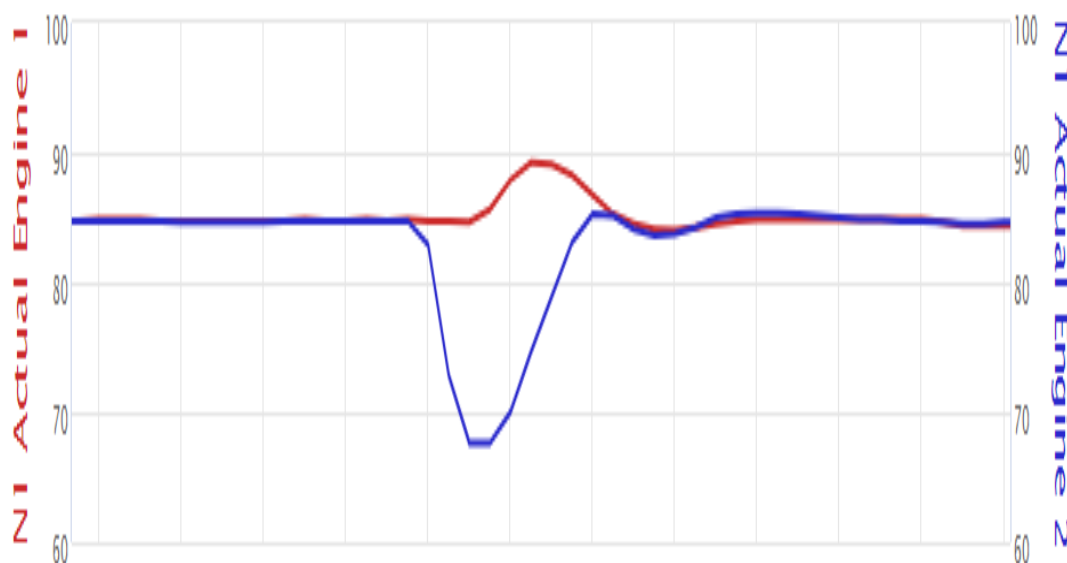
At 10:28 h, engine 2 N1 decreased to 68% uncommanded [sic] and then increased to 85% over a period of 5 seconds uncommanded [sic].

Figure 8: Engine 2 N1 decreased to 68% and then increased to 85% over a period of 5 sec.

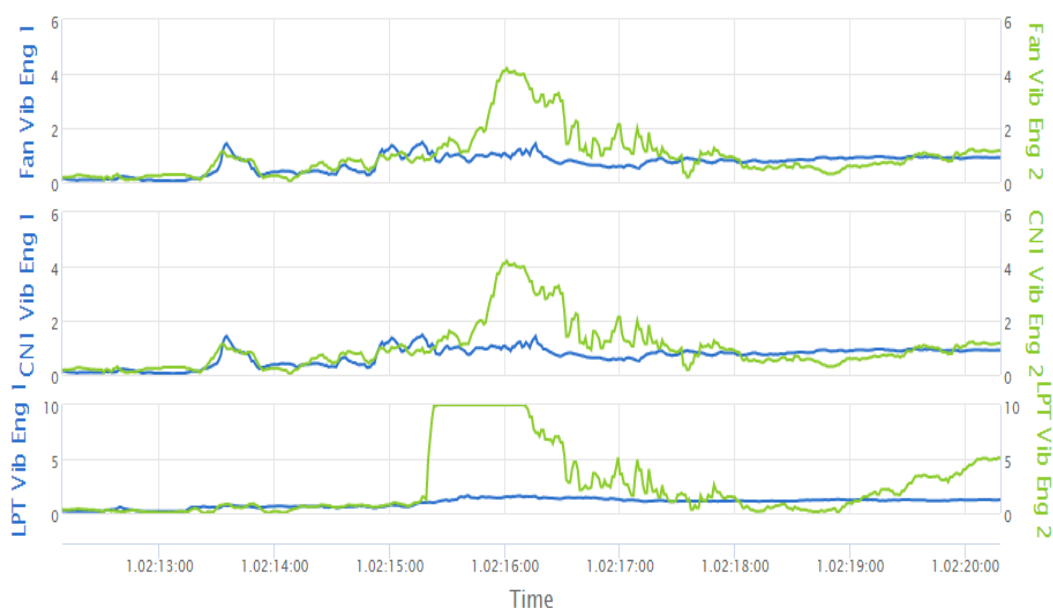
At 10:53:51 h, the A/P was disengaged and the TO/GA² was engaged accompanied by an A/P warning. The Engine 2 turbine vibration showed severe vibration of 9.90 units.

At 10:54:16 h, Engine 2 Fan Vibration increased to 4 units.

Figure 9: Engine 2 fan, compressor and turbine vibration.

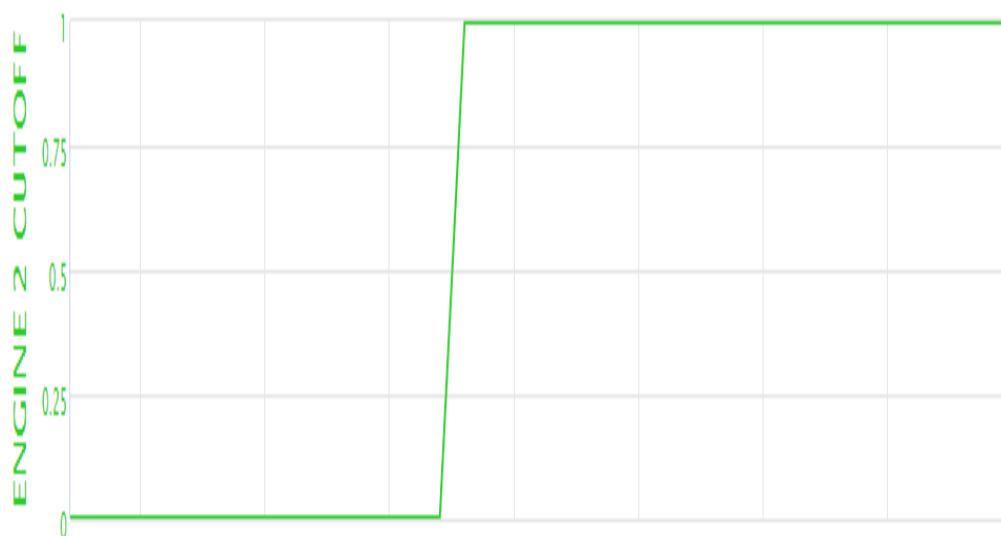
At 10:59 h, Engine 2 Cut-off parameter toggled.

Figure 10: Engine 2 Cut-off parameter toggled

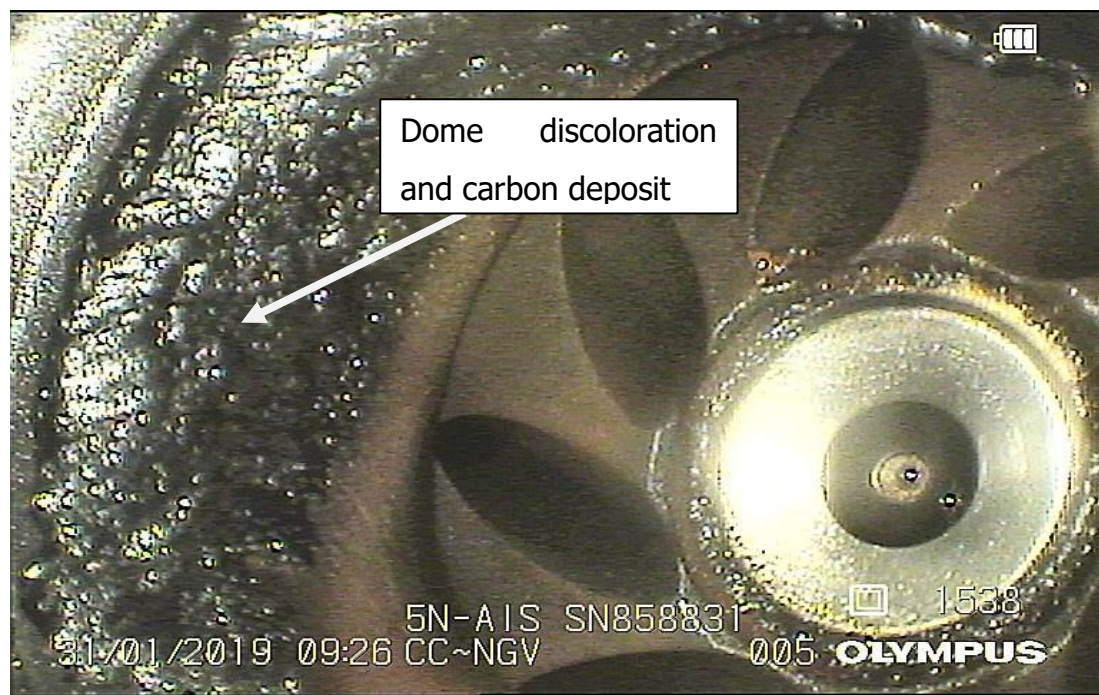
S/N	Item	Location	Number	Findings	Remark
1	Fan Blade	Inlet	38	All fan blades dirty	Serviceable
2	Combustion Chamber	S10-S15		Dome discoloration and carbon deposit	Serviceable
3	HPT Nozzle Guide Vanes	S10-S15	46	Burns and missing material on L/E of NGVs NGV T/E Slots delamination White metallic chips around most NGVs	Not Serviceable
4	HPT Blades	S17, S18	72	Missing Codep coating mainly on L/E of all blades burned, missing pieces and rubbing discourager seal	Not Serviceable

Figure 13: Combustor Nozzle- Dome discoloration and carbon deposit around the Nozzle Guide Vane

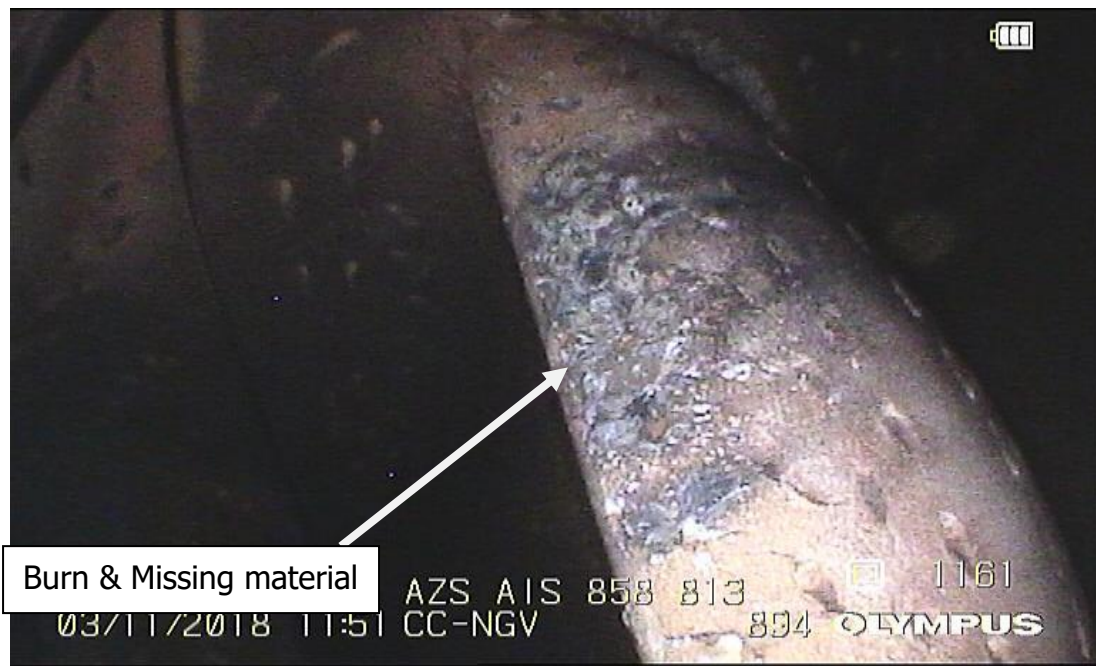
Figure 14: Burn and missing material of the HPT nozzle

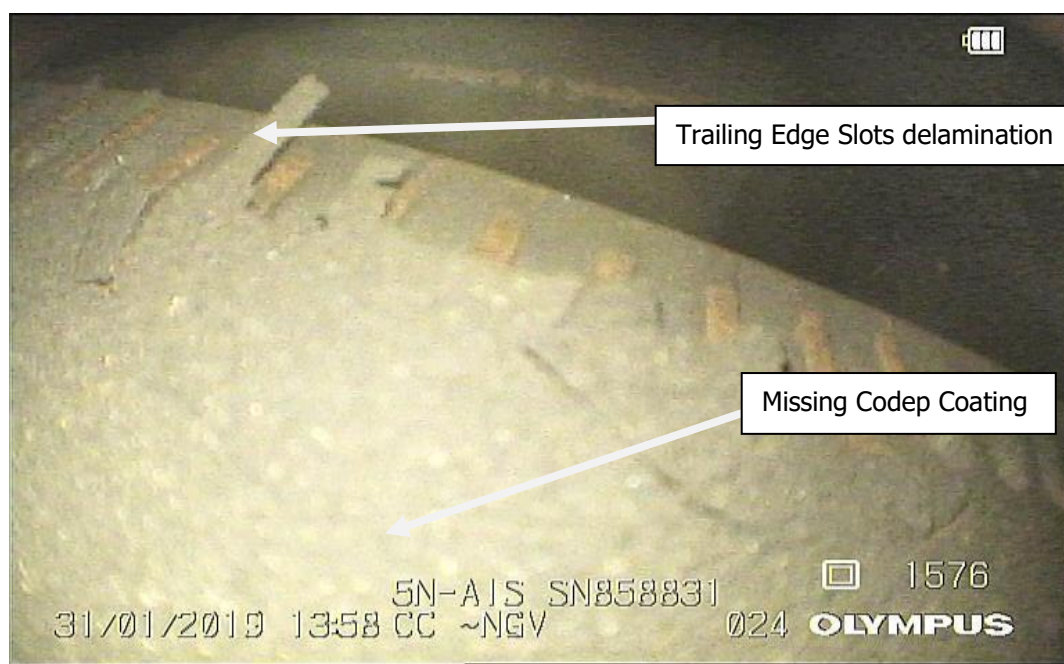
Figure 15: Trailing edge slots delamination and missing codep coating of HPT blade

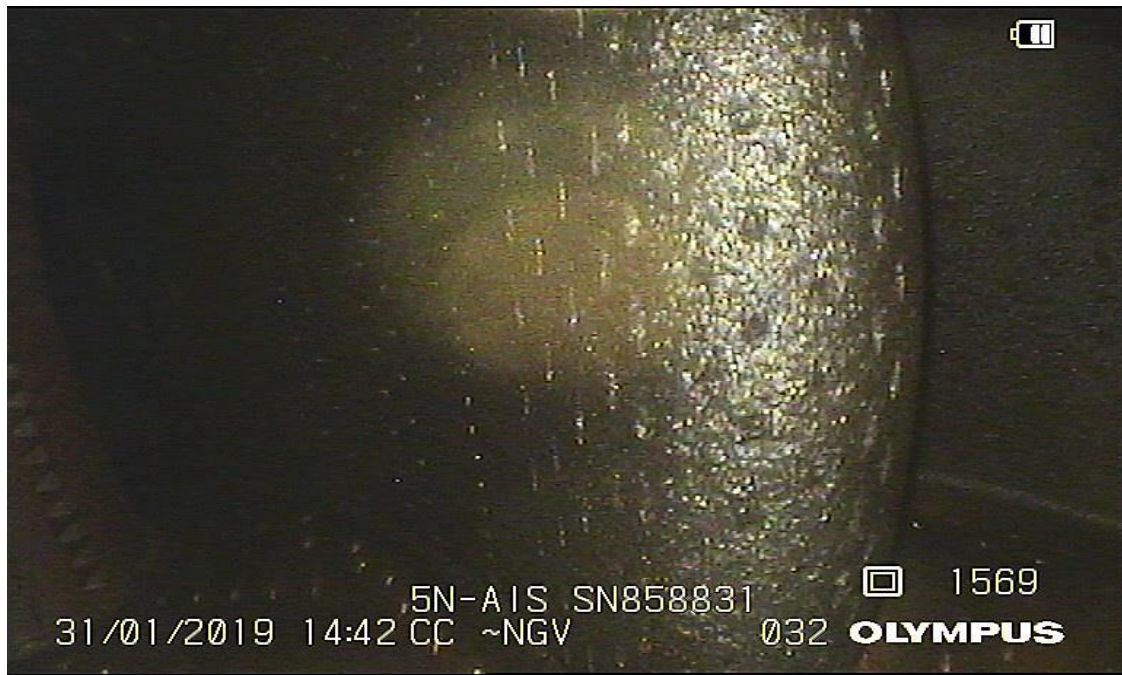
Figure 16: Nozzle Guide Vanes Leading edge and Preservation Oil

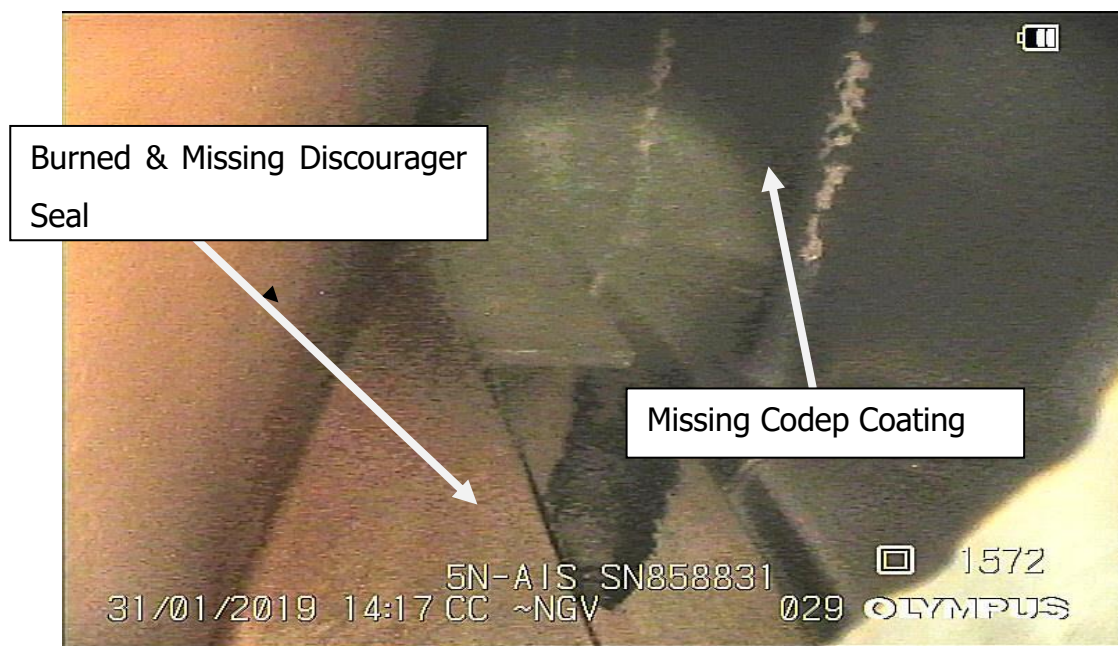
Figure 17: Burned and missing discourager seal

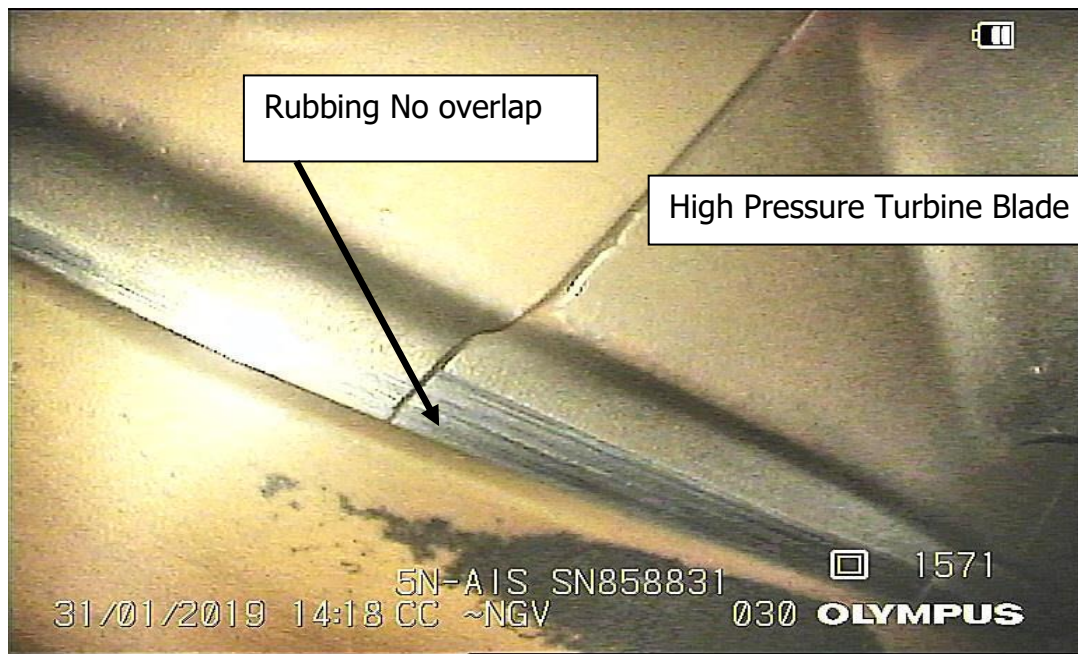
Figure 18: Rubbing no overlap of high pressure turbine blade

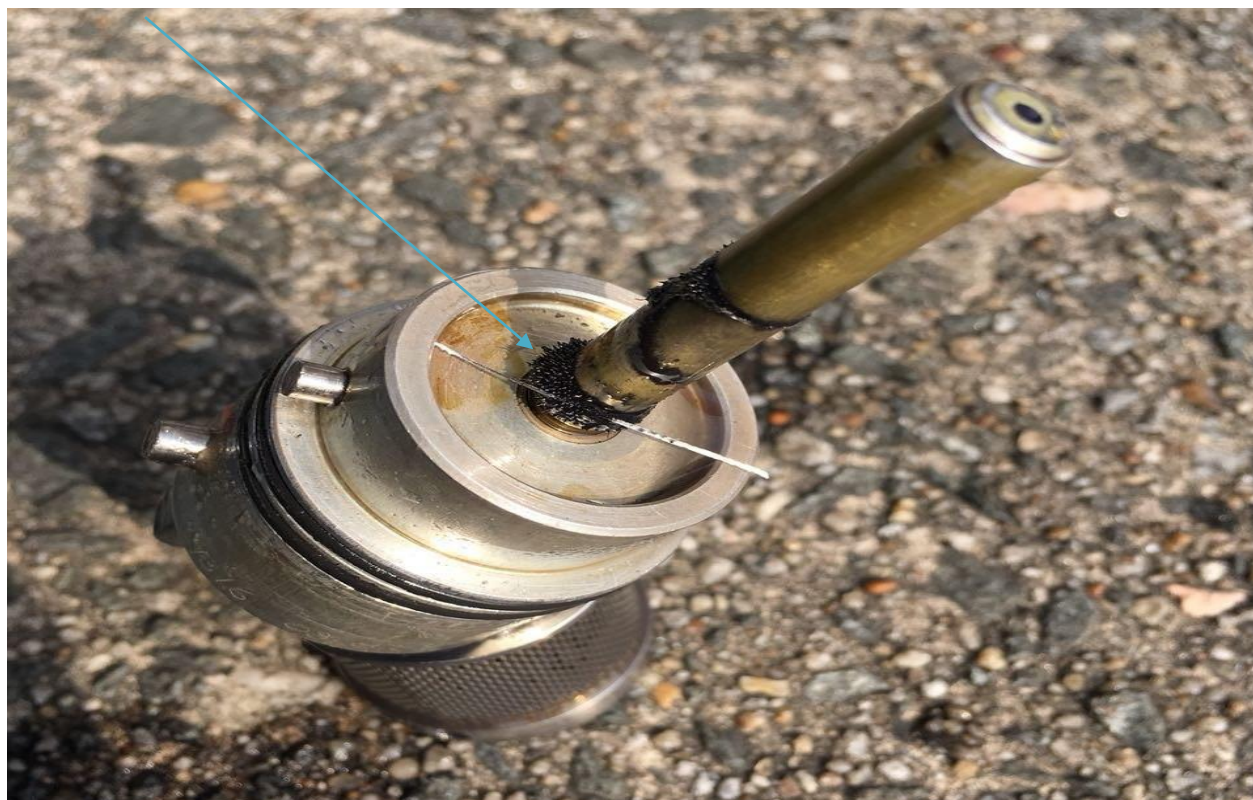
Metallic particles were found on the number two engine magnetic chip detector Aft Sump after the occurrence.

Figure 19: Number two engine Magnetic Chip Detector aft sump showing metallic particles

As there was severe turbine vibration, it is probable that, the number 4 and number 5 bearings, which are located in the aft sump of the engine, gave in. Consequently, pieces of particles from the damaged bearings or seals clogged the aft scavenge oil filter leading to the illumination of the oil filter bypass warning light in flight.

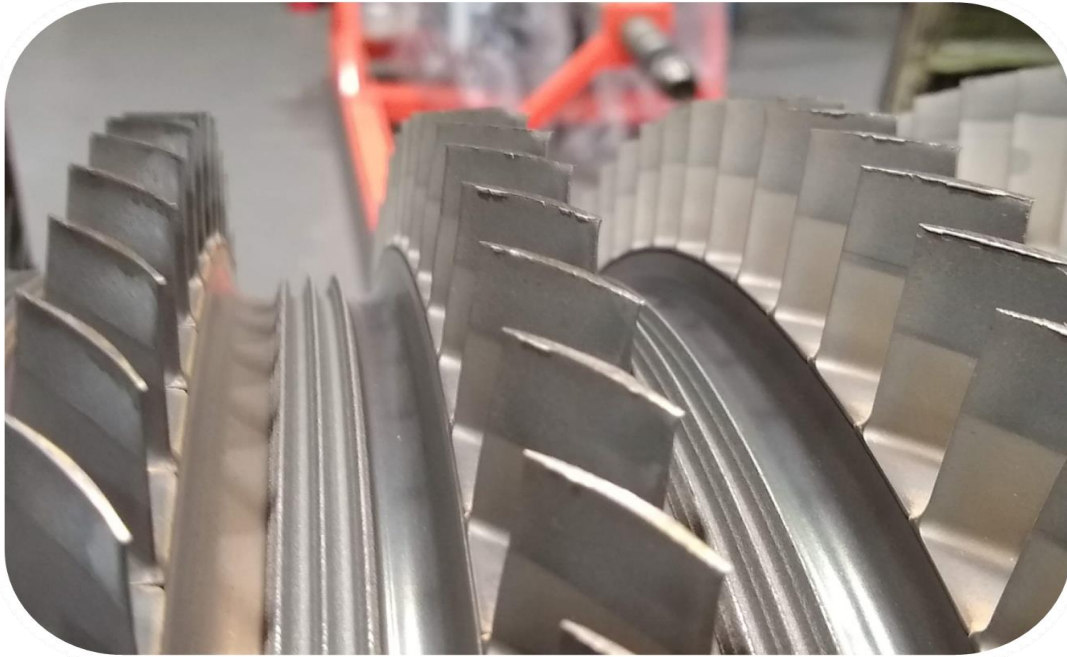
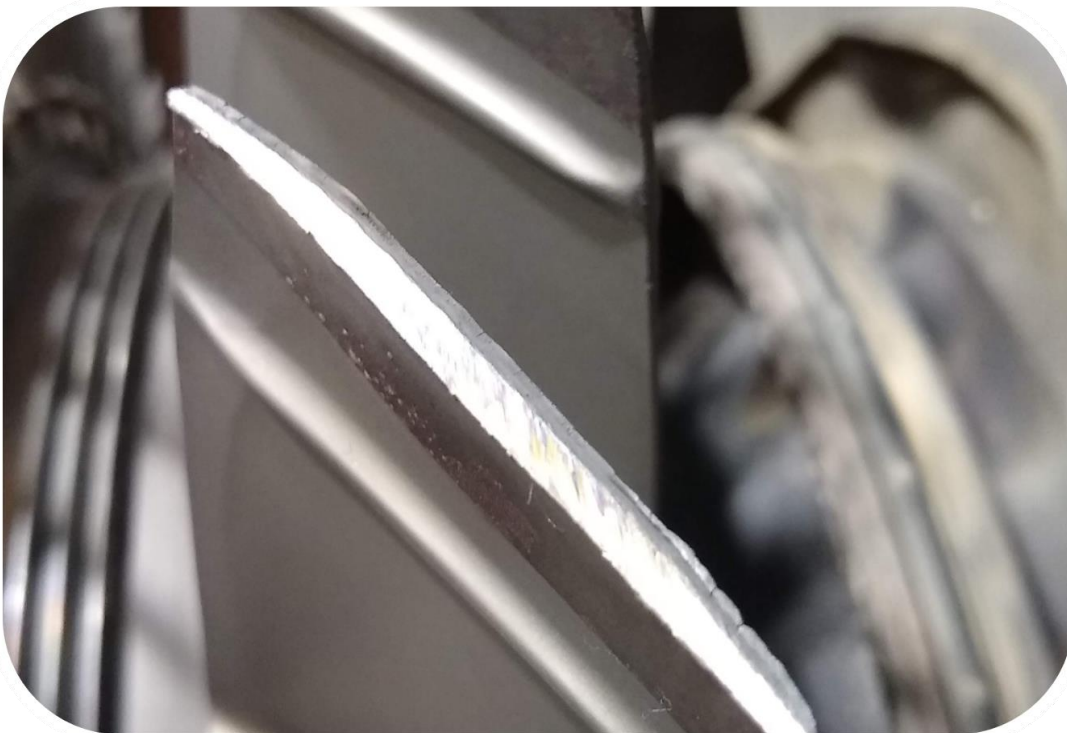
Blades stages 1-9 found heavy tip rub see following pictures.

Figure 20: High Pressure Compressor Blades stages 1-9 heavy tip rub

Figure 21: High Pressure Compressor Blades tip rub

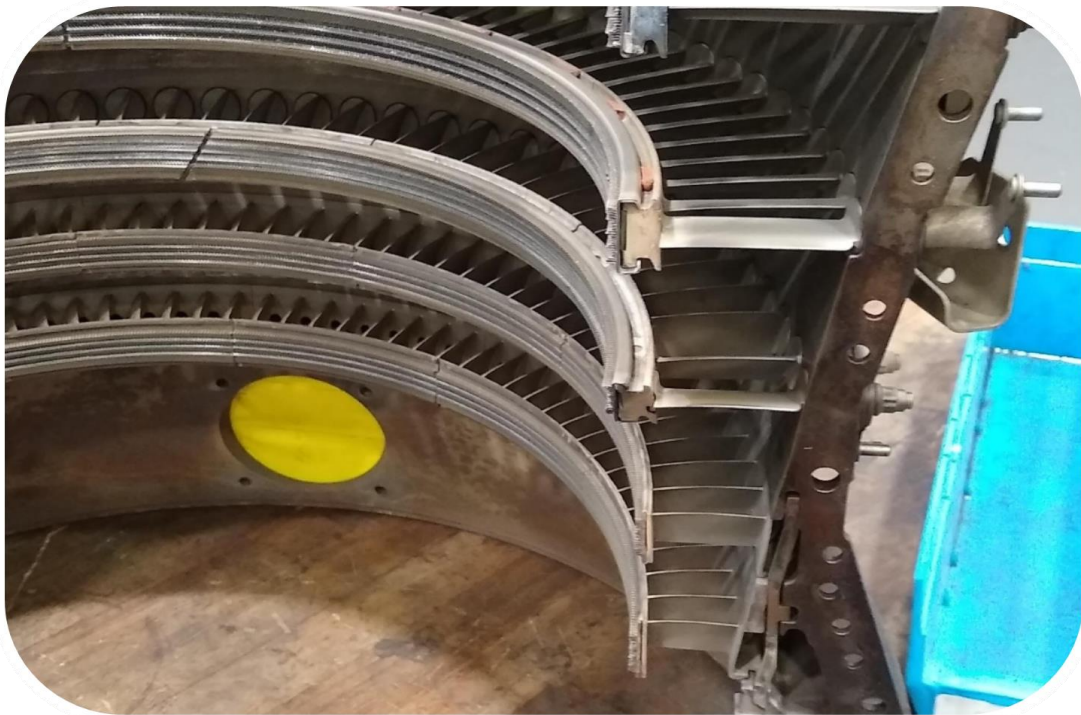
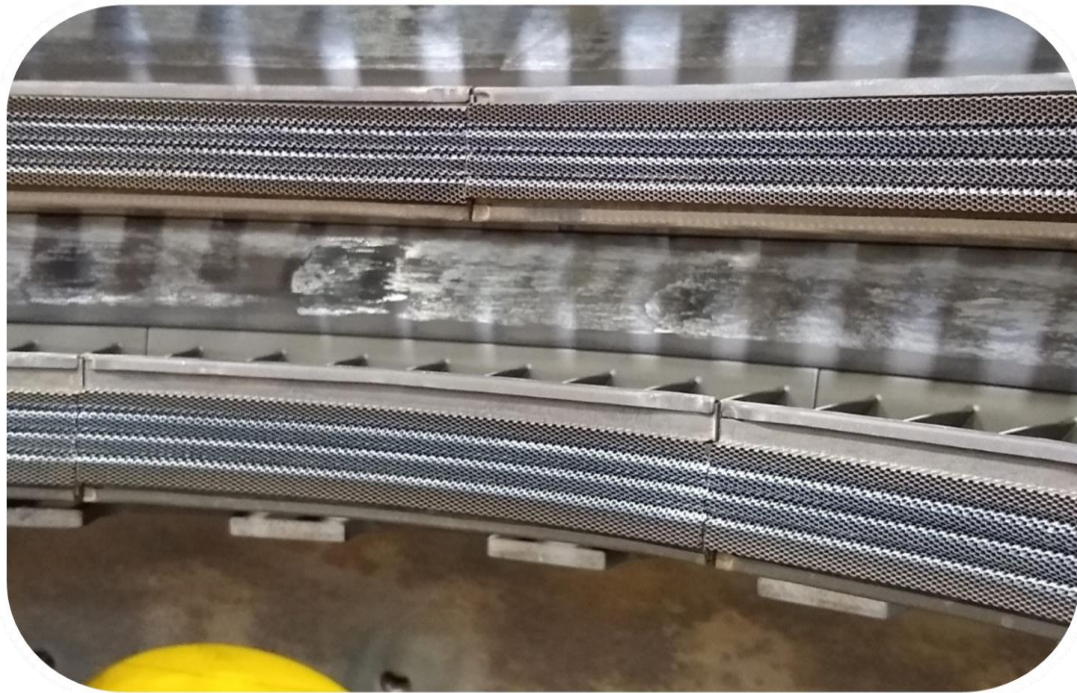
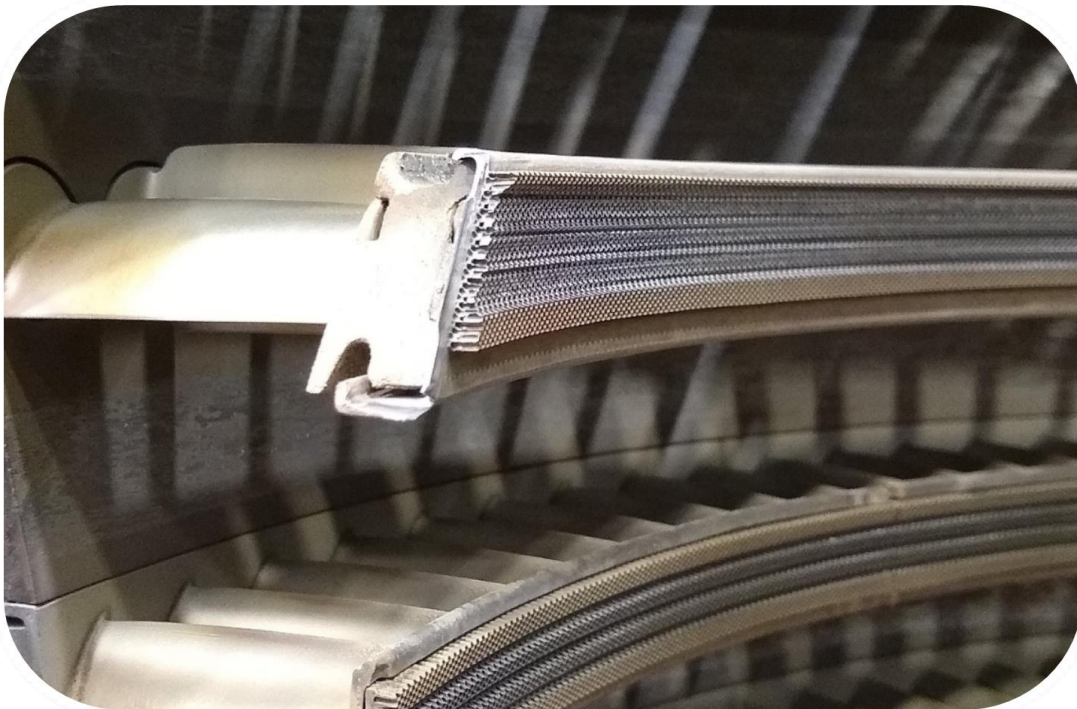
Heavy rub noted on cases and stationary Air seals Stage 1-5 due to HPC rotor and Blades making contact with cases after No.4 Bearing failure. See Pictures below.

Figure 22: High pressure Compressor Heavy rub on Cases and stationary Air seals
Stage 1-5

Figure 23: High pressure Compressor Heavy rub on Cases

Figure 24: High pressure Compressor rub on Cases

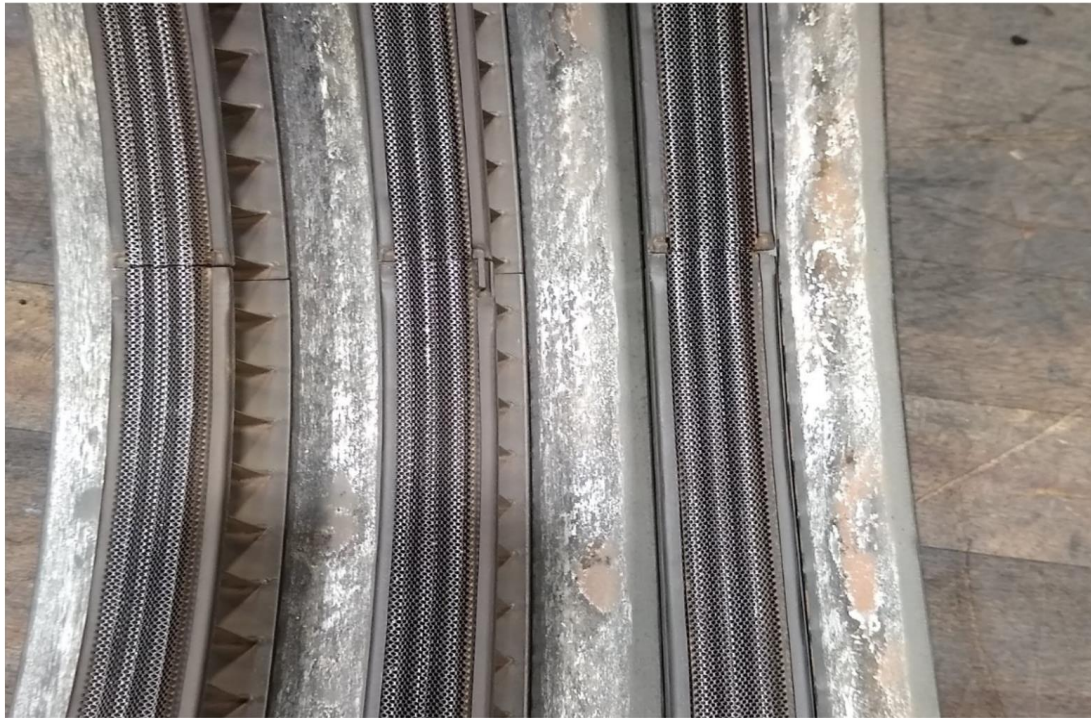
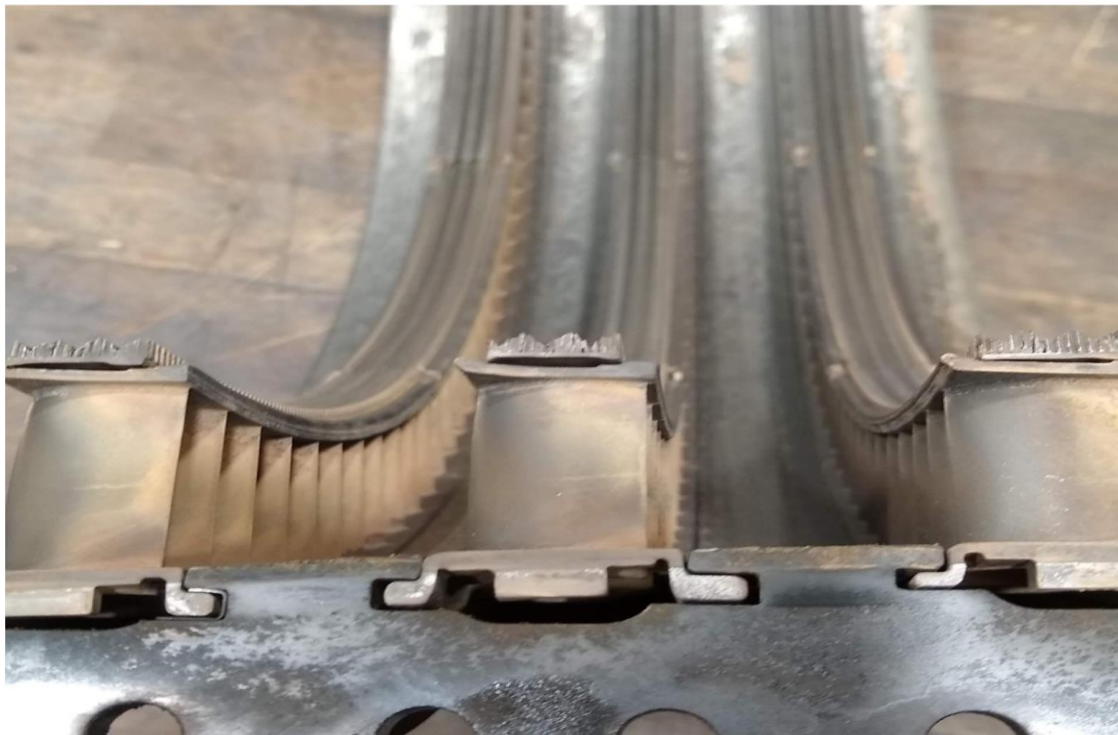
High pressure Compressor (HPC) rear cases heavy rub noted on cases due to HPC rotor and blades making contact with cases after No.4 bearing failure.

Figure 25: High pressure Compressor (HPC) blades rear cases heavy rub

Figure 26: High pressure Compressor (HPC) blades rear cases rub
