Aviation Accident and Incident Investigation Directorate

**Report on the investigation of the runway excursion incident
to Boeing B727 with registration EY-724, at Kigali
International Airport on November 13th, 2020.**

Ref AAID 2021-02

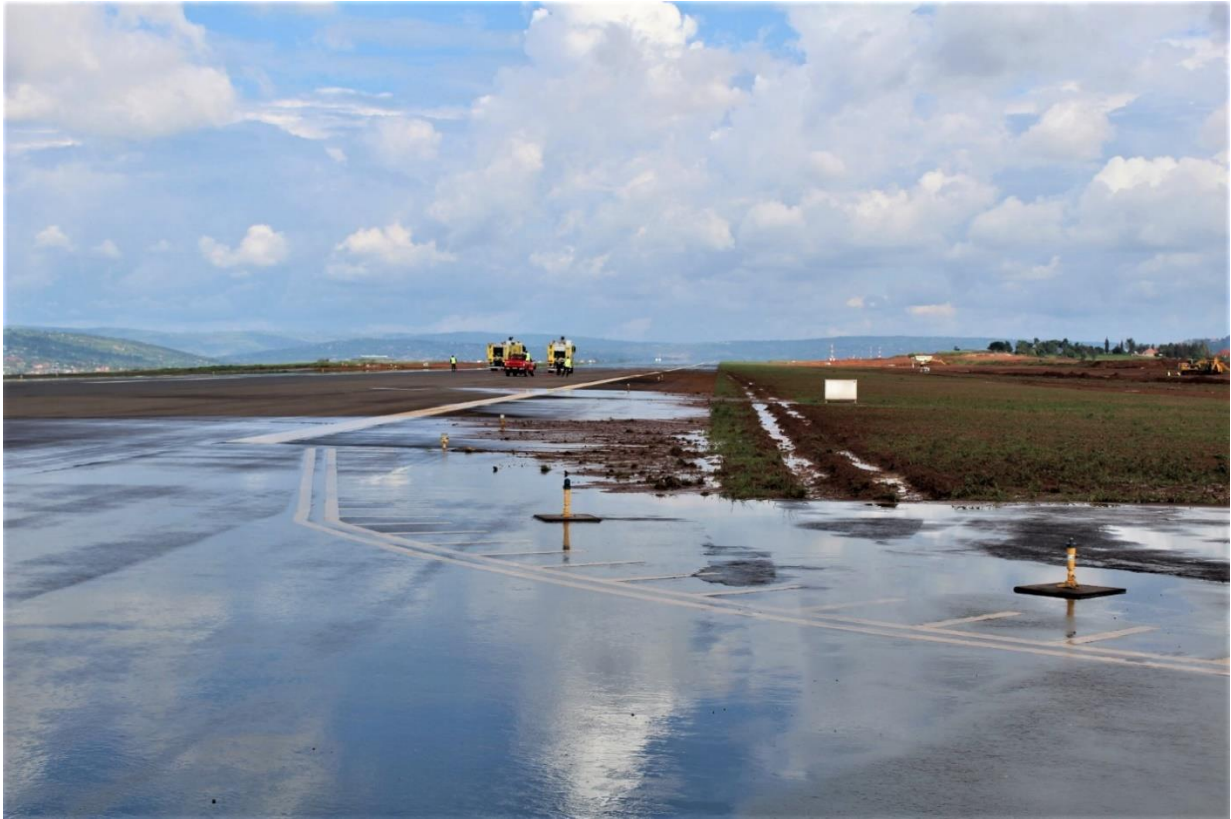
Figure 2: Track of left-hand landing gear beyond runway shoulder at taxiway Charlie. Note: picture is taken when looking in Easterly direction

At this stage the centre of the left-hand landing gear had reached a distance of approximately 1,5 m from the edge of the runway shoulder.

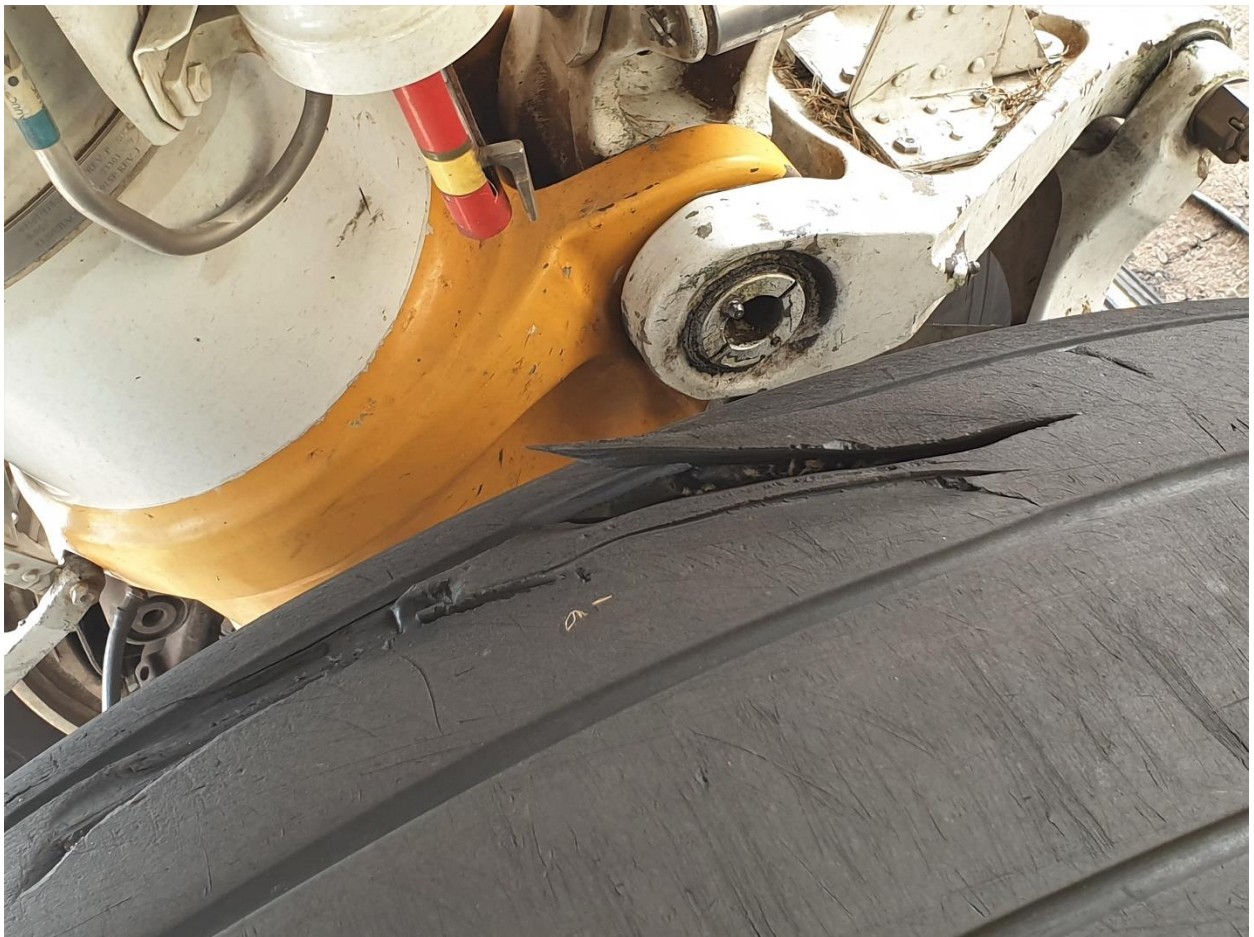
As a result from impact with the runway edge lights on the left-hand side of runway 28, all six tires of the aircraft showed cuts, see figure 3 below:

Figure 3: Tire damage as a result of impact with runway edge lights.

- 3.1.16 The left-hand main gear travelled over the grass area next to the pavement of the runway shoulder over a distance of 577 m.
- 3.1.17 During the runway excursion of flight TAK 270 15 runway edge lights were shattered, resulting in damage to all tires of the aircraft.

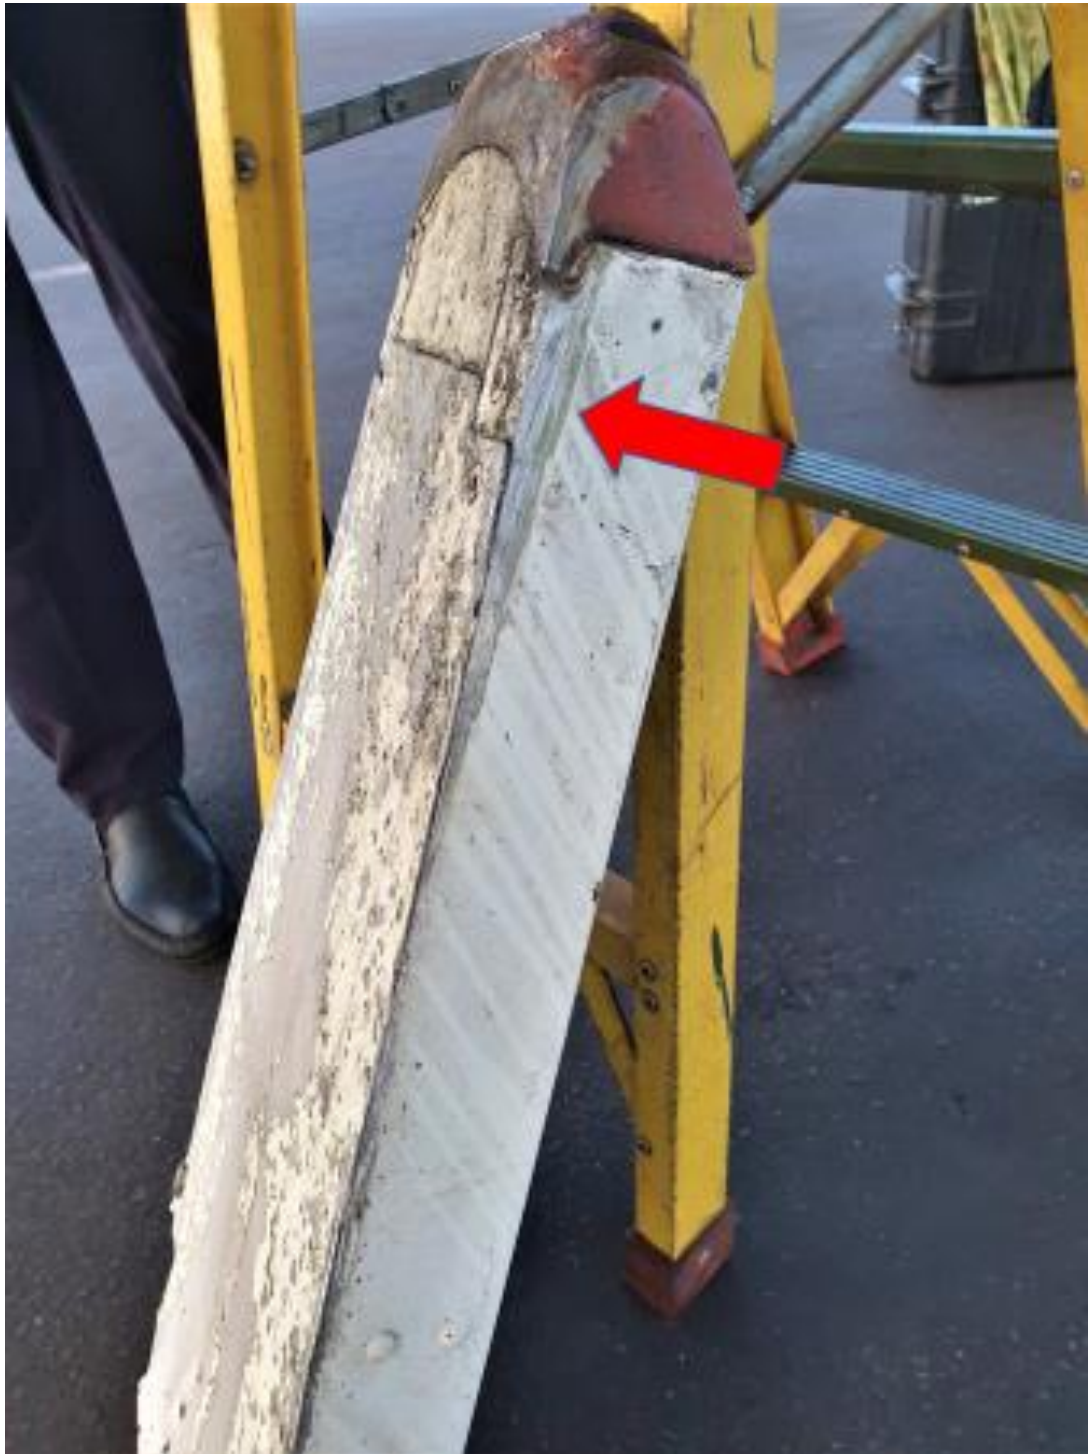
The tailskid mechanism of the EY-724 was found heavily damaged. The tailskid plate was torn off, the detached part was found on the left-hand side of the runway past taxiway Charlie, approximately at the position where the aircraft re-entered the paved shoulder of the runway, see figure 4.

Figure 4: Torn-off tailskid plate with fresh scrape marks.

The red arrow on figure 4 indicates the fresh scrape marks that were found on the right-hand aft part of the tailskid plate.

The extensive damage to the tailskid mechanism as described in paragraph 1.3.2, in particular the scrape marks on the right-hand aft part of the torn-off tailskid plate found on the runway, show that the aircraft touched down with an unusual high pitch-up and right-roll attitude. The cracked mounting bracket and the uncompressed tailskid cylinder pointing aft are further indications of a high sideways impact force that was exerted to the mechanism during the landing flare.

The damage pattern to the tailskid mechanism is a clear indication of an incorrect crosswind landing technique, resulting in an unusual high pitch-up and right roll attitude upon touchdown. This attitude will have impaired forward visibility, which is a credible explanation for the statement from both pilots that they suddenly lost visibility during touchdown.

- 3.1.14 The damage pattern of the tailskid mechanism indicated that the aircraft touched down at an unusual high pitch-up and right roll attitude.
- 3.1.15 After touchdown flight TAK 270 lost directional control, and travelled outside the runway over a total distance of 1005 m.

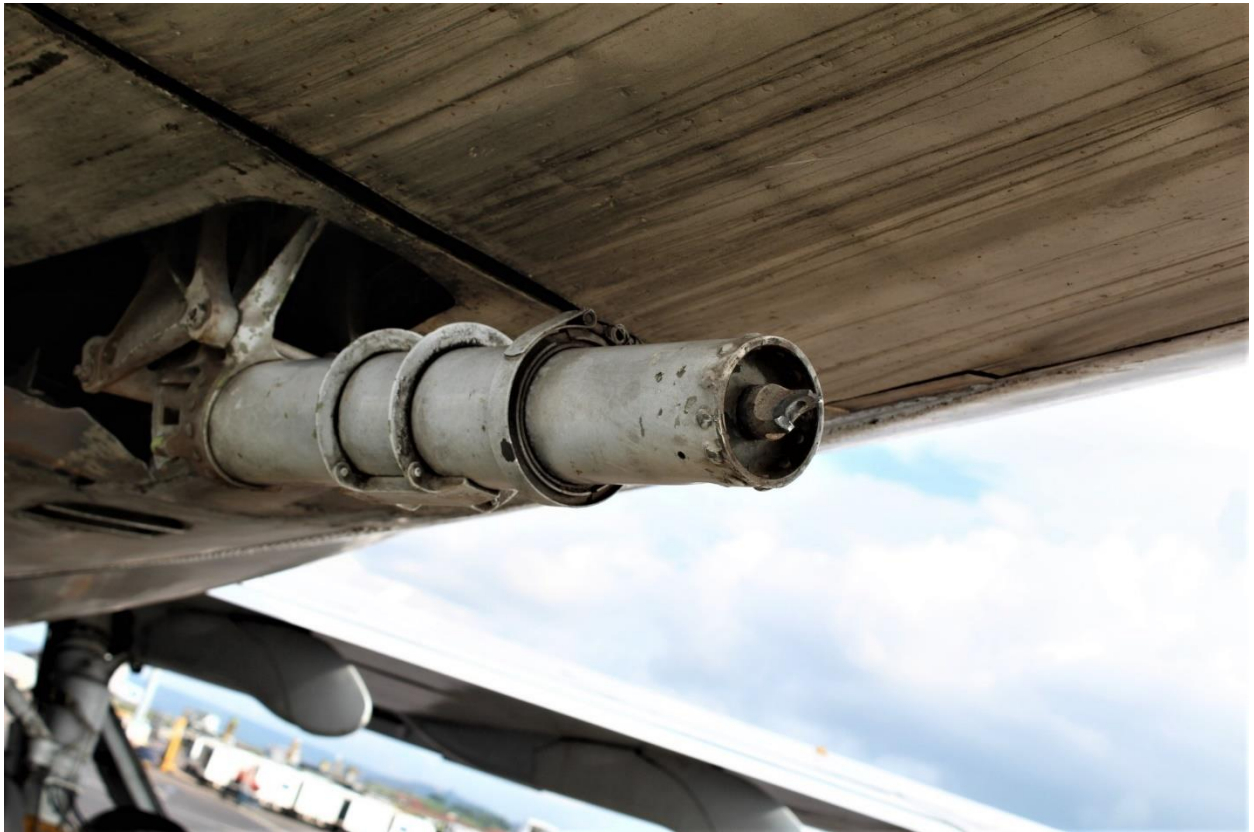
It was further found that the tailskid cylinder was not compressed and was pointing rearward instead of having its regular vertical position. Its mounting bracket inside the lower aft fuselage was cracked, see figure 5 below.

Figure 5: Broken tailskid cylinder pointing rearward.

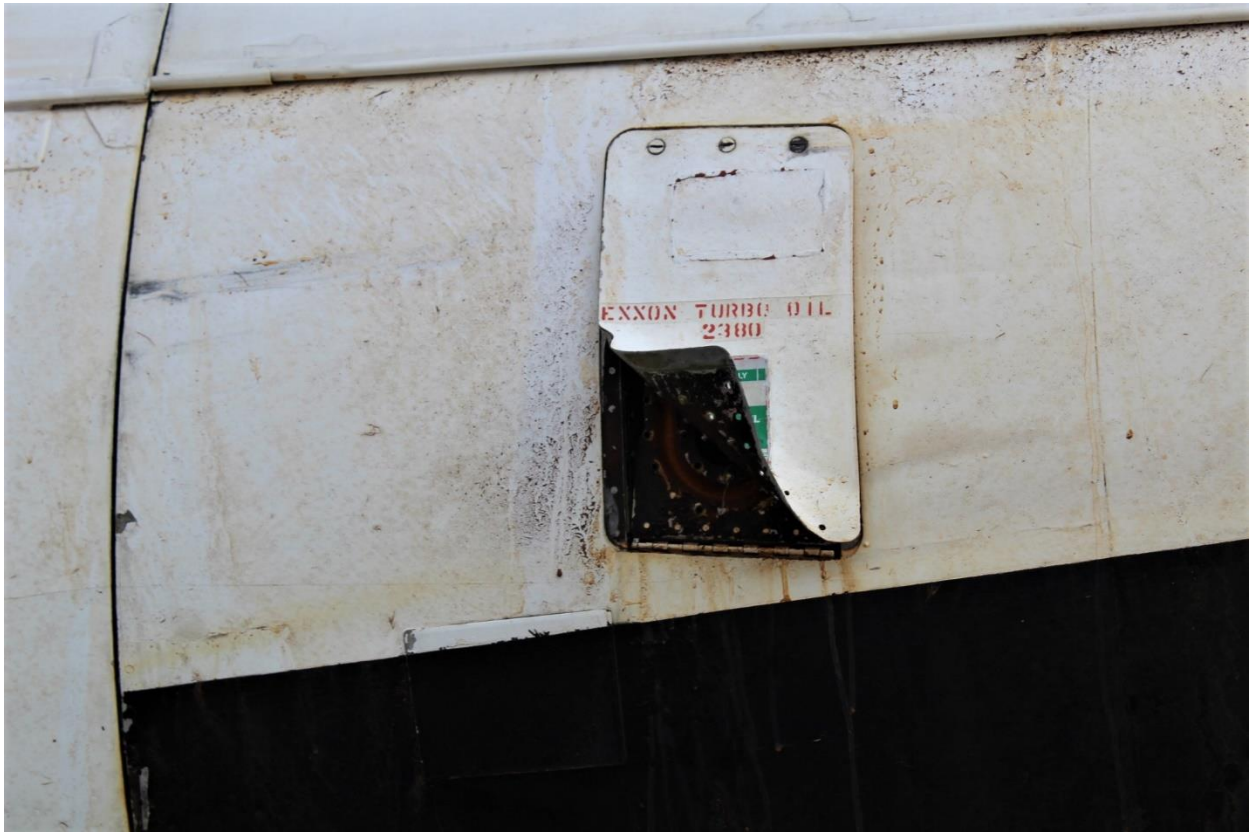
Additionally the access panel for oil servicing of the No. 2 engine was found ripped loose and bent, see figure 6.

Figure 6: Damage to no. 2 engine oil servicing panel.

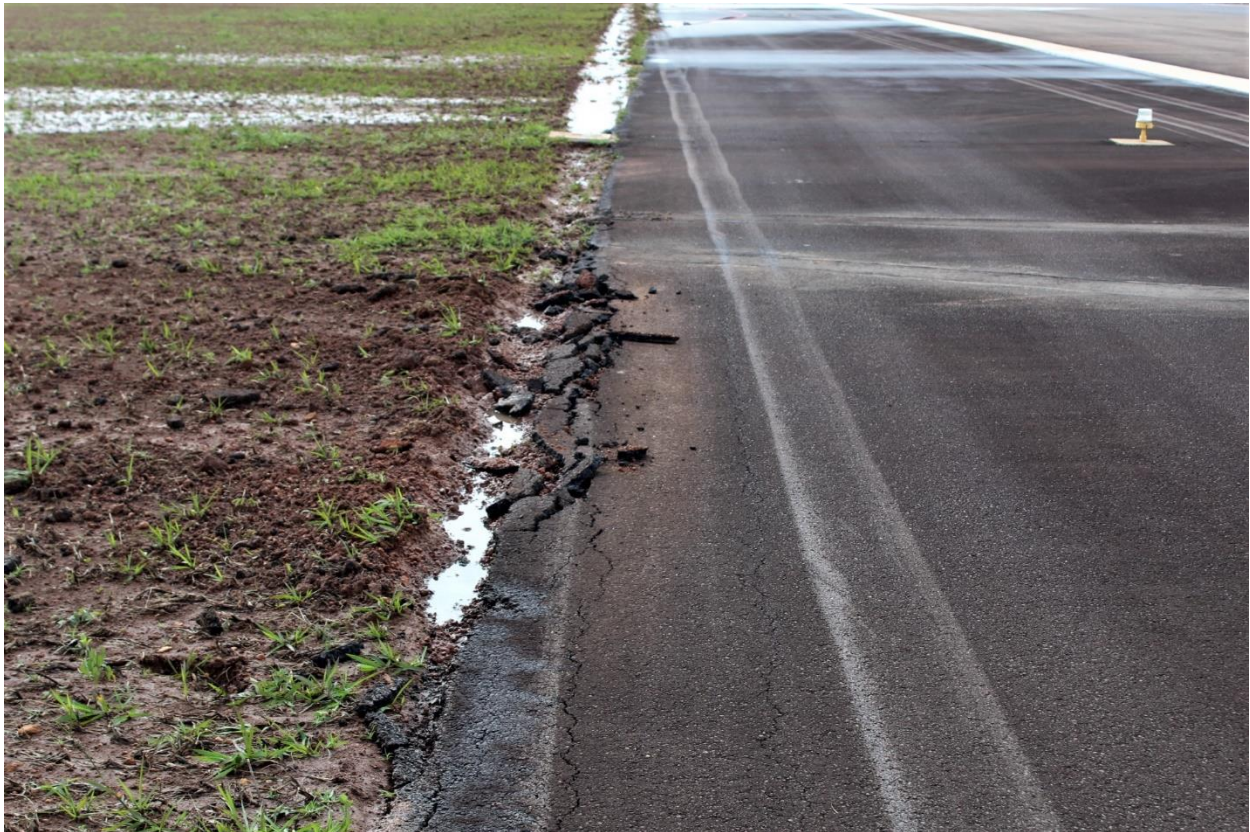
The runway excursion resulted in shattering of a total of 15 runway edge light fixtures and damage to the edge of the left runway shoulder, see figure 7.

Figure 7: Damage to damage to the edge of the left runway shoulder.

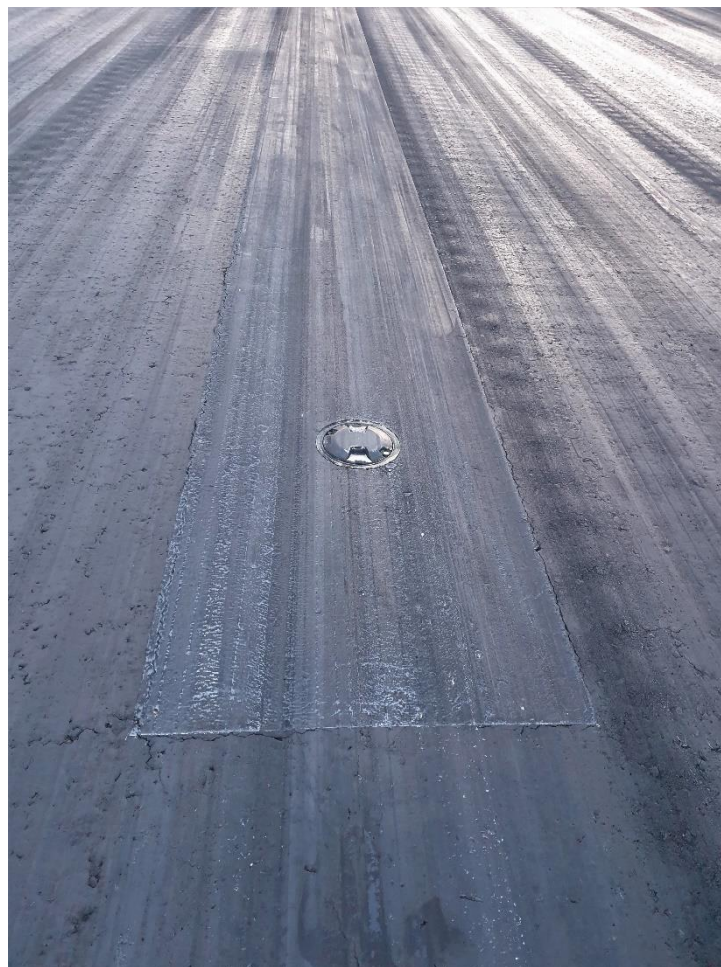
When checking the runway condition shortly after the incident, it was found that the entire touchdown zone of RWY 28 was covered with a substantial layer of rubber as is illustrated by figure 10 below, indicating how the white centreline marking has been faded by accumulated rubber deposits from tires of landing aircraft.

Figure 10: Rubber deposits in touchdown zone of RWY 28.

- The entire touchdown zone of runway 28 was covered by a substantial layer of rubber deposits (also see figure 10 in paragraph 1.10). In combination with a wet runway this forms a well-recognised circumstance for a lack of runway friction.
- The main gear tires of the EY-724 aircraft were all worn to the minimum acceptable limit.
- Deceleration during the landing roll of flight TAK 270 was unusually slow, which is an indication of reduced wheel brake effectiveness. GPS data indicate that the aircraft was still travelling at a groundspeed of 111 knots (205 km/hour) at a position 300 m West of taxiway Charlie, see Figure 12 below:

- 3.1.12 The Rwanda Airports Company should implement procedures for removal of rubber deposits and the conduct of runway friction tests.
- 3.1.13 During touchdown the tailskid mechanism of the aircraft was heavily damaged.

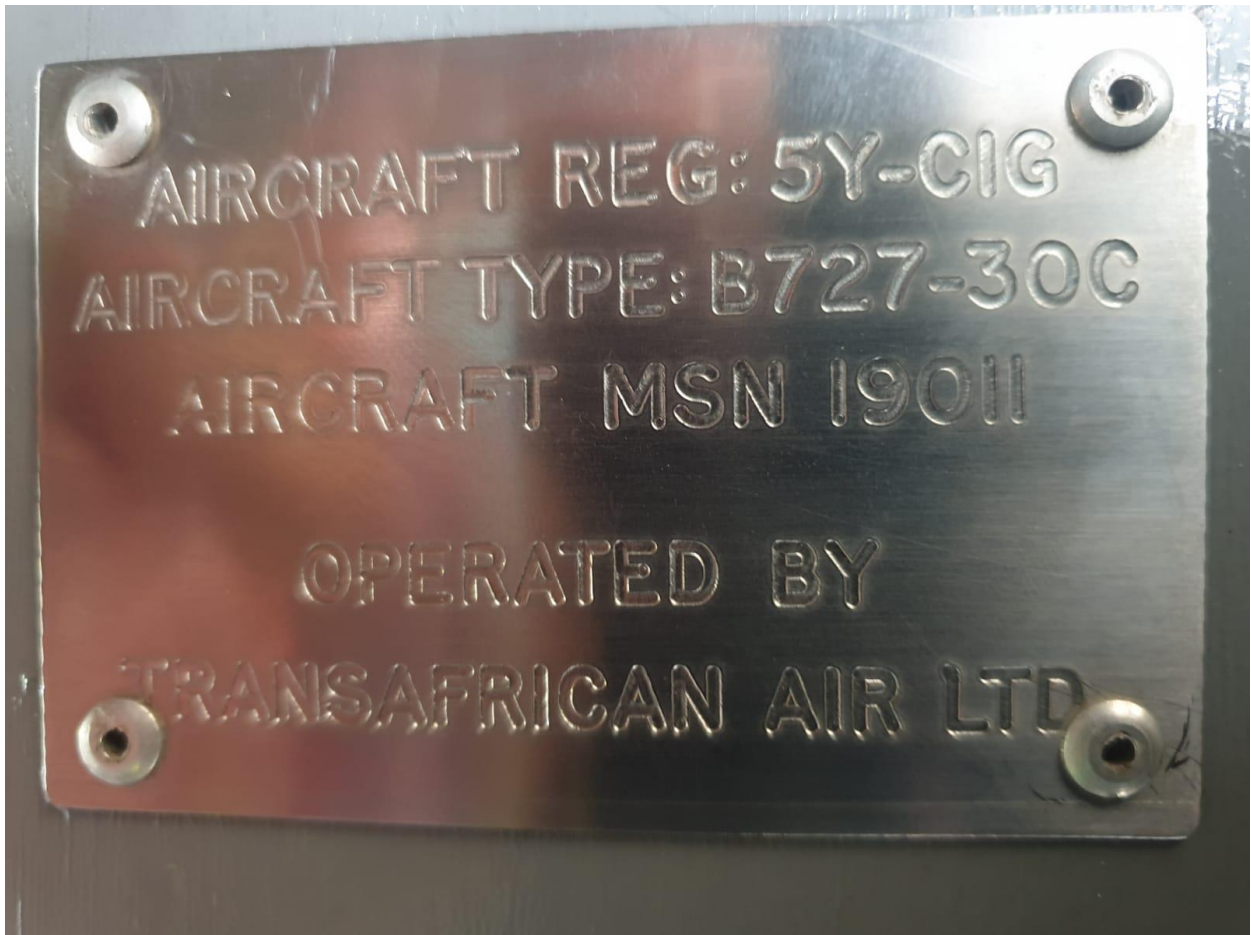
At the time of the runway incursion incident the B727 aircraft carried the Tajik external registration mark EY-724. The identification plate in the cockpit however indicated the Kenyan registration 5Y-CIG, while the operator is listed as Transafrican Air Ltd, see figure 11 below:

Figure 11: Identification plate showing Kenyan registration.

In order to clarify this matter, the AAID has repeatedly tried to contact both the Tajik and Kenyan Authorities but did not receive a response. It can be concluded however that operating an aircraft with a discrepancy between the external registration mark and the identification plate in the cockpit is a violation of ICAO Standards.

- 4.6 The Civil Aviation Authorities of Tajikistan and Kenya are recommended to resolve the discrepancy between the external Tajik registration mark EY-724 and the Kenyan registration 5Y-CIG on the identification plate in the cockpit of the B727 with MSN²¹ 19011.

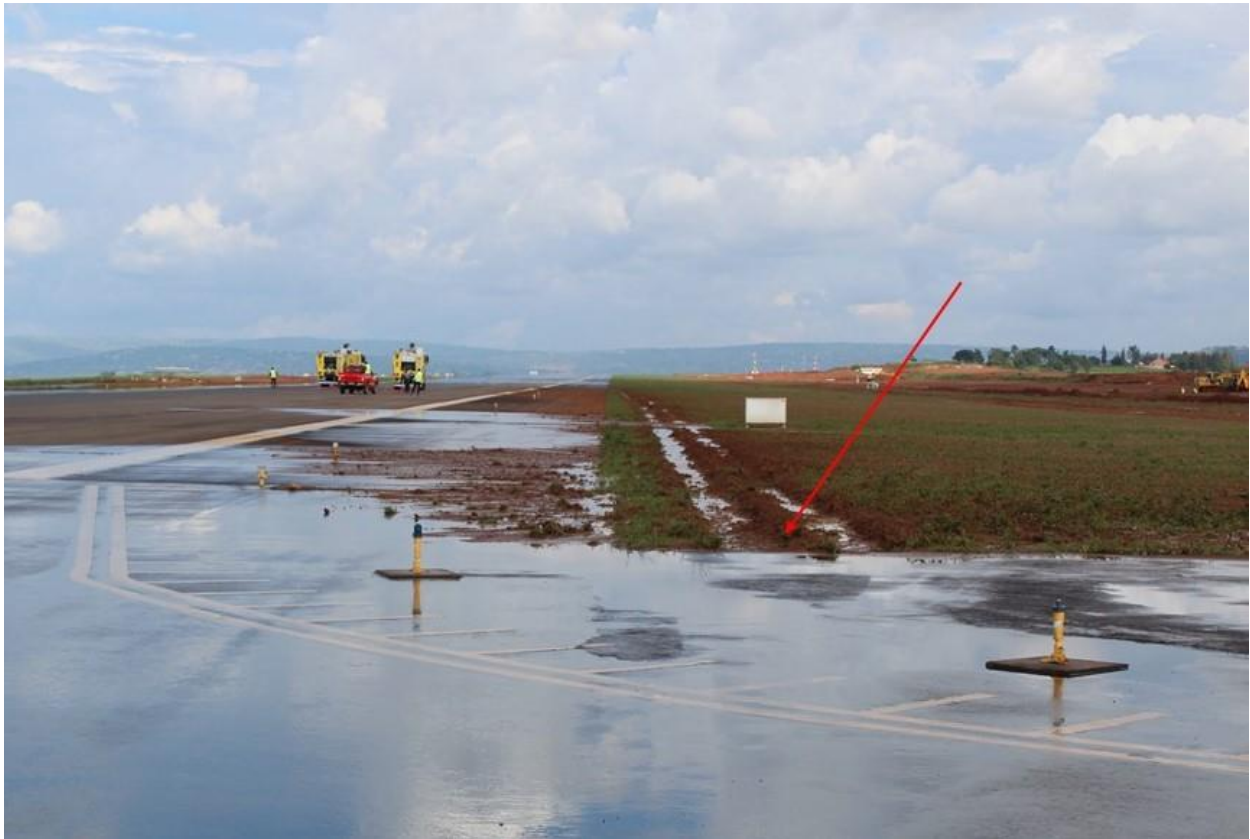
From the GPS groundspeed data supplied by Zone 4 International it can be deduced that flight TAK 270 passed taxiway Charlie at a speed between 210 and 215 km/hour with an aircraft mass of 139.400 pounds or 63.230 kilograms. The kinetic energy resulting from these figures could easily have resulted in a crash of the aircraft, in particular at the moment whereby the left-hand landing gear, while travelling through the soft grass area next to the runway, hit the side of taxiway Charlie as is illustrated by the red arrow on picture 15 below.

Figure 15: Impact point of left-hand landing gear with the side of taxiway Charlie.

It also must be noted that the lateral distance between the track of the left-hand nose gear wheel and the edge of the runway shoulder was approximately one metre only. Should the nose gear during the high speed phase of the landing roll have left the pavement of the shoulder, then a crash of the aircraft would have been unavoidable.
