## Serious incident to the BOEING 777 - 228ER registered F-GSPG operated by Air France on 2 May 2015 near Mount Cameroon (Cameroon)

### Activation of EGPWS warning while flying around cloud masses, execution of an emergency manoeuvre, at night, en-route at FL90

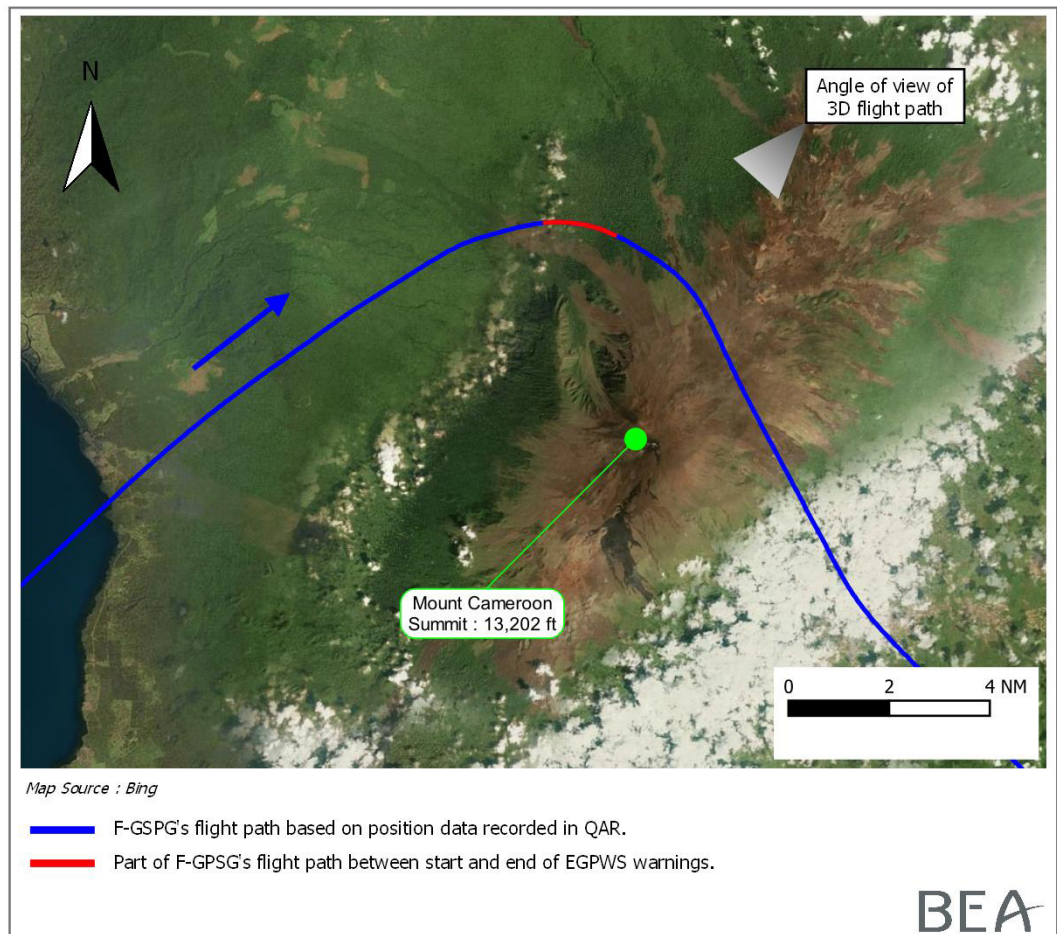
Figure 2: Flight path of F-GSPG while avoiding Mount Cameroon

Around ten minutes after take-off, the aeroplane was 6 NM north-west of Mount Cameroon. The crew indicated in their statements that the exchanges with the ATC had become dense.

The PM suggested to the PF that he take a right heading to join the start of the DME arc to runway 30 at Douala. When the aeroplane was on a heading of 61°, the PF controlled a right continuous-turn to the selected heading of 120°.

At 20:14:02, around 30 s after the start of the turn, the aeroplane was at an approximate height of 5,000 ft when the EGPWS "TERRAIN AHEAD" caution was activated for four seconds. The two ND automatically changed to *Terrain* mode. Three seconds after the activation of the warning, the PF increased the selected heading to 134°. The aeroplane continued to turn right with a bank angle of around 25°.

A few seconds later, at 20:14:12, the radio altimeter height had decreased to 4,150 ft and the "TERRAIN AHEAD PULL UP" warning sounded for eight seconds. The crew indicated that the NDs turned red. In their statements, the cabin crew member in the cockpit and the PF indicated that they made out trees on the right of the aeroplane.

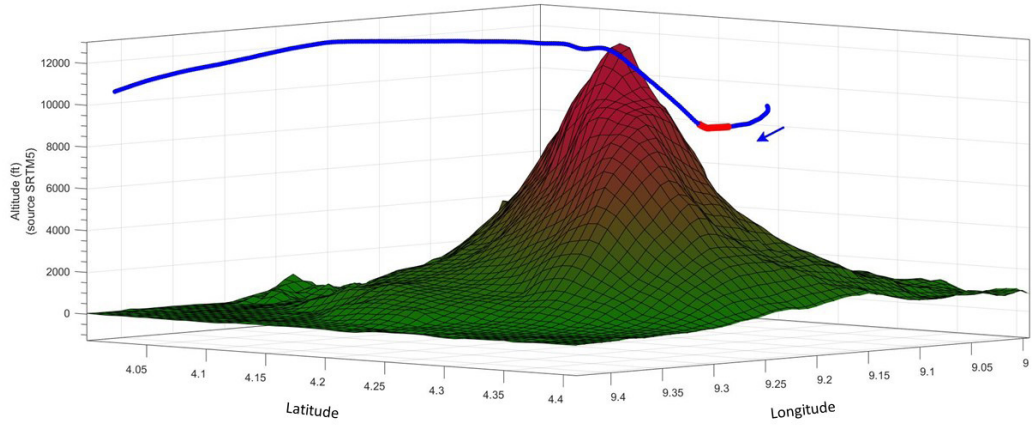
Figure 3: 3D flight path of F-GSPG while avoiding Mount Cameroon

- F-GSPG's flight path based on position data recorded in QAR.
- Part of F-GSPG's flight path between start and end of EGPWS warnings.

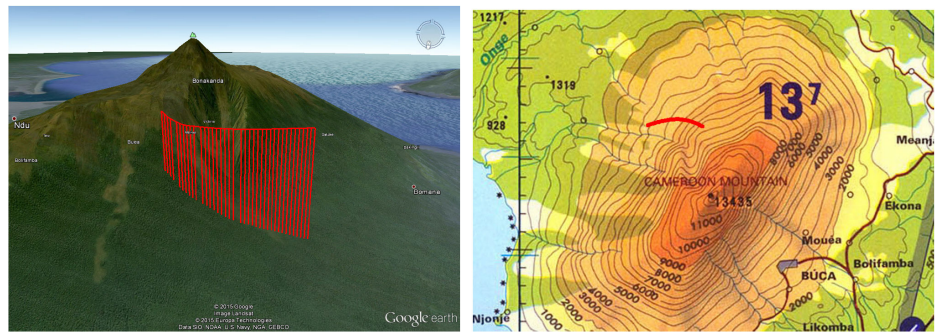
Figure 4: Flight path of aeroplane during activation of EGPWS alerts

The PF disengaged the AP and made a nose-up input. He advanced the thrust levers full forward to obtain maximum thrust one second later. The autothrottle (A/T) was disengaged five seconds after the start of the manoeuvre.

During the eight seconds of the warning, the pitch attitude and vertical speed increased. The maximum pitch attitude was 15°. The aeroplane remained in its turn and the relief pilot asked the PF to level the wings.

The EGPWS warning ceased at 20:14:20. The bank was briefly cancelled before the turn resumed with a bank angle of around 25°. FL120 and a heading of 150° were selected.

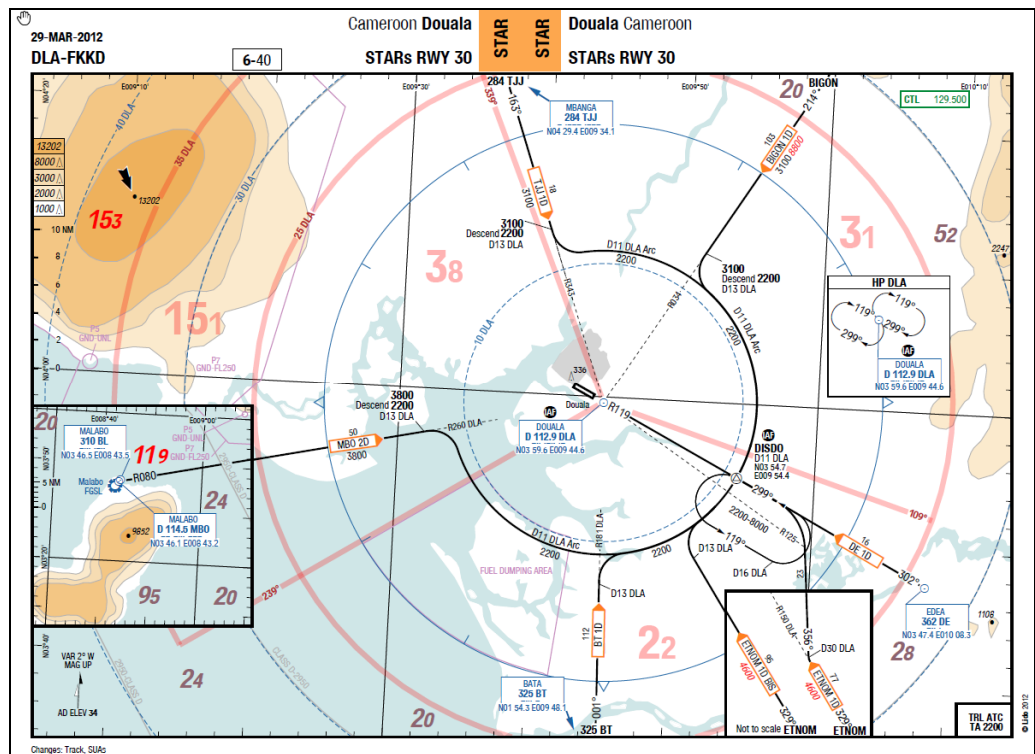
Figure 8: LIDO chart used by crew to monitor their flight

The Douala arrival sheet was not to scale (Malabo was in an insert) so the notion of distance was a little lost. Their representation of the threat posed by the terrain was erroneous.

This chart shows the Malabo airfield in an insert, placing this airport on the correct bearing with respect to the Douala airfield but at a distance which is not to scale. In reality, it is situated at around 40 NM to the south-west.

The day of the incident, the right turn immediately after take-off avoided the threat posed by the terrain on the ile de Malabo. The representation of the Douala arrival chart might then have led to the belief that the flight passed south of Mount Cameroon and that the path would not be affected by the terrain.

- ❑ the terrain around Malabo airport with a peak at 9,852 ft;
- ❑ Mount Cameroon and the altitude of its peak at 13,202 ft;
- ❑ Grid MORAs rising to 15,300 ft around Mount Cameroon.
