JET BLAST: HOW SMALL CHANGES CAN LEAD TO BIG OUTCOMES

Jet blast is an aerodrome hazard and is mitigated in a number of ways. Whilst pilots are aware of the implications of familiar aircraft, new aircraft can introduce small but unknown changes, with significant effects, as **Ulf Henke** explains.

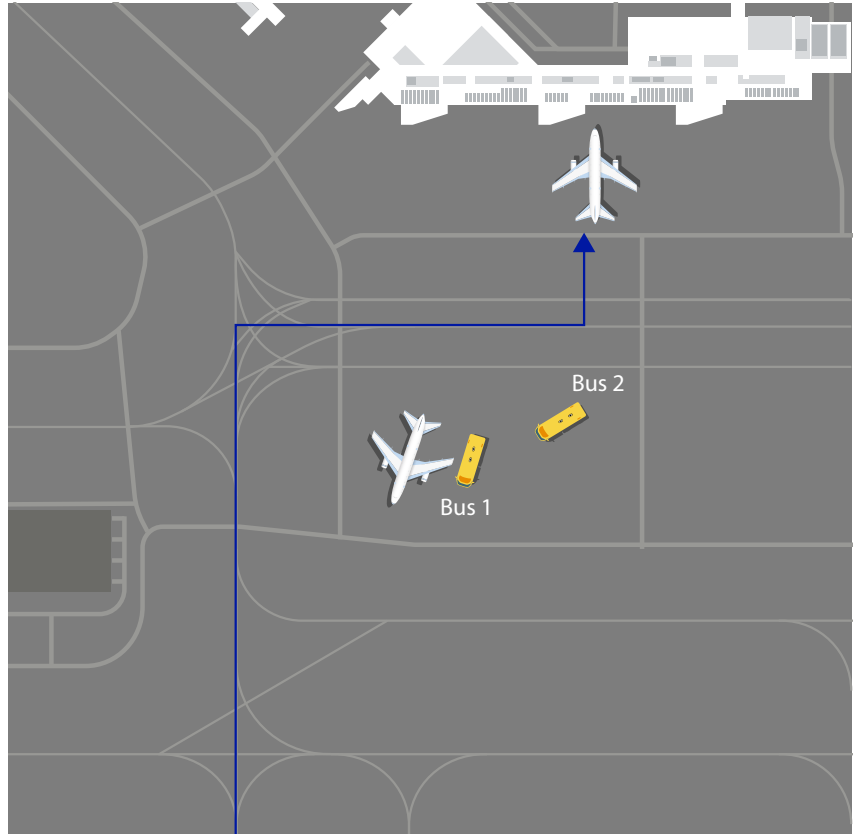
Figure 1: Schematic drawing: Location of the passenger buses in relation to the aircraft

The situation was totally different on a parking stand on the opposite side of the taxiway. This stand is located about 150 meters south-southwest of the stand that the B748 had been taxiing onto. At the time, the B748 entered its parking stand, ground handling of another large aircraft on the position behind it was in progress and passengers were inside two buses waiting for the cabin crew to release the aircraft for boarding. The passenger buses were parking on the aircraft stand located on the opposite side of the taxiway, the first one facing south, the second one facing southwest, in a sort of V-shape formation.

On the passenger buses, some windows were dented inwards, while others were shattered by the jet blast and shards blown into the buses. In the bus closest to the parked aircraft, the flying shards broke a window on the opposite side. Luckily, the passengers suffered only minor cuts and bruises.

The V-shaped formation of the parked passenger buses may have accelerated the jet blast velocity of the engines, creating a ‘Bernoulli effect’ as a result. This would have channelled the air in between them and thus accelerated it, blowing some side windows out of the passenger buses. (Note that the European Union has set minimum requirements on the stability and minimum permissible forces to withstand for front side windows of cars, buses, and trucks, but there were no minimum requirements at the time of the incident on allowable forces to side windows.)
