SERIOUS INCIDENT

Aircraft Type and Registration:	ERJ 170-100 LR, G-CIXW	
No & Type of Engines:	2 General Electric Co CF34-8E5A1 turbofan engines	
Year of Manufacture:	2008 (Serial no: 17000230)	
Date & Time (UTC):	7 June 2021 at 1150 hrs	
Location:	Descent to Birmingham Airport	
Type of Flight:	Commercial Air Transport (Passenger)	
Persons on Board:	Crew - 5	Passengers - 18
Injuries:	Crew - None	Passengers - None
Nature of Damage:	None	
Commander's Licence:	Airline Transport Pilot's Licence	
Commander's Age:	48 years	
Commander's Flying Experience:	4,050 hours (of which 83 were on type) Last 90 days - 20 hours Last 28 days - 2 hours	
Information Source:	Aircraft Accident Report Form submitted by the pilot and information provided by the operator

Synopsis

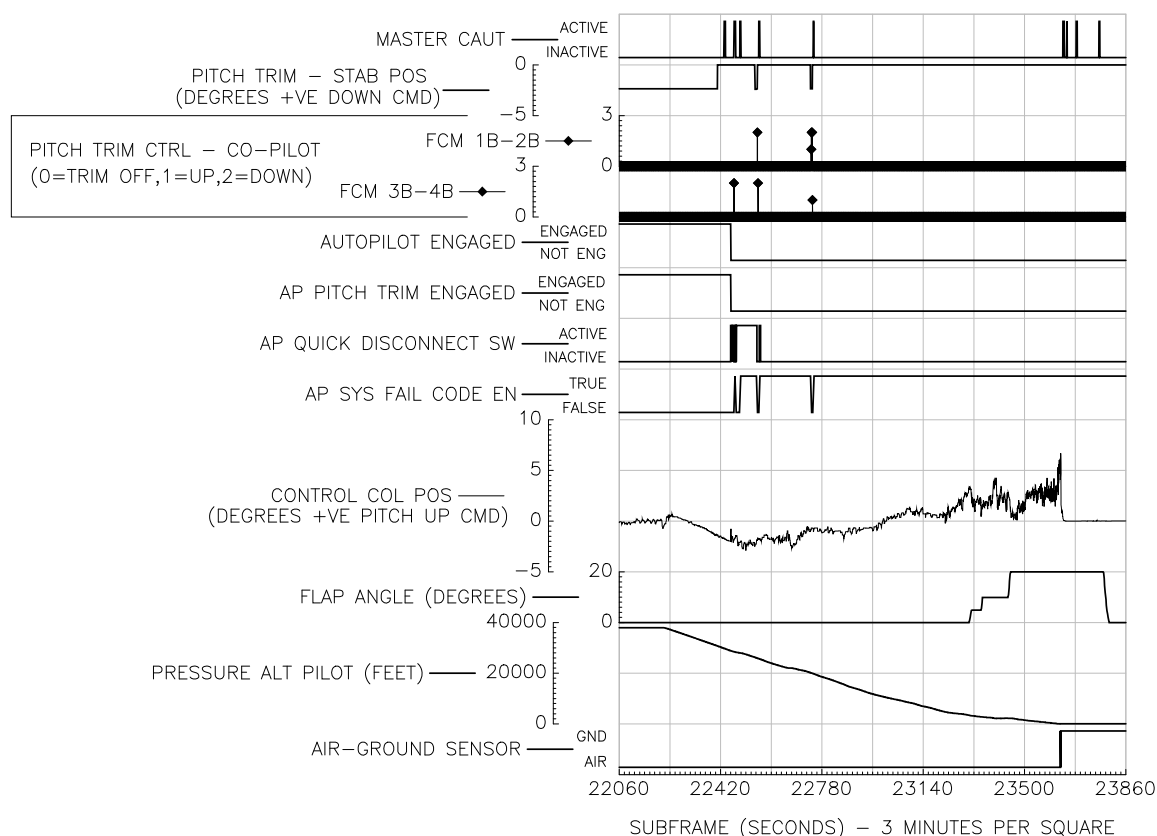
Figure 1

Prior to the descent from FL380 the AP was engaged, the pitch trim was recorded at -2.4° (nose up) and control column inputs were small. The descent was initiated with the AP in vertical path mode. Increasing amounts of control column pitch down input were recorded with no change in pitch trim until a jump in the recorded value passing through FL307 from -2.4° to 0° . Approximately 23 seconds later, the master caution was triggered. Approximately 24 seconds after that the AP was disengaged and remained disengaged for the rest of the flight. AP system failure was recorded about 15 seconds after it was disengaged, briefly at first and then continuously except for two short periods of 5 to 10 seconds. These two periods were when the recorded pitch trim position values switched from 0° to -2.4° , the AP system failure parameter became inactive, and co-pilot trim commands were recorded. After this the pitch trim position returned to 0° , the AP system failure parameter re-activated, and a master caution was triggered.

Pitch trim positions recorded during other flights were between approximately -4.7° and -7.4° during the final approach and landing phases. This would give more pitch up trim than the last reasonable value recorded on the incident flight of -2.4° of pitch trim. It is likely

that this -2.4° of pitch trim reflected the actual pitch trim of the HSTAB during the approach and landing as this was the last value recorded before the parameter switched to reading an unreasonable value of 0° and there was no recorded trim activity after that. Less than normal pitch up trim is also indicated by greater than the normal pitch up control inputs required by the pilot.

Pertinent extracts from the flight data recording
