SERIOUS INCIDENT

Aircraft Type and Registration:	Airbus A319-131, G-DBCF	
No & Type of Engines:	2 International Aero Engine V2522-A5 turbofan engines	
Year of Manufacture:	2005 (Serial no: 2466)	
Date & Time (UTC):	6 August 2021 at 0935 hrs	
Location:	During climb from Edinburgh Airport	
Type of Flight:	Commercial Air Transport (Passenger)	
Persons on Board:	Crew - 5	Passengers - 101
Injuries:	Crew - None	Passengers - None
Nature of Damage:	No damage	
Commander's Licence:	Airline Transport Pilot's Licence	
Commander's Age:	55 years	
Commander's Flying Experience:	16,651 hours (of which 4,476 were on type) Last 90 days - 43 hours Last 28 days - 26 hours	
Information Source:	AAIB Field Investigation

Synopsis

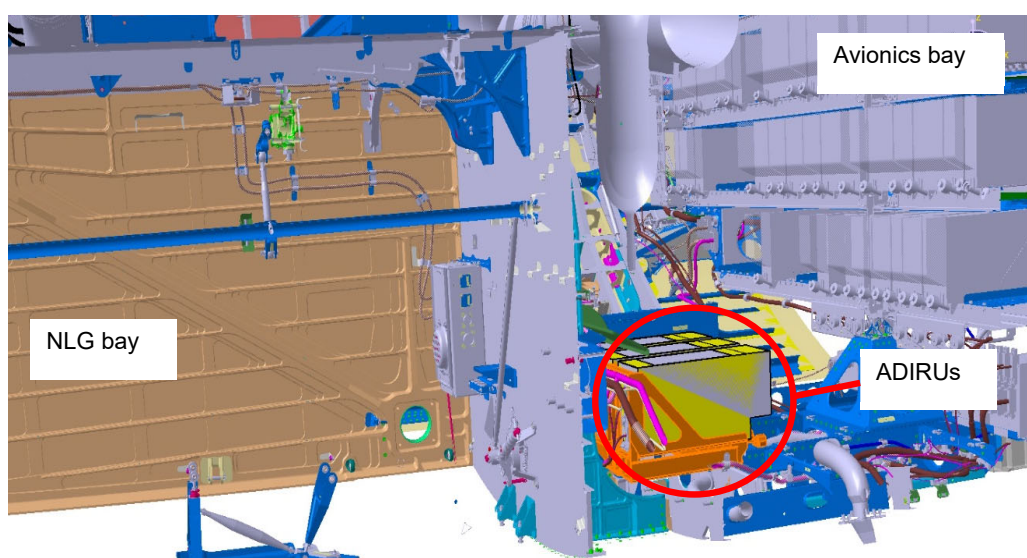
Figure 2
ADIRUs location

The aircraft's three ADIRUs were fitted to an avionics rack located immediately aft and above the NLG bay (Figure 2). There was no anti-vibration mounting for the rack or the ADIRUs, so any vertical shock transmitted through the NLG would be transferred to the airframe and avionics rack.

As the NLG incorporates a shock absorber, when operating within its normal operating limits of travel a significant proportion of the vertical forces experienced by the NLG when traversing along runways, landing and taking-off are absorbed and dissipated. Only a fraction of this force is transferred to the airframe. When the NLG shock absorber is over or under extended, less energy can be dissipated and the proportion of forces transferred to the airframe is increased.

During takeoff from Edinburgh, the aircraft experienced a sharp vertical jolt and the NLG weight-on-wheels proximity sensors toggled on and off as the wheels crossed an uneven patch of the runway surface.

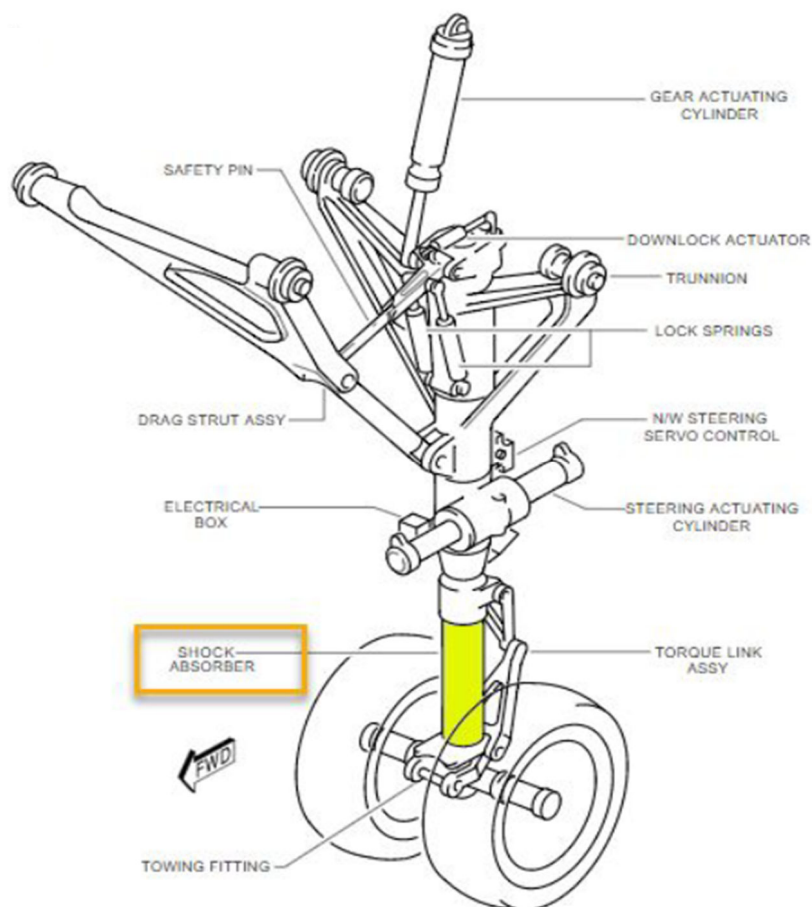
Figure 3

After landing, a maintenance team met the aircraft and conducted an inspection and service of the NLG in accordance with Troubleshooting Manual (TSM) 32-20-00-810-802 - '*Vibrations felt on the NLG during Takeoff and Lift-off Phases*' as recommended in the TFU. The team focussed on the TSM subtasks related to the NLG shock absorber which was found to be overextended by 0.6 inches.

The NLG shock absorber is an oleo-pneumatic telescopic strut arrangement with no separator piston, (Figure 3), that uses a chamber filled with compressed nitrogen gas to act as a spring to absorb the shock of aircraft landing gear vertical forces.

Shock absorption efficiency relies upon the balance of oil and nitrogen to ensure the shock absorber deflects within a specific range to maintain absorption efficiency. If the balance of either substance is incorrect, the shock absorber will not be able to absorb and dissipate vertical forces effectively. The result is an increase in vertical shock loads transferred to the airframe.

Several instances of incorrect NLG servicing had previously been reported to the manufacturer by more than one operator, indicating a potentially problematic maintenance procedure. Consequently, in 2010, the aircraft manufacturer revised the servicing task in the Aircraft Maintenance Manual and introduced a modified maintenance check of the NLG shock absorber every 24 months or 5,000 flight cycles. Should an abnormal NLG vibration event occur, a maintenance check of the assembly and possible servicing would be required. It stated that a dedicated automatic Liquid and Nitrogen Charge Equipment (LANCE) is being developed to avoid the need to jack-up the aircraft and to reduce the potential for incorrect servicing of the landing gear.
