FINAL REPORT No 4-02/1-18(4-19)

**on serious incident, runway excursion at Riga international airport (EVRA),
on 21 June 2018, aircraft Bombardier CS300, YL-CSC**

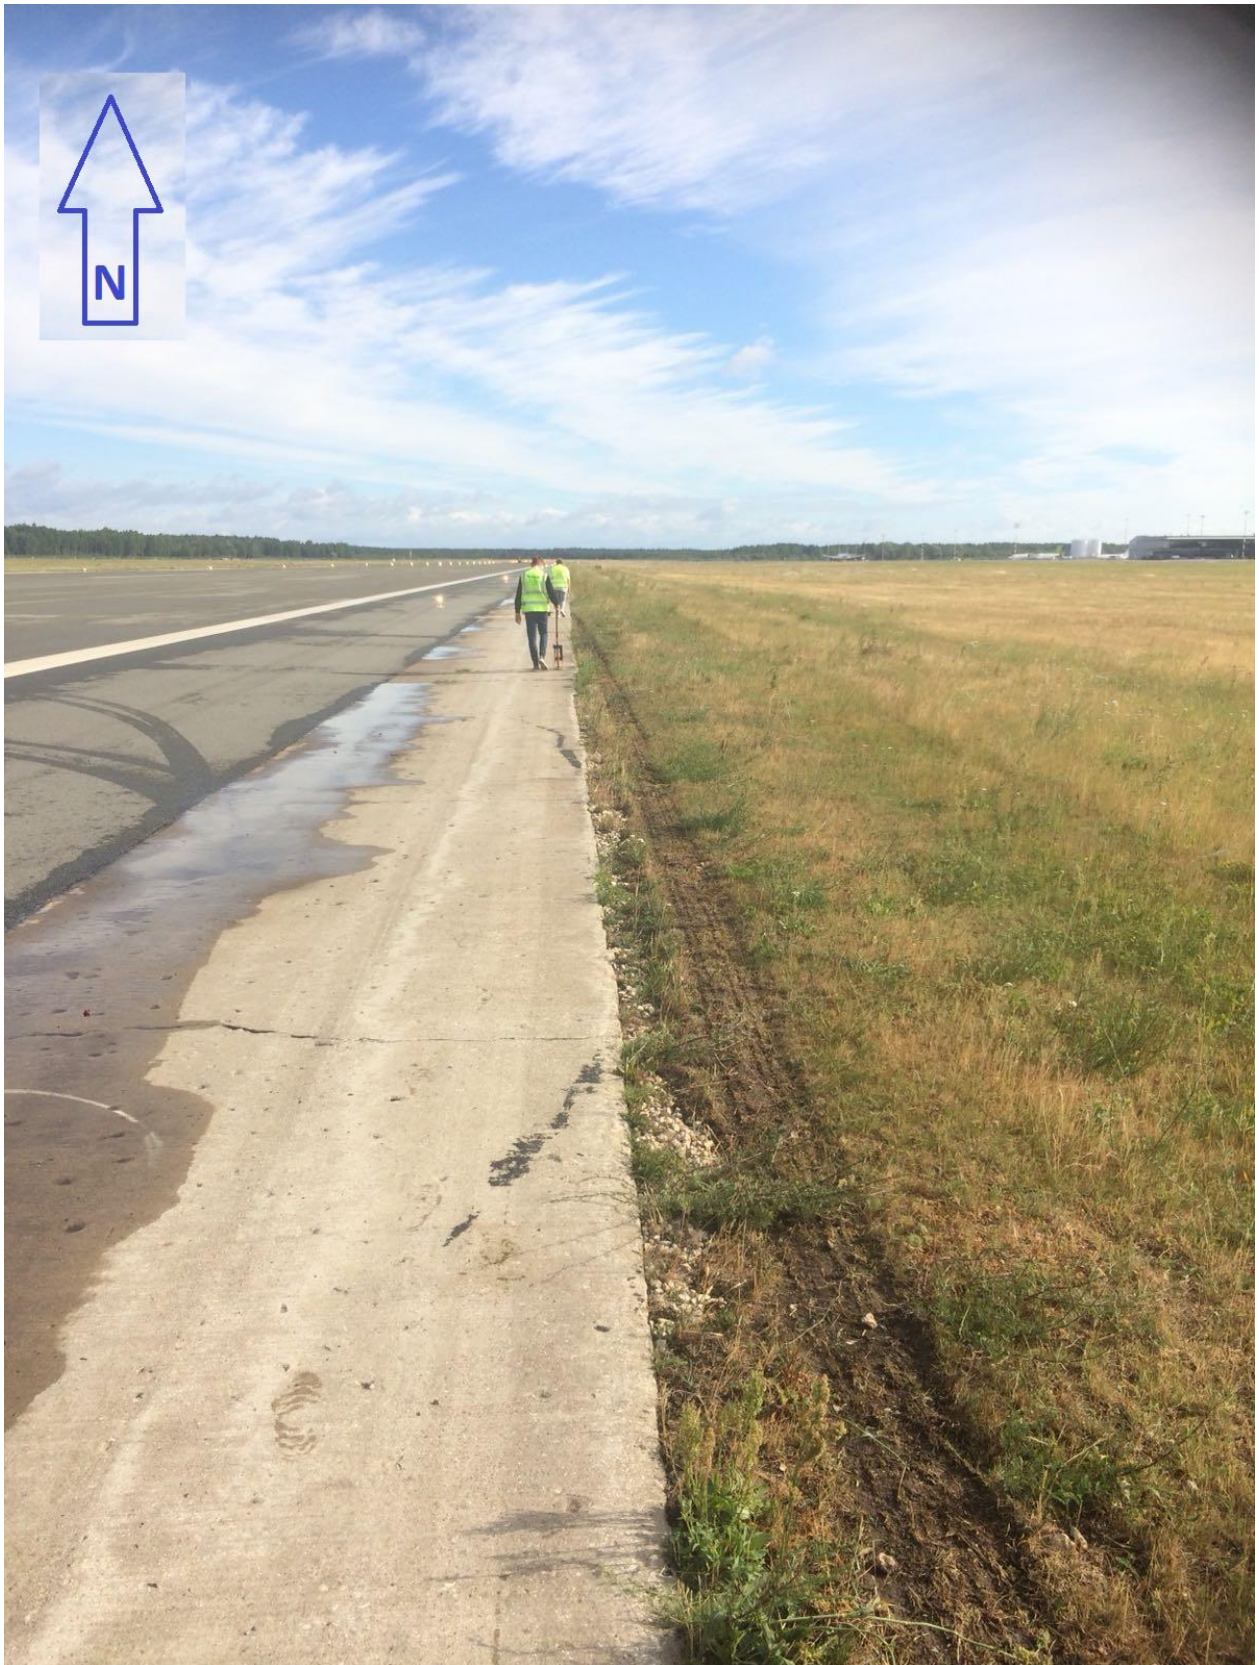
Picture 2 Length of the of the aircraft's MLG left outer tire trace in the grass 121m

TAIIB investigators were not called to incident site. In accordance to information sent by Operator during RWY inspection, heavy rubber deposits on the RWY left part were observed, which could be created by partially blocked landing gear tires. Mentioned deposits shows evidence of possibly heavy braking with skidding tires. Only left side main landing gear both tire rubber deposits recognized on the RWY. No signs of the right side main landing gear tires rubber deposits recognized on the RW.

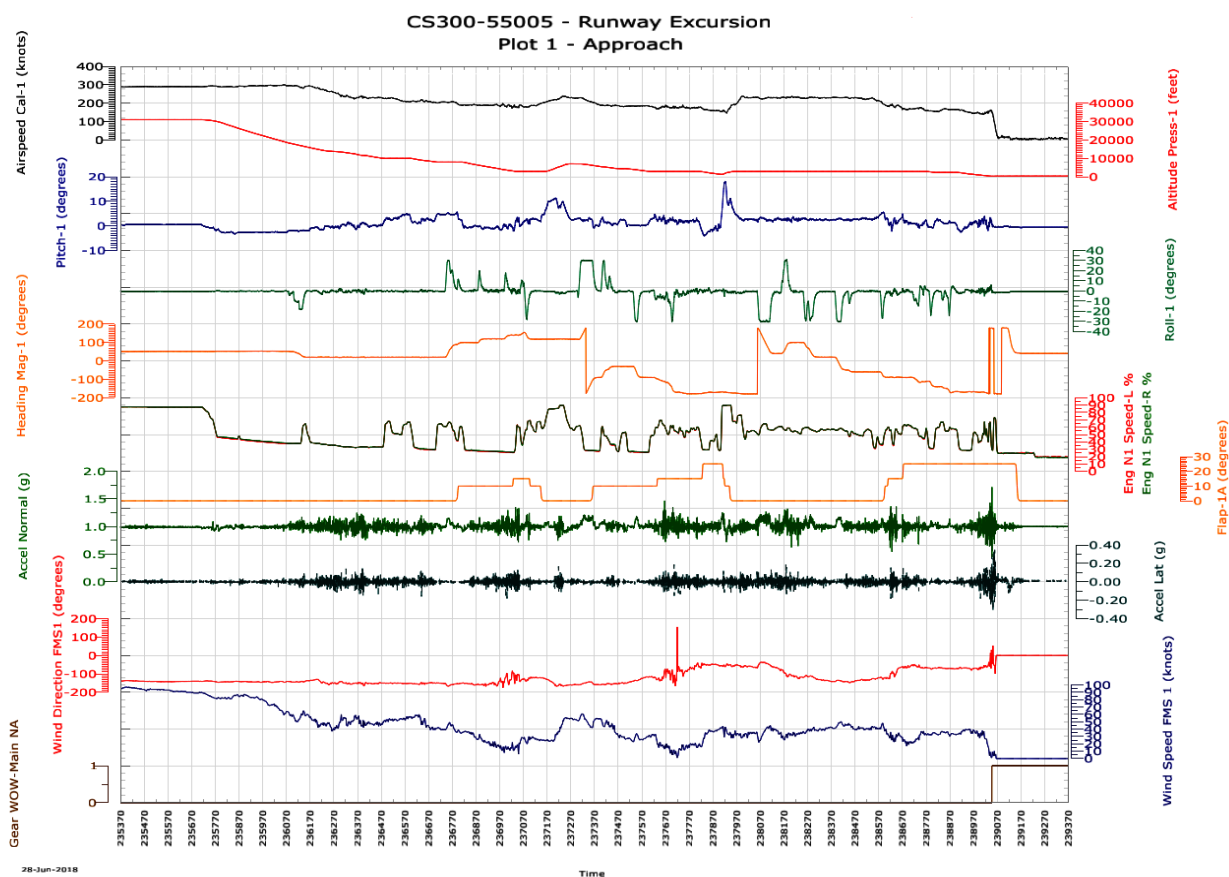
During final approach below 100ft RALT - airspeed variations between ~145kts and ~165kts recorded, wind speed to 15kts, wind direction changes between 290° and 325°. Pitch angle 1° to 3°, bank angle to 6.2°.

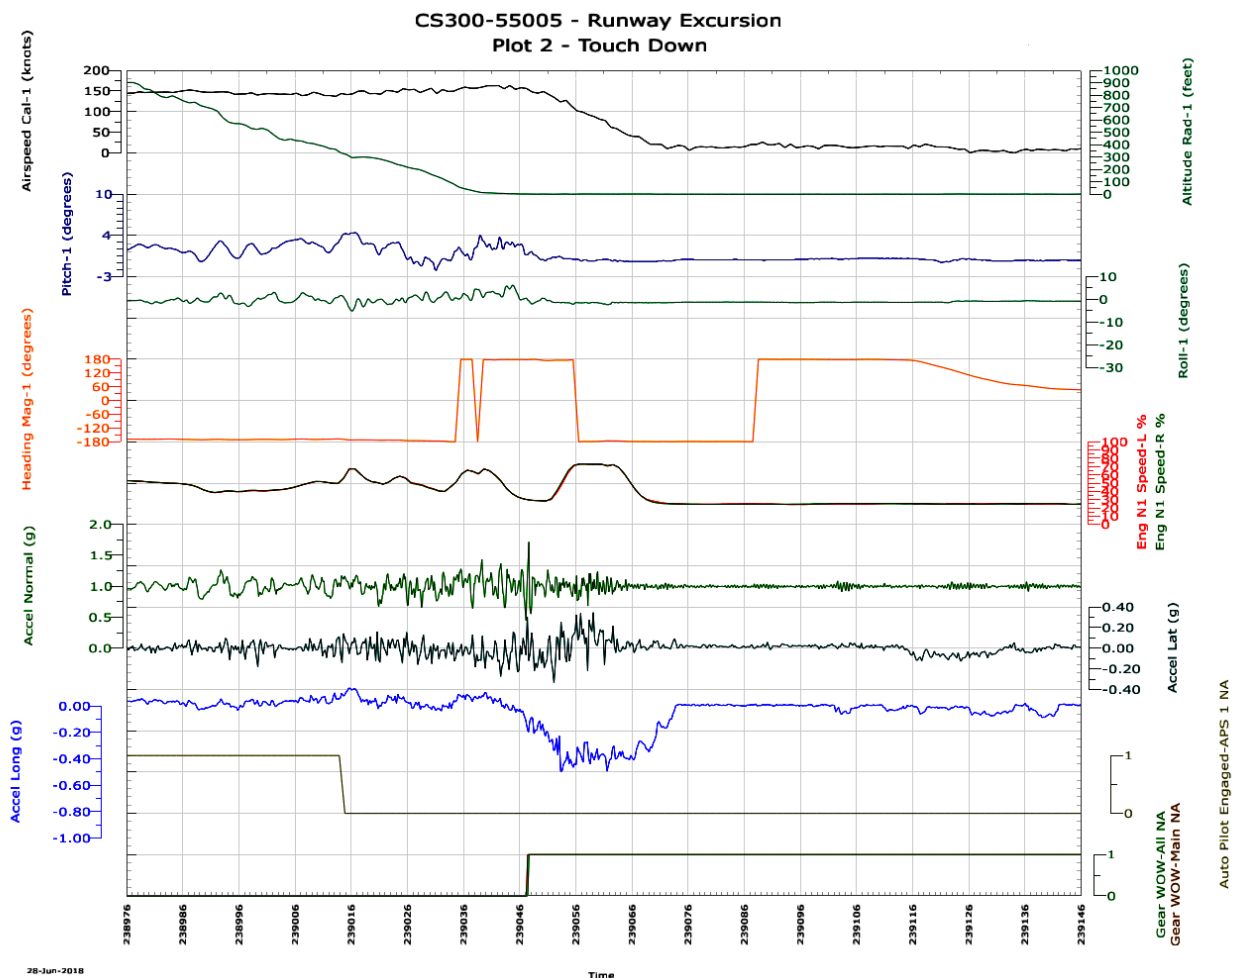
FDR data revealed following: Touchdown performed with airspeed about 160kts, pitch angle of 1° , bank angle below 2° . After touch-down, aircraft movement (veer-off to the left) observed with subsequent heading changes between 180° and 190° degrees over speed reduction period recorded.

Flight control inputs, which caused non-intentional deviation of aircraft direction and resulted in unexpected side load. Accidental activation of non-relevant modes (TOGA) on critical part of flight phase (Final part of approach), which resulted in reduced level of automation (disengaged autopilot selected flight modes and manual flight control without FD guidance) used.

Max Vertical acceleration during landing about 1.71G. All wheels on ground at approximately the same time (within 0.2 seconds).

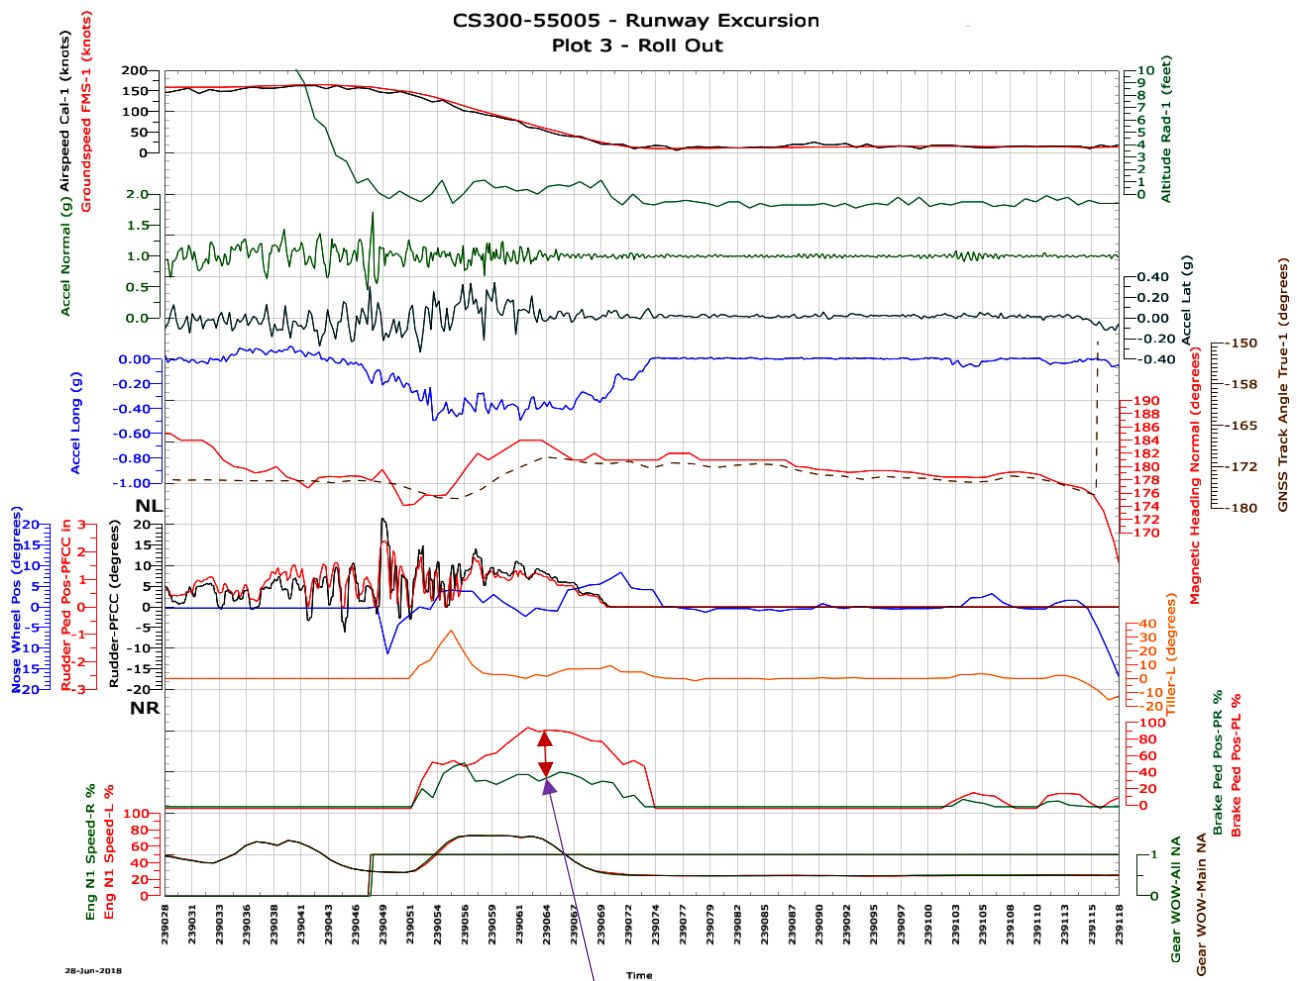
Flight control input recordings show application of right rudder pedal with simultaneous increase of left hand brake pedal application.

FDR data confirmed asymmetric brake application during landing. Higher brake force application on left hand side main gear wheels (red line on Plot 3) caused aircraft deviation to the left with subsequent aircraft side skid. During skidding, exposed side load on the nose wheel left tire sidewall reached load on which tire inner liner was detached from the rim and nitrogen pressure was lost. When brake force on left brake pedal was reduced, directional control of aircraft was regained.

14. Asymmetric brake application during landing that create higher brake force application on left hand side main gear wheels caused aircraft deviation to the left with subsequent aircraft side skid.
