# Loss of separation involving Airbus A330, VH-EBK, and Boeing 787, G-ZBKF

near Sydney Airport, New South Wales on 28 September 2022

**ATSB Transport Safety Report**

AO-2022-047

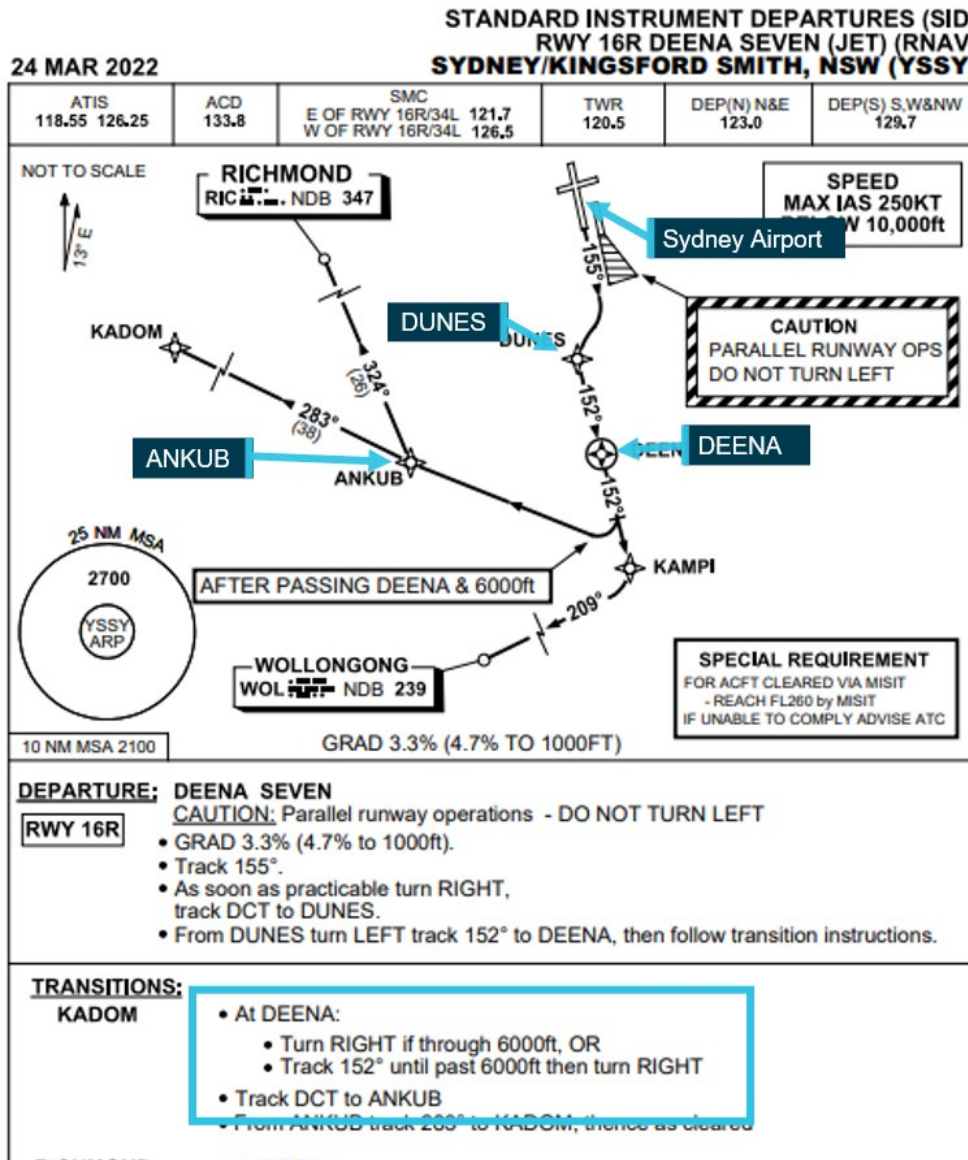
Figure 1: DEENA SEVEN standard instrument departure (SID) from runway 16R

At approximately 1508 local time, BA16 was cleared for take-off from runway 16R by the Sydney tower controller. They were cleared to conduct a DEENA SEVEN (DEENA 7) standard instrument departure (SID)<sup>4</sup> (Figure 1) from runway 16R and to climb to 5,000 ft.

The DEENA 7 SID required an aircraft to turn right as soon as practicable after take-off, towards the DUNES waypoint<sup>5</sup> and then turn left to track 152° towards the DEENA waypoint. The aircraft was required to have passed DEENA and climbed above 6,000 ft prior to turning right towards the ANKUB waypoint. If the aircraft had not reached 6,000 ft at DEENA, there was a requirement to continue on a heading of 152° until passing an altitude of 6,000 ft, before turning towards ANKUB.

Despite this, the design of the DEENA SEVEN SID (and possibly others) did not provide a positive method of providing lateral separation assurance to departing aircraft with differing climb performance. As the aircraft had to satisfy 2 separate conditions prior to turning, there was no way of ensuring aircraft would turn at the same distance from the airport. As such, lateral separation could not be assured.

Airservices Australia advised that the DEENA SEVEN SID had been redesigned to remove the conditional requirements of the procedure. At the time of writing, the change had been approved and was planned to be released in the first implementation package for the Western Sydney International (Nancy-Bird Walton) Airport project. However, no timeframe for the release of the package was provided.

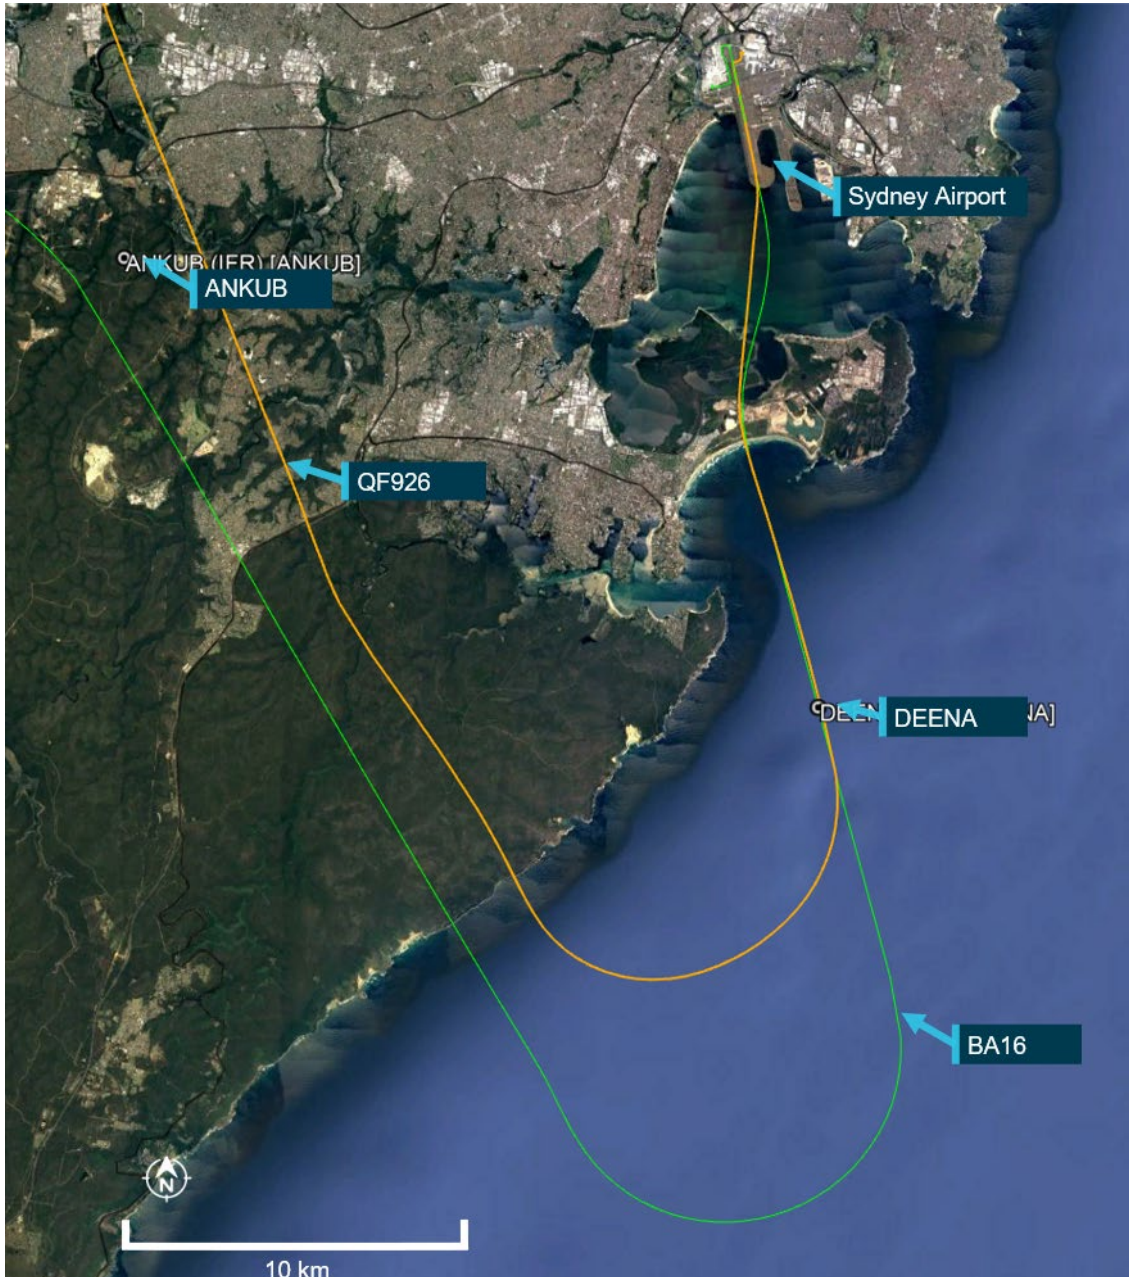
**Figure 2: Flight tracks of both aircraft during their departure from Sydney**

BA16 climbed through 6,000 ft at around 25 km from Sydney Airport and initiated a turn to ANKUB in accordance with the SID. QF926 passed DEENA approximately coincident with climbing through 6,000 ft and initiated a turn to ANKUB at approximately 20 km from the airport, also in accordance with the SID (Figure 2).

Qantas Q926 is depicted in orange and BA16 is depicted in green.  
 Source: Google Earth with Flight Radar 24 tracks and annotated by ATSB

There was a loss of separation standards (see the section titled *Required separation*) between the two aircraft with the minimum vertical separation reducing to 600 ft and lateral separation reducing to 2.4 NM.
