# Unreliable altitude indications, Boeing 737-476SF, ZK-TLJ

167 km west of Meekatharra Airport, Western Australia on 10 June 2022

Aviation Occurrence Investigation (Short)

AO-2022-033

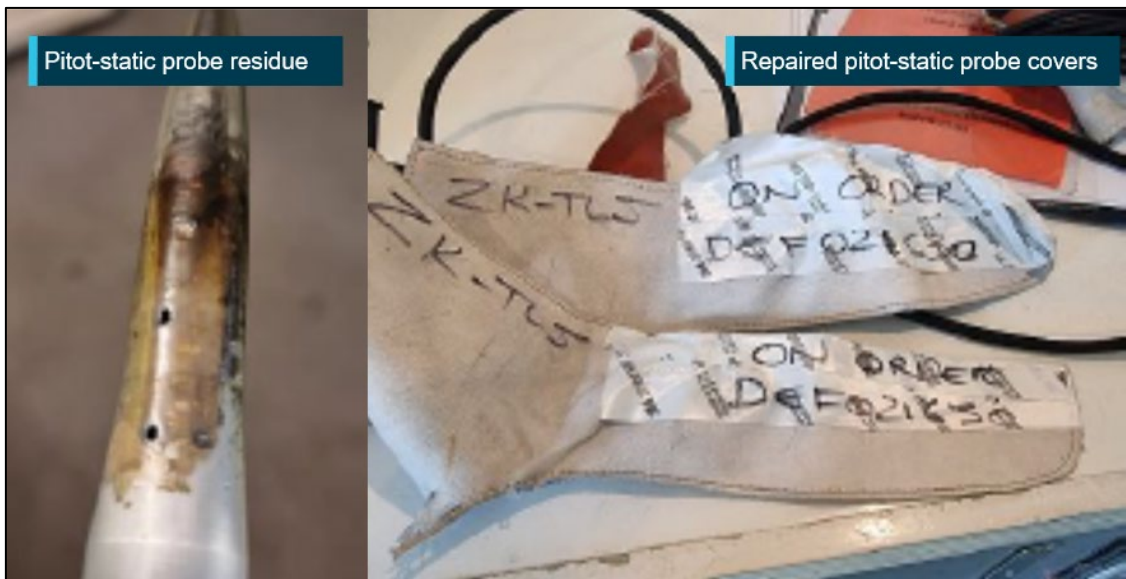
**Figure 1: Pitot-static probe and covers**

After landing at Perth, engineering staff inspected the 4 combined pitot-static probes and found residue on all 4 probe surfaces (Figure 1). All of the probes were subsequently removed and the pitot-static lines were flushed with nitrogen. This was carried out in accordance with the manufacturer’s maintenance procedures, which did not require a sample of any debris to be collected and analysed. Therefore, the presence of debris in the pitot-static system was not determined.

The probes were replaced with serviceable items, the system was tested, assessed serviceable, and the aircraft returned to service. The pitot-static probe covers onboard the aircraft were also inspected and found to have had a temporary repair applied to them (Figure 1).

Following completion of the wash, the participating LAME noticed that all 4 pitot-static probe covers had remained fitted during the dry motor and engine run operations, which resulted in the covers melting onto the probes. The covers were subsequently removed, and the tubes were cleaned using a plastic scraper, a scouring pad and solvent. A detailed visual inspection was carried out on the probes, and they were assessed serviceable. The aircraft was returned to service on 9 June 2022 and completed about 11.5 hours of flying over 7 sectors with no reported incidents, prior to the flight on 10 June 2022.

The damaged covers were hung on a board with a note describing the incident and that replacement covers had been ordered. Later that day, another engineer saw the covers, and put flame proof tape on them so that they could be reused until the replacements arrived.

communication between them, as reported by the operator. As a result, the covers melted, and residue was deposited onto all 4 pitot-static probes.

- Changed all pitot-static probe covers to Boeing -approved recommended covers that are made of heat resistant material (Kevlar™).
- They will release a safety statement after every potential safety occurrence as an interim measure prior to the completion of a formal internal investigation.

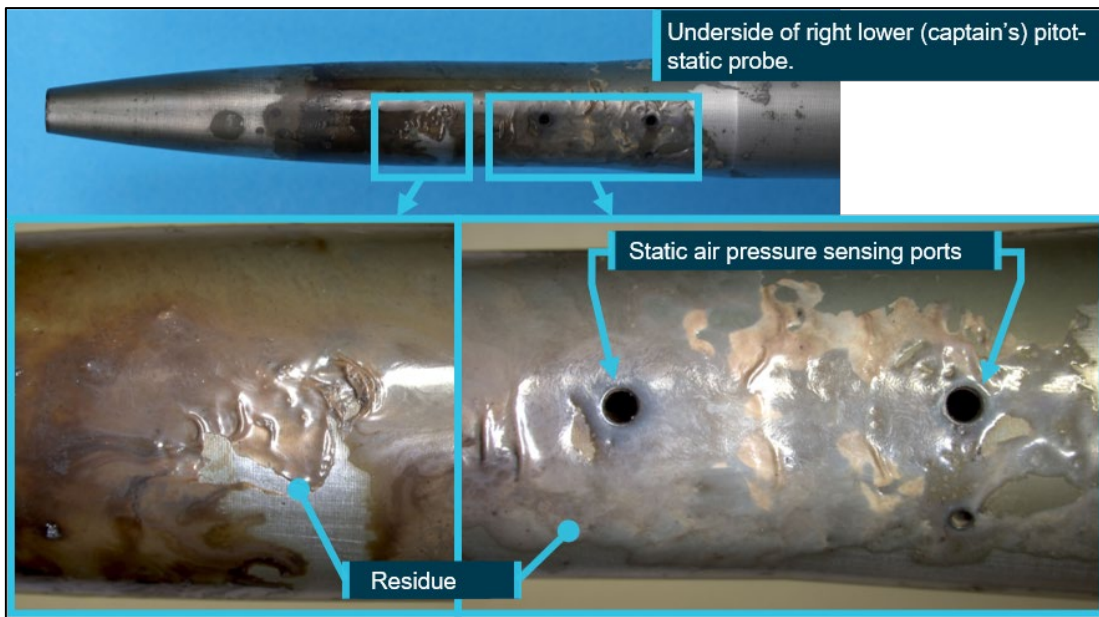
**Figure 2: Pitot-static probe residue**

The 4 probes were sent to the ATSB’s technical facilities in Canberra for detailed examination. That examination identified varying amounts of foreign residue adhered to the lower surface of all 4 pitot-static probes. The right upper and lower probes presented with foreign object debris in the pitot drain ports. The source of this debris could not be determined.

The depth of the residue varied between almost none on the right upper probe, to a maximum of about 0.4mm in an uneven, rippled profile on the right lower probe (Figure 2). An internal examination was not conducted.

After identifying that the pitot-static probe covers had melted, the probes were cleaned and a visual inspection performed, before being returned to service. However, a post-incident inspection of the probes and the ATSB’s examination found residue from the covers remained on the probe surfaces.

Despite this, the analysis of the QAR data showed a stable altimetry system error extending back to the 7 flights after the engine wash. Further, the 7 flights had been completed between the wash and the incident flight with no reported altitude discrepancies from flight crews. Although the decision to not replace the pitot-static probes increased the risk of error resulting from turbulent air over the static pressure sensing ports, the QAR data did not demonstrate a link between the remaining residue and the incident flight.

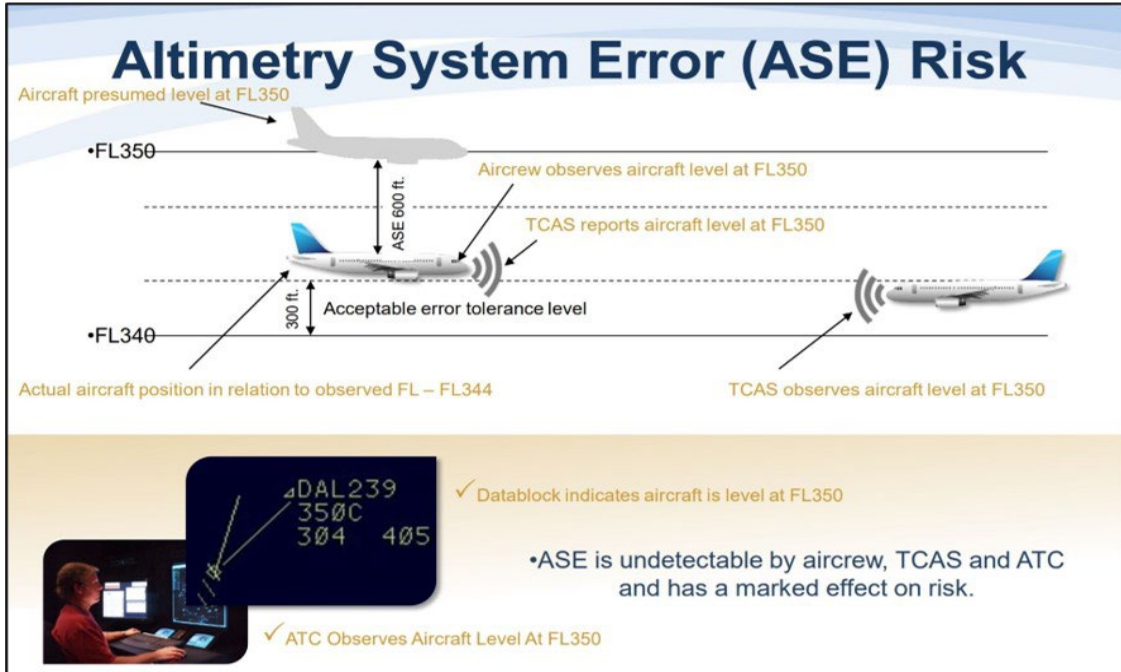
Figure 3: Altimetry system error risk

According to the International Civil Aviation Organization,<sup>14</sup> altimetry system errors may occur for various reasons including from damage to the pitot-static system. These faults can send incorrect data to ATC and the traffic alert and collision avoidance system, as well as the aircraft's altimeters. In turn, this could result in a breakdown of vertical separation and increase the risk of collision, as depicted in Figure 3, if the error is not detected by the flight crew and reported to ATC.

Altimetry system errors not only result in erroneous indications to the flight crew, but the protection systems afforded by ATC and the aircraft’s traffic alert and collision avoidance system can also be degraded. Therefore, it is important that flight crews advise ATC of any errors so ATC can assure adequate vertical separation exists with other aircraft.
