# Air Accident Investigation Sector

### - Final Report -

AAIS Case N°: AIFN/0016/2012

## Engine Hot Gas Leak

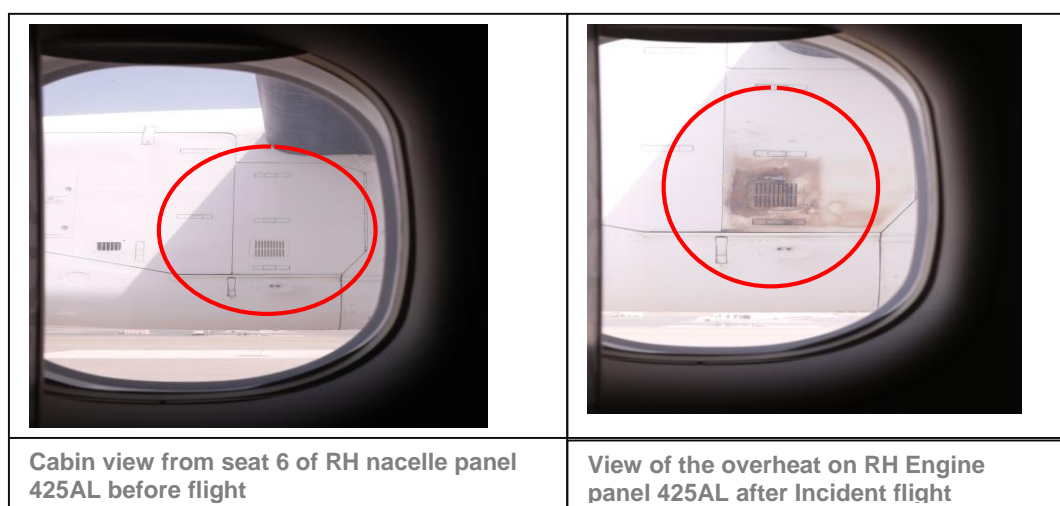
**Figure 1. RH Engine Inboard Nacelle Panel 425AL**

As stated by the flight crew, while passing 2,300 ft altitude, and as the passenger was beginning to become distressed, the co-pilot was requested by the Commander to leave his seat and investigate the persistent concerns made by the passenger. The co-pilot said that he observed from the passenger cabin window that the inboard RH engine nacelle had signs of a bright light within the compartment, indicating a possibility that there was a fire behind the panel. The paint on the panel was also blistering and bare metal was exposed.

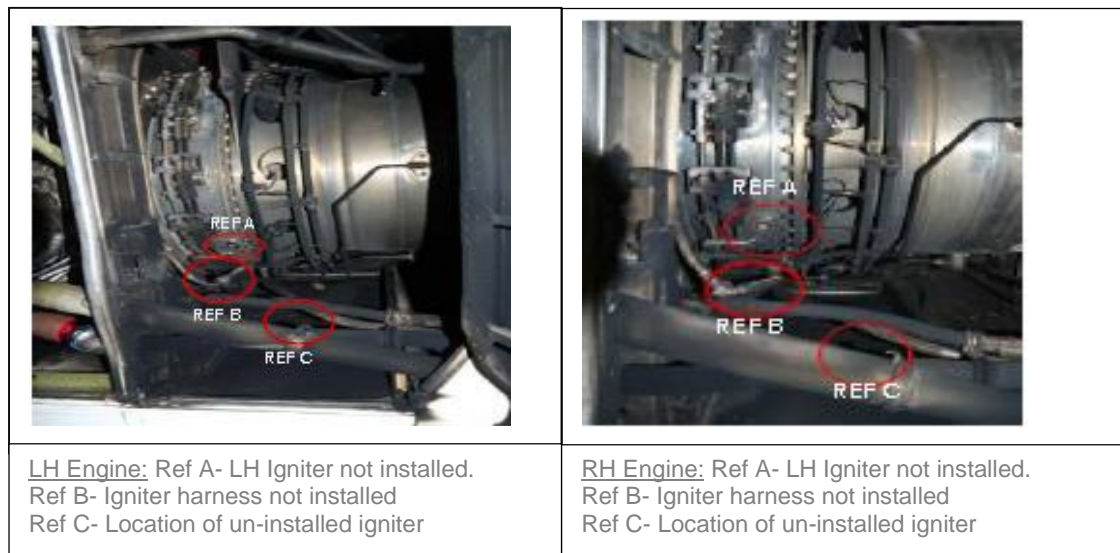
**Figure 4.** Photos showing inside the LH side of both engines

5. The LH igniters from both engines were found lying inside the engine compartment.
6. The electrical harnesses that connect to the igniters were not connected.
7. Evidence of black soot indicating signs of overheating was found within the engine compartment including on the structure and tubings.
8. No signs of overheating were observed on the compartment fire detectors, which were located approximately 16.5 inches from the open port.
9. The RH igniter plugs and harnesses on both engines were intact and installed.

The following photos were taken shortly after the incident and the observations were similar on both engines. Identification is mentioned based on looking from the aft of the Aircraft looking forward (ALF).

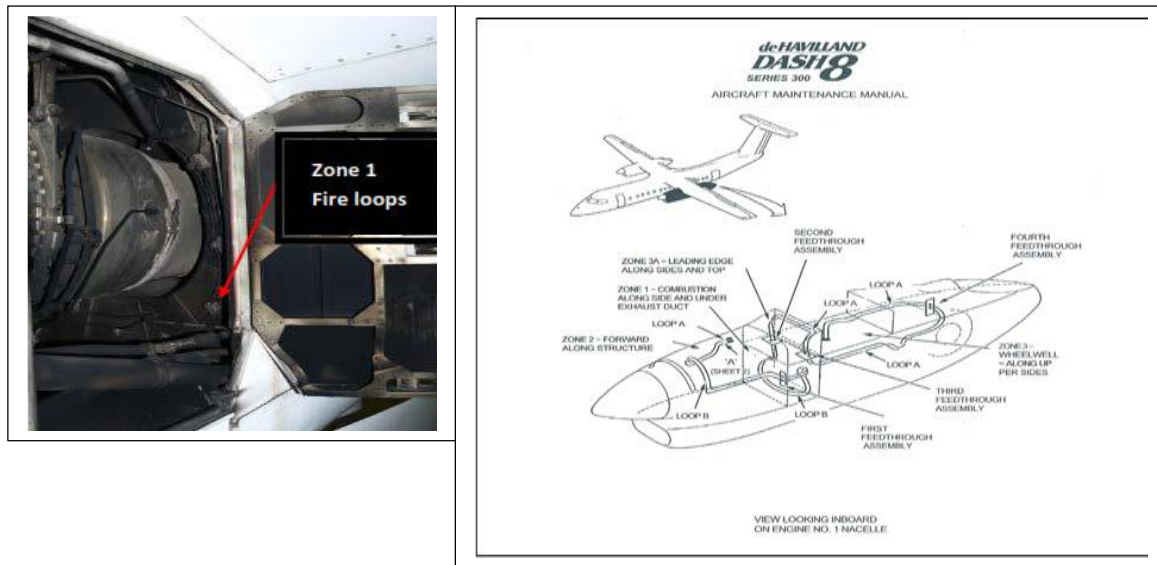
Figure 6. Location of Zone 1 Fire Detectors

The engine igniters are located approximately 16 inches from the fire detector loops, as noted in figure 6, and are designed to trigger fire and/or overheat warnings when the detection loops are exposed to temperatures<sup>16</sup> between 177 and 221°C. As per the engine manufacturer, the temperature of the escaping hot gases at the igniter open port would have been approximately 500 degrees Celsius. However, during the Incident flight, no fire warnings were triggered.
