## Investigation report

C9/2010L

# **Serious incident: Jetliner Collision with Runway Edge Lights at Take-off in Oslo on 23 October 2010**

Embraer ERJ 190-100 LR

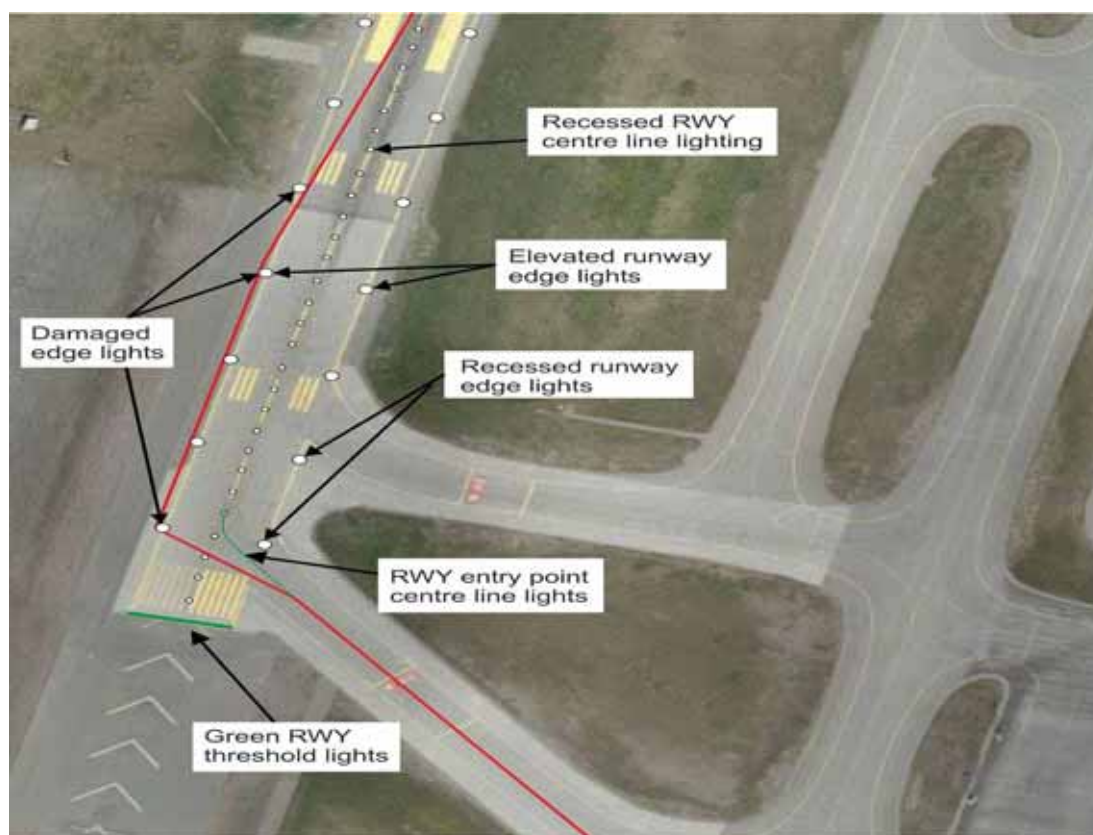
Figure 2. The aircraft's entry to the runway and the take-off run. (Photo: Oslo airport AS)

The aircraft crossed the runway centre line at 17:09:39, aligned with the runway on top of the left runway edge lights at 17:09:51. The aircraft was not stopped at any phase. Rather, the rolling take-off commenced at 17:09:56 with a slow acceleration. The take-off run continued over the left runway edge lights until the fourth light fixture, at which point it became apparent to the captain that the aircraft was not on the runway centre line. The investigation could not establish how the captain recognised this. Both pilots heard a clunk almost simultaneously with the course correction towards the centre line. They felt that the sound resembled the sound of the nose gear travelling over a recessed centre line light fixture. During the take-off run the aircraft was manoeuvred to the centre line and, following this, the take-off proceeded in a normal fashion.

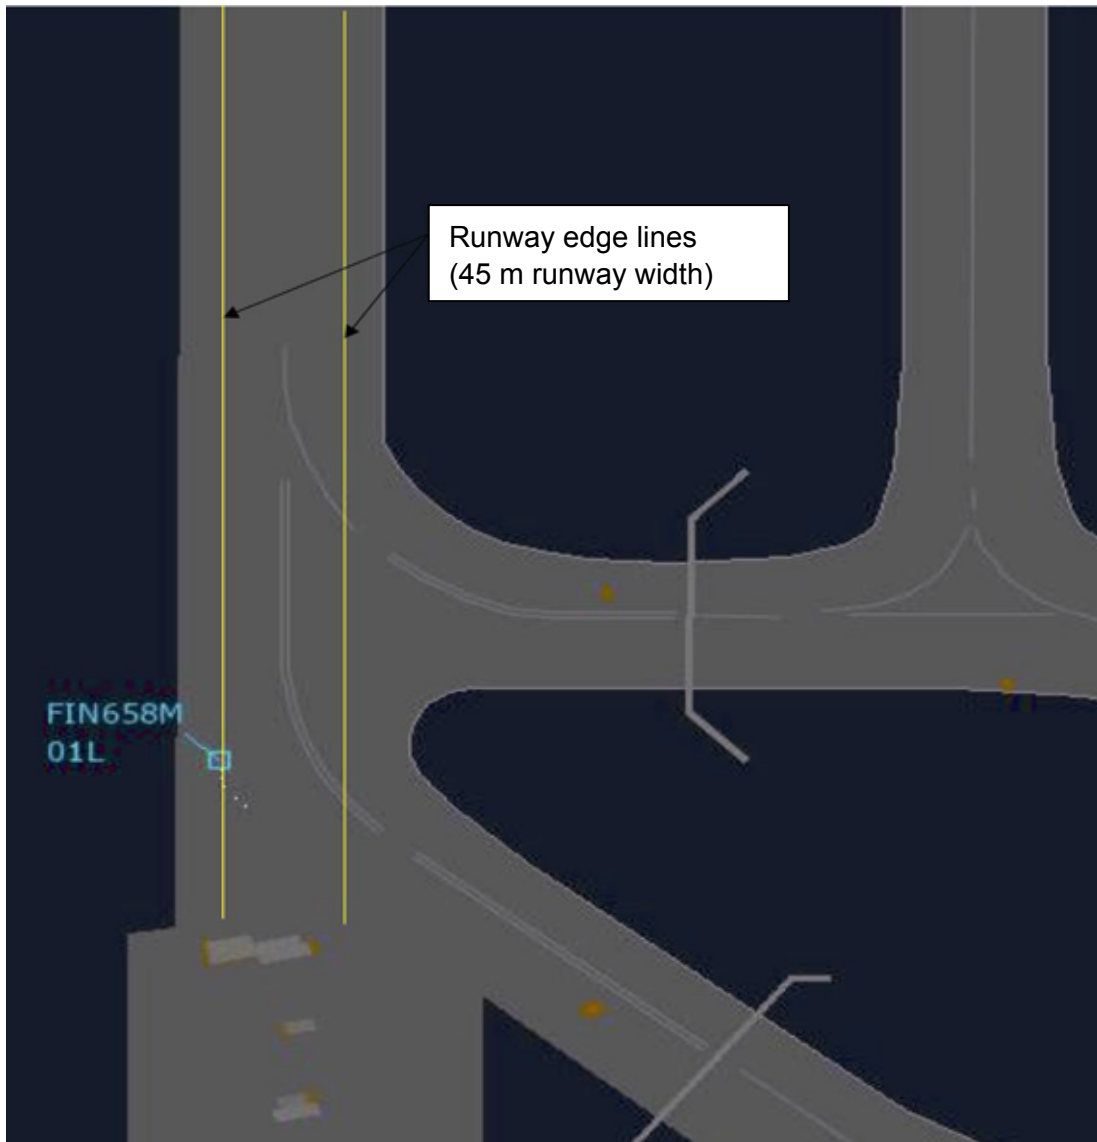
Figure 3. The aircraft on the left side of the runway in the ground radar snapshot. (Source: Oslo airport, ATM/CNS department)

From the ground radar picture the air traffic controller could have deduced that the Finnair aircraft, about to take off, was clearly on the left side of the runway (Figure 3). Since

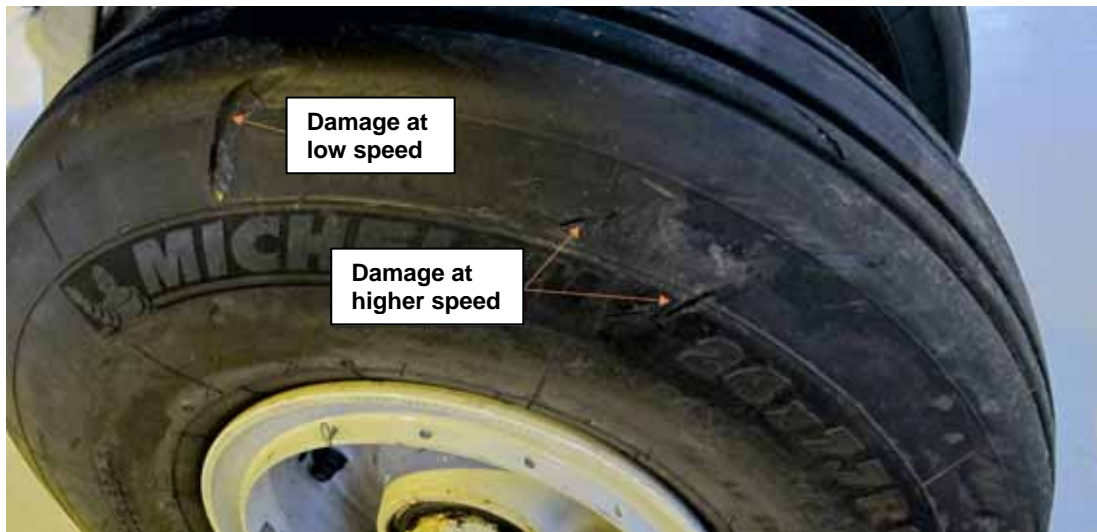
Figure 4. Damage to the nose gear tyre.

The RH sidewall of the inner tyre on the LH main gear was damaged. So was the sidewall of the nose gear RH tyre. The tyres were changed after the flight.

On 12 Nov 2010 the investigation commission inspected and photographed the removed tyres. There were abrasions on the sidewall of the inner tyre of the LH main landing gear as well as one approximately 16 mm deep gash on its shoulder. There were abrasions, a gash and a section where a piece of tread was missing on the nose gear RH tyre. The tyre damage is shown in figures 4 and 5.

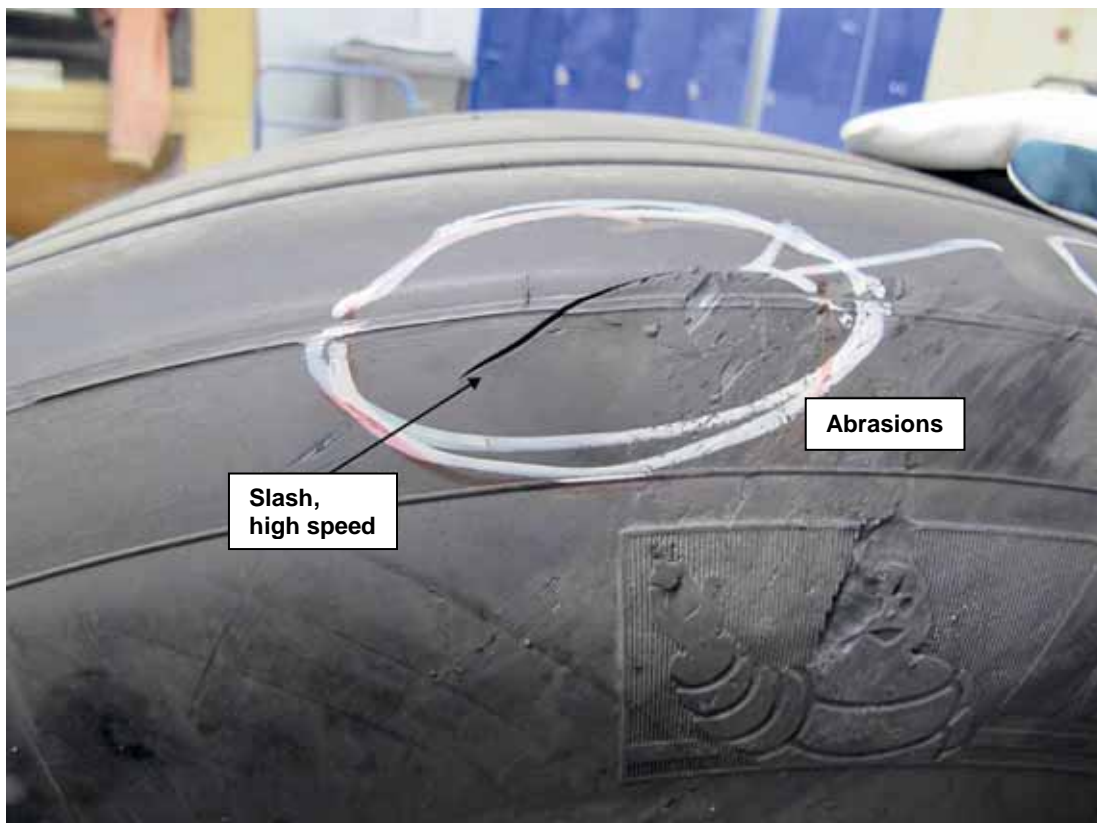
Figure 5. Damage to the main gear tyre.

The fifth edge light was probably broken when the inner tyre of the LH main gear hit it. At this stage the speed of the aircraft was approximately 60 kts. This caused an approximately 16 mm deep gash on the sidewall; its angle implies that it was generated at a higher speed than the second slash of the nose gear tyre.

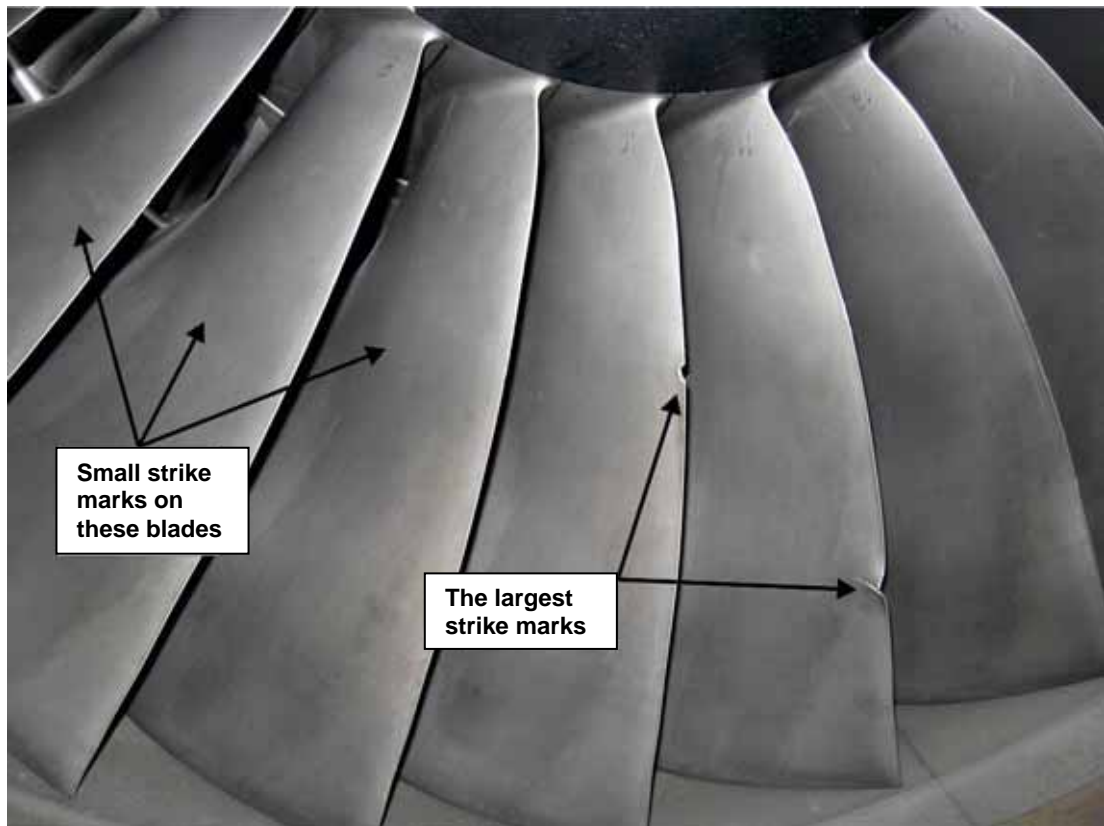
Figure 6. Damage to the fan blades.

There were strike marks on five RH engine fan blades. One of the blades sustained a 25 mm long crack, running parallel with the fan blade chord. There were strike marks and dents on the second and third high pressure compressor rotor stage blades as well as on the stator vanes between the stages. The damage exceeded the maximum allowable values and, therefore, the engine had to be removed for repairs.

During the engine's teardown examination small clear glass shards were found in the soft fan tip blade sealant. Clear glass is found in runway edge light fixtures. There were strike marks on five adjoined fan blades. The most badly damaged fan blade bore two strike marks. The bigger mark was clearly in the bypass duct area. The piece that hit the fan blade apparently disintegrated into tiny fragments which subsequently entered the bypass duct. The strike mark also caused a 25 mm long crack, running parallel with the fan blade chord. The smaller strike mark was in the engine core area. Therefore, the piece that hit it was probably sucked into the engine core. Four other fan blades also displayed small strike marks on the borderline of the bypass duct and the engine core. Also the fan case inlet bore small strike marks.

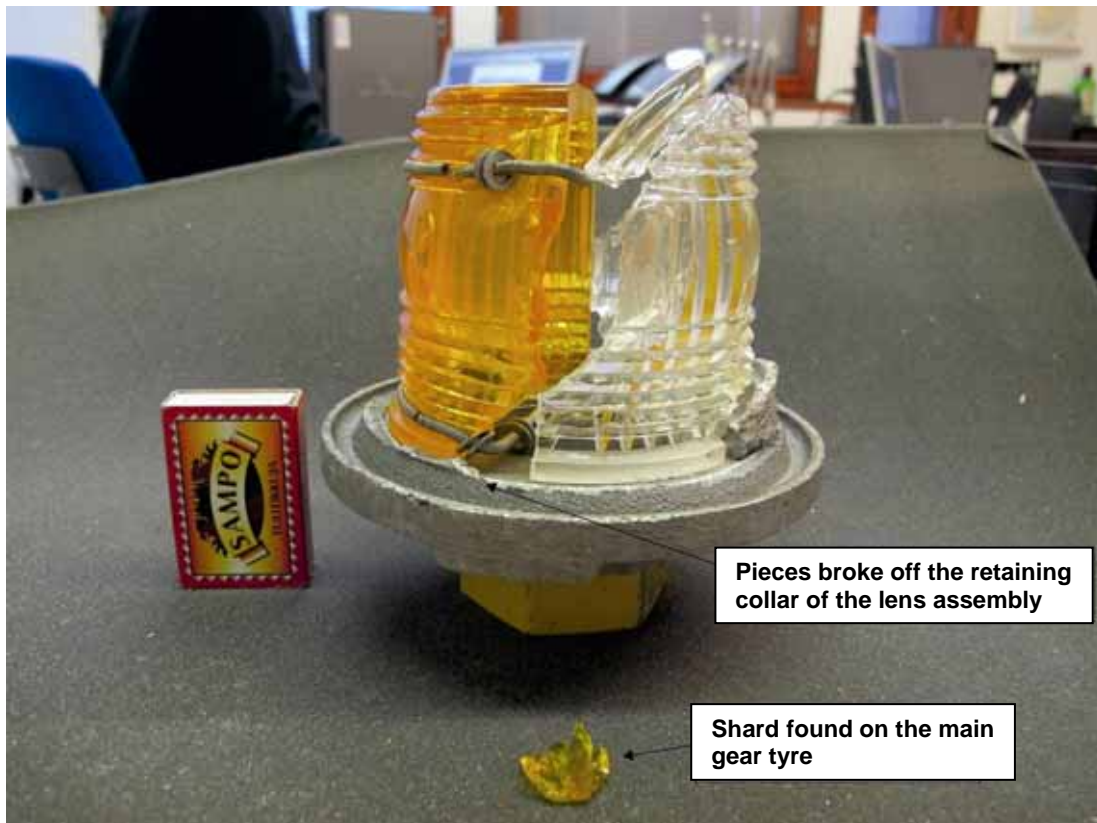
Figure 7. The first light fixture, assembled from the recovered parts. (Photo: SIAF)

The first, fourth and fifth left runway edge lights of RWY 01L at Oslo airport were damaged. The Safety Investigation Authority, Finland received broken pieces of a light fixture which, according to airport services, came from the first edge light. Apart from its mount, the lens assembly and the lamp it was possible to partially re-assemble the fixture. The pieces of the fourth and fifth light fixtures had been discarded and so were not available. According to airport services, light fixture parts were strewn across the concrete on the runway, and broken glass was scattered around the concrete.

The airport services inspected the runway at Oslo. Remains of the damaged runway edge lights were found which, according to airport services, came from the first light fixture. It was possible to partially re-assemble the fixture from the remains (see figure 6). Pieces of the aluminium retaining collar of the lens assembly and the mounting column were missing. Airport services had discarded the remains of the fourth and fifth light fixtures, which had scattered across a wide area on the runway. The garbage bin had already been emptied when the investigation commission asked for the parts.

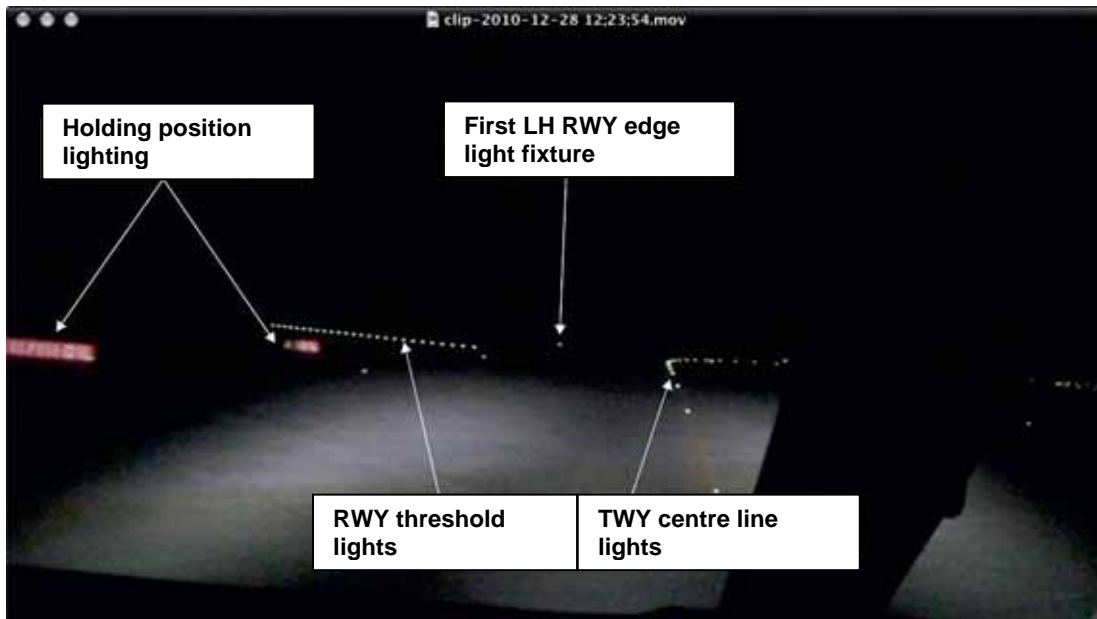
Figure 8. The view from TWY A1 when approaching RWY 01L. (Source: simulator/SIAF)

When approaching the runway from TWY A1, the green taxiway centre line lights are straight ahead and the green runway threshold lights are on the left. These lights can confuse the pilot, especially if his gaze moves from the front sector, for example, towards the final approach. Moreover, the green runway entry point centre line lights on taxiways A1 and A2 made it more difficult to discern the right runway edge lights.

It was challenging to discern the right edge of the runway due to the broken runway edge markings and because the two first recessed runway edge lights were barely visible. Taxiways A1 and A2 are close to each other, separated by a fairly wide paved area, which brings its own challenges to positioning. The ILS glide path antenna reflection area is on the left side the RWY 01L threshold area. Near the runway it is asphalt-paved and further away the area is gravelled. Normally, runway safety areas are unpaved.

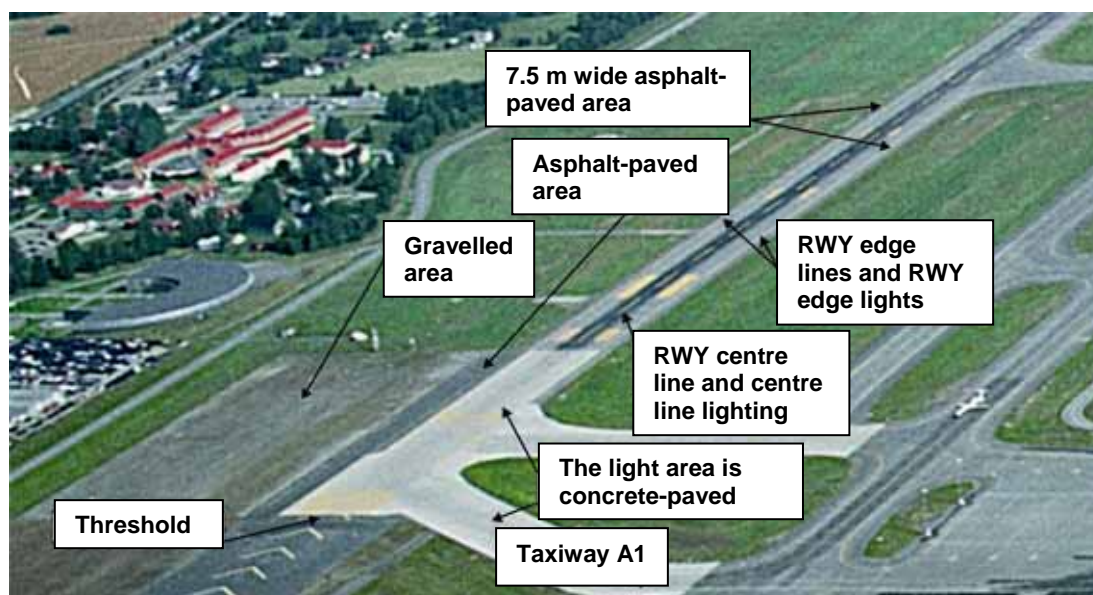
Figure 9. Runway threshold area and its surroundings. (Photo: Oslo Lufthavn AS)

- The runway is 45 m wide, but there is a 7.5 m wide paved runway shoulder. Outside the western edge of RWY 01L's take-off position, on the opposite side of TWY A1, there is also an exceptionally large asphalt-paved area, beyond which there is a gravel-covered area. This being the case, the surrounding terrain does not provide a clear indication of having arrived at the edge of the runway.

- Runway markings are yellow in Norway. The runway threshold area is paved with concrete. From aerial photos it was evident that the painted markings are less discernible on concrete compared to asphalt. In other words, their contrast is weaker on concrete. The yellow runway markings may have contributed to the observation of the aircraft's position relative to the runway.
