Takeoff with erroneous takeoff data, Embraer 195-E2

Learning to reduce the risk of using
erroneous takeoff data

The Hague, September 2023

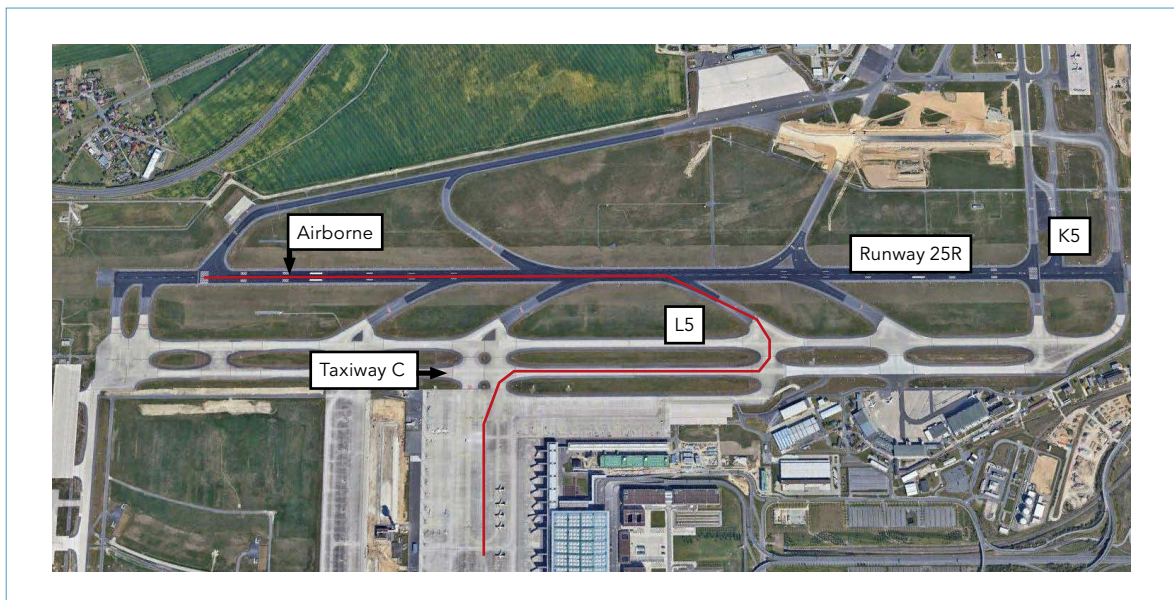
Figure 2: Aircraft route (red line), Runway 25R with taxiways towards intersections K5 and L5. (Source map: Google Earth)

The aircraft took off from intersection L5 while the performance calculation was based on intersection K5. Therefore the engine’s thrust and flap position were calculated and set for an available runway length (Take Off Run Available, TORA) of 3,385 metres, see Table 2. The acceleration of the aircraft to reach the calculated speeds V1 and Vr was also based on this distance. The actual TORA was 2065 metres, 1320 metres less. As a result, the acceleration of the aircraft was too slow to safely take off from intersection L5. This explains why the aircraft became airborne 443 metres¹⁹ before the end of the runway (see Figure 2).

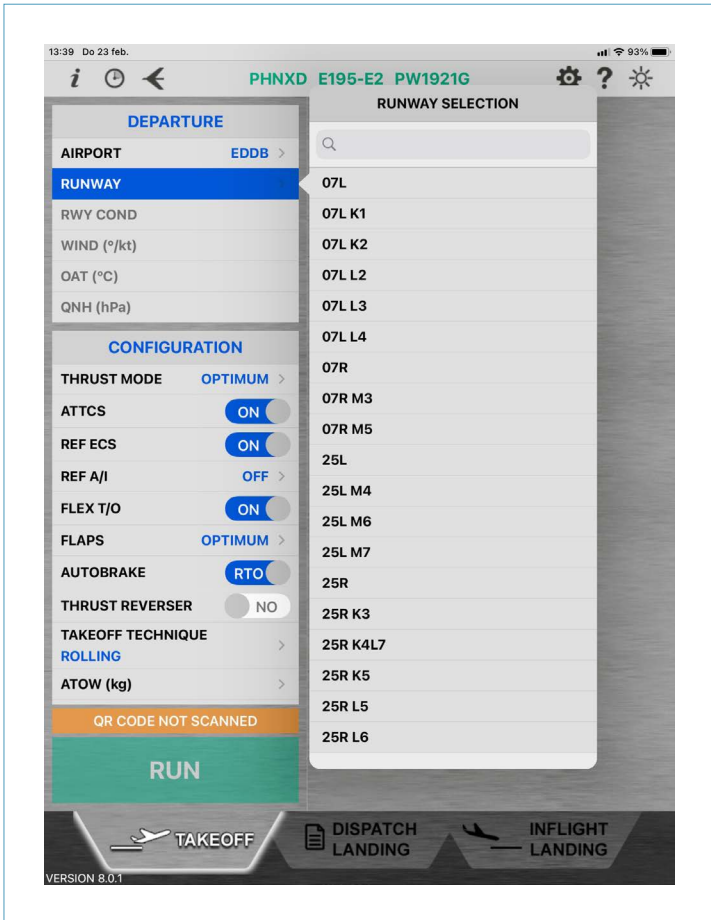
Figure 3: Page of electronic flight bag.

Data entry into ePerf is a routine operation that is often repeated. Therefore, the pilots entered the required information quickly. All available runways and corresponding entry points of the selected airport were listed in a pull down menu. This listing was in numerical and alphabetical order and Runway 25R K5 was listed just above 25R L5, see Figure 3. Both crew members accidentally touched and selected 25R K5 instead of 25R L5.

ePerf does not have a graphical representation of the selected takeoff starting point (the so called runway synoptic). A runway synoptic provides visual feedback after selection of the runway and intersection. According to the aircraft manufacturer, adding this function to the ePerf was considered in the user forum²⁴ in 2022, but it did not become part of the short or mid-term list of improvements for this application based on operators' priorities. This feature was discussed again in 2023 and placed on the short-term list of improvements. According to the aircraft manufacturer, the inclusion of a graphical representation of the runway is under development and expected to be incorporated in the software in 2024.²⁵ Furthermore, Embraer was in the process of implementing two other modifications of ePerf in order to reduce selection errors. First, a two-step intersection selection (first the runway, then the intersection on a separate menu) on ePerf is intended to decrease the number of selection errors (release Q3 2023). Second, highlighting the intersection used for calculation (inverse video display) in the output page header is intended to increase the chance of detecting a selection error (release Q3 2023).

The point from which pilots initiate the takeoff, was selected from a list containing all possible runway and intersection combinations, presented in a numerical and alphabetical order. Both intersections K and L were presented in ePerf, even though K intersections were not normally used by the operator. Runway 25R's intersections K5 and L5 were presented consecutively on the dropdown menu list, see Figure 3.
