Propulsion System Fire (SCF–PP–PSF)

Investigation Report

**Serious Incident to
Boeing 747-8F, N624UP
Hong Kong International Airport**

20 July 2021

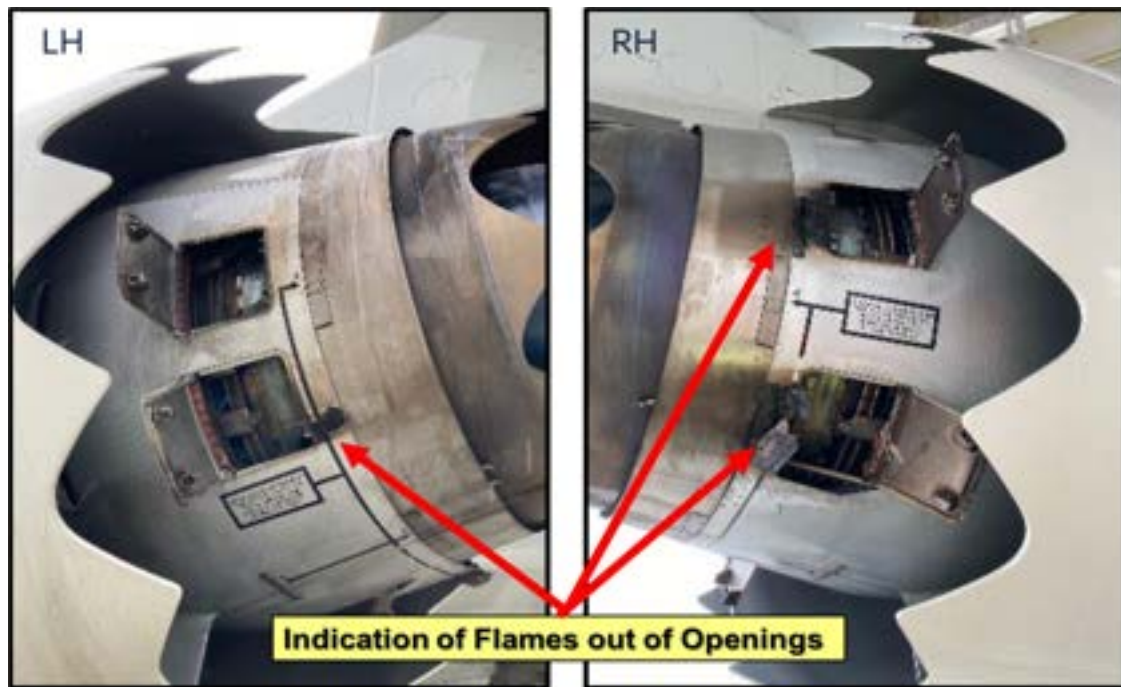
- (1) The aircraft was not damaged except thermal damage observed at the exterior core section of the No. 1 Engine.
- (2) The soot shown at the openings of the thrust reverser (T/R)'s four pressure relief doors on the No. 1 engine.

Figure 8: Soot shown at the Openings of T/R Pressure Relief Doors

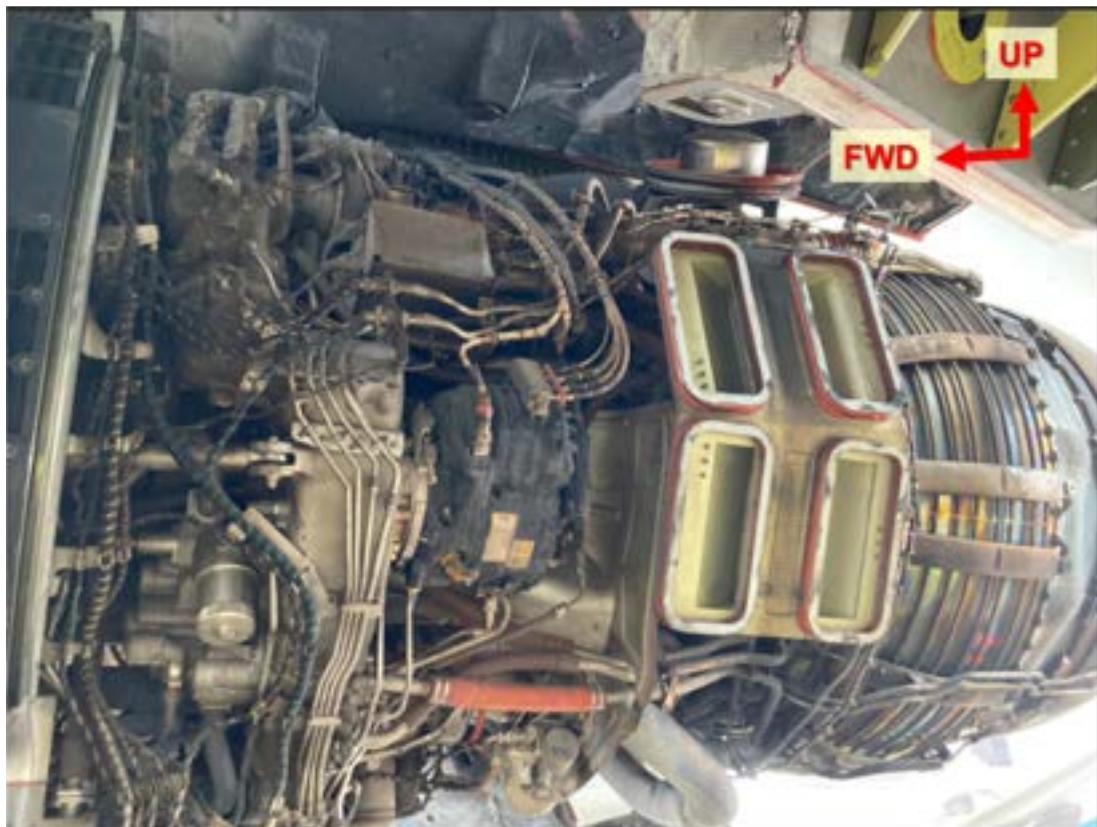
- (3) After opening the engine core cowling, thermal damage was observed on both sides of the exterior engine core. Details are in Section 1.16.1.: Powerplant Examination at GE Facility.

Figure 9: Left-Hand Side of the Exterior Engine Core

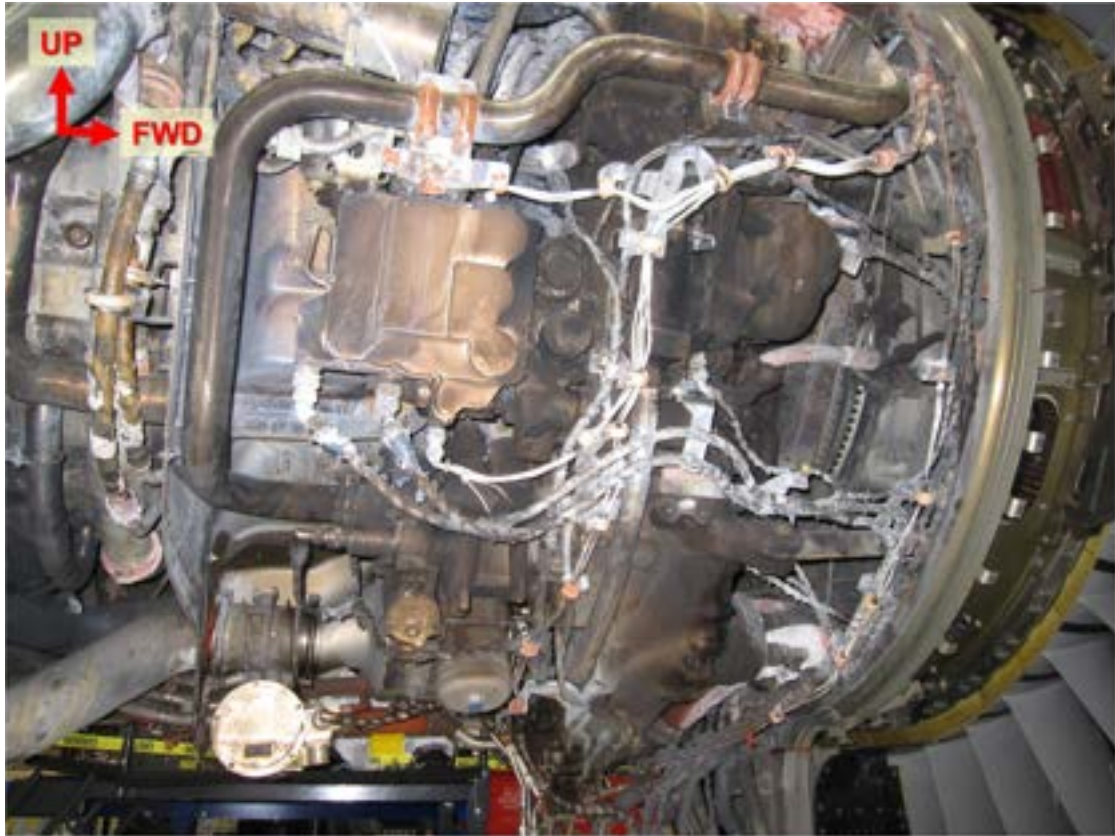
Figure 10: Right-Hand Side of the Exterior Engine Core

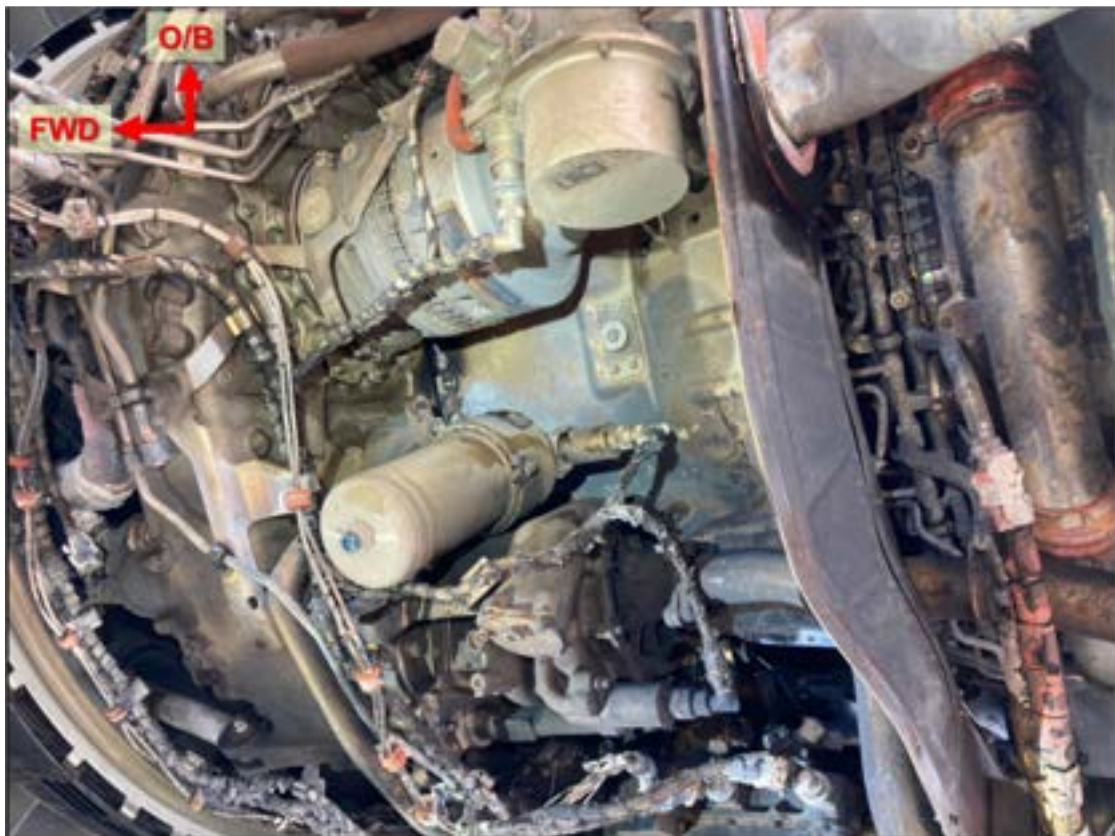
Figure 11: Under Section of the Exterior Engine Core

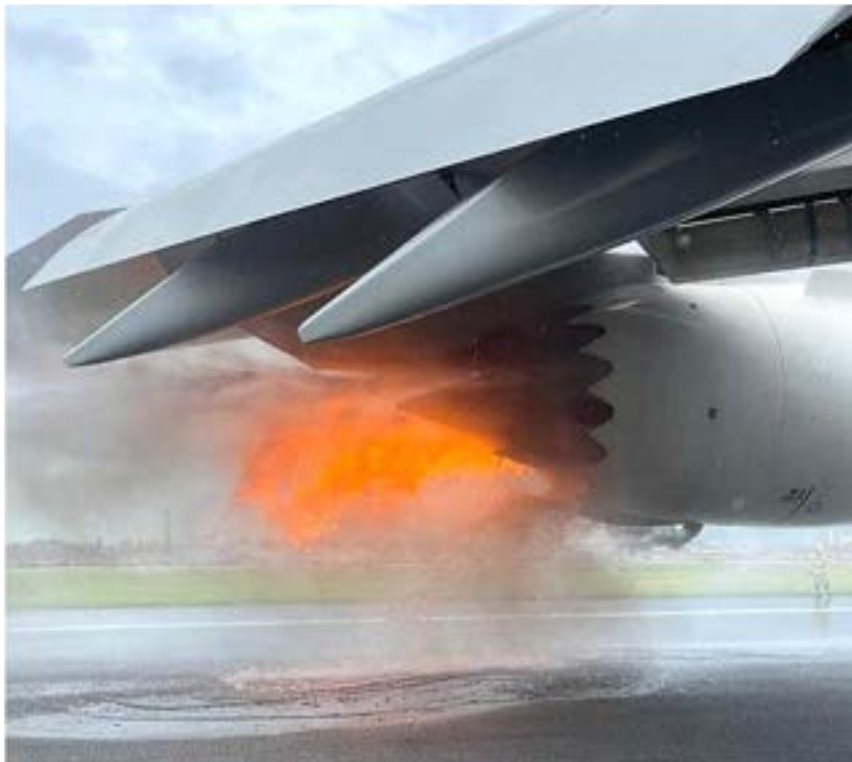
- (1) At 1220 hours, the "FIRE ENG 1" EICAS warning message appeared for 12 seconds after the No. 1 engine shutdown. The flight crew pulled the No. 1 engine fire handle and discharged two fire extinguisher bottles, but the fire warning continued.
- (2) The fire warning ended shortly before landing. The total fire alarm time lasted for approximately 9.5 minutes. After the aircraft landed safely on Runway 07L, the AFC inspected the No. 1 engine and brakes and found no fire.
- (3) About 22 minutes after landing, at 1252 hours, the AFC noticed white smoke and then fire in the No. 1 engine when water was being applied to the engine surrounding to maintain cooling effect. Additional fire suppressants were applied to the engine and the fire was extinguished within 40 seconds.

Figure 12: No.1 Engine Ground Fire

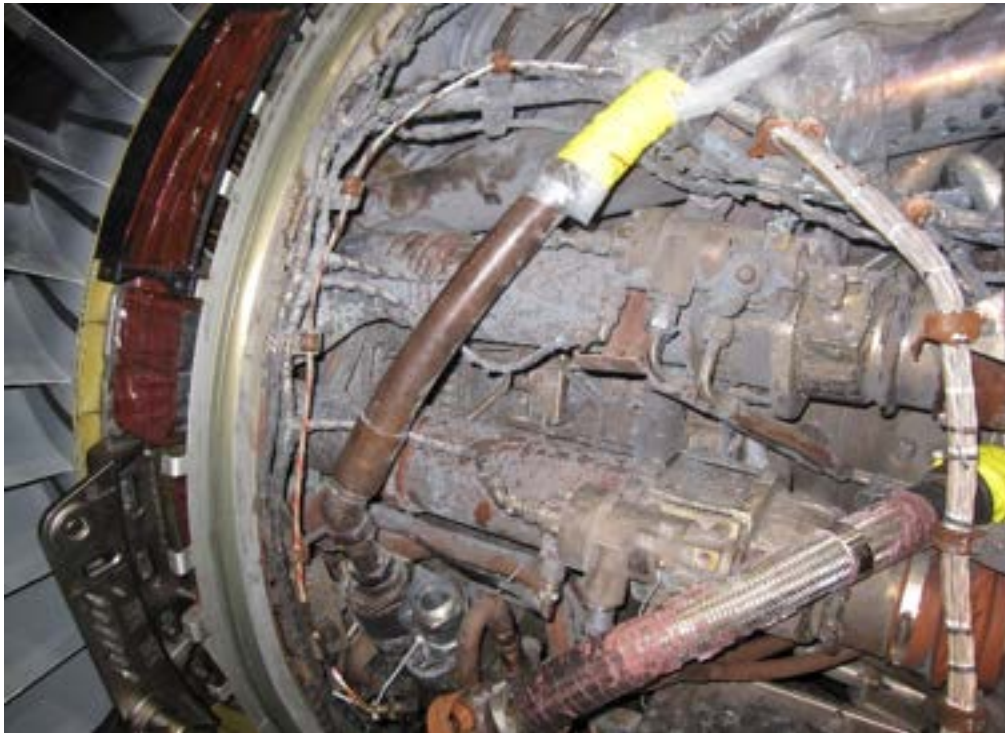
- (3) The thermal and fire damage consisted of sooting and melted or consumed c-clamp/p-clamps cushions, fire loop rubber isolators, electrical cable outer sheathing, and fire sleeves.

Figure 15: Left Side Close-Up of Thermal and Fire Damage

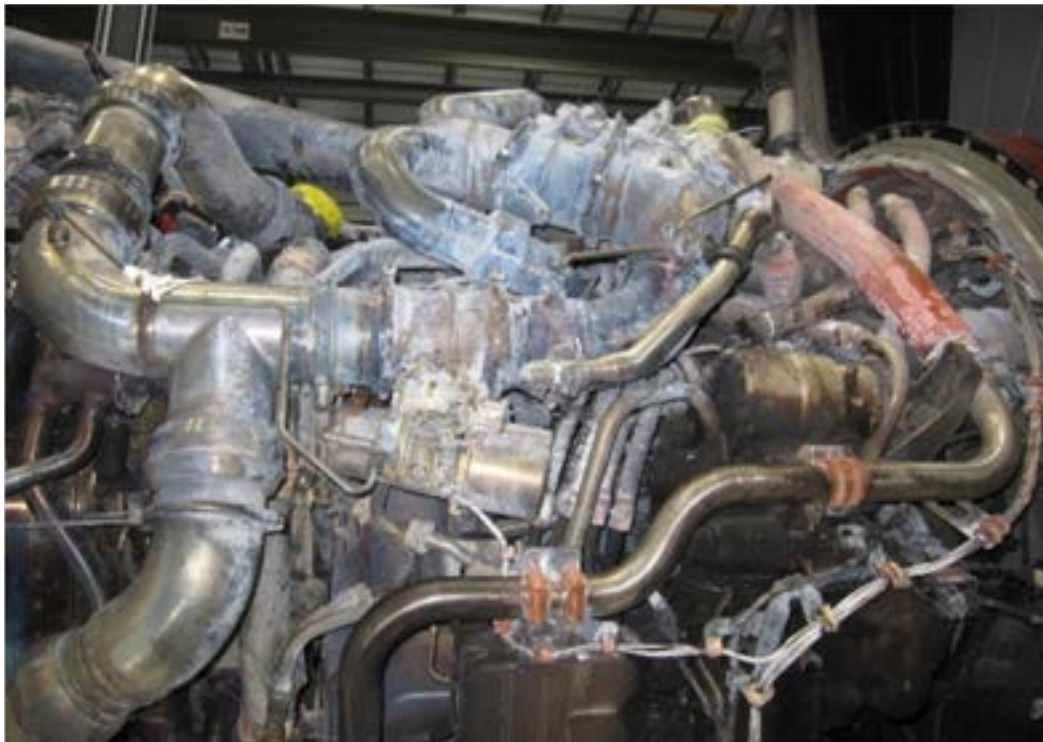
Figure 16: Right Side Close-Up of Thermal and Fire Damage

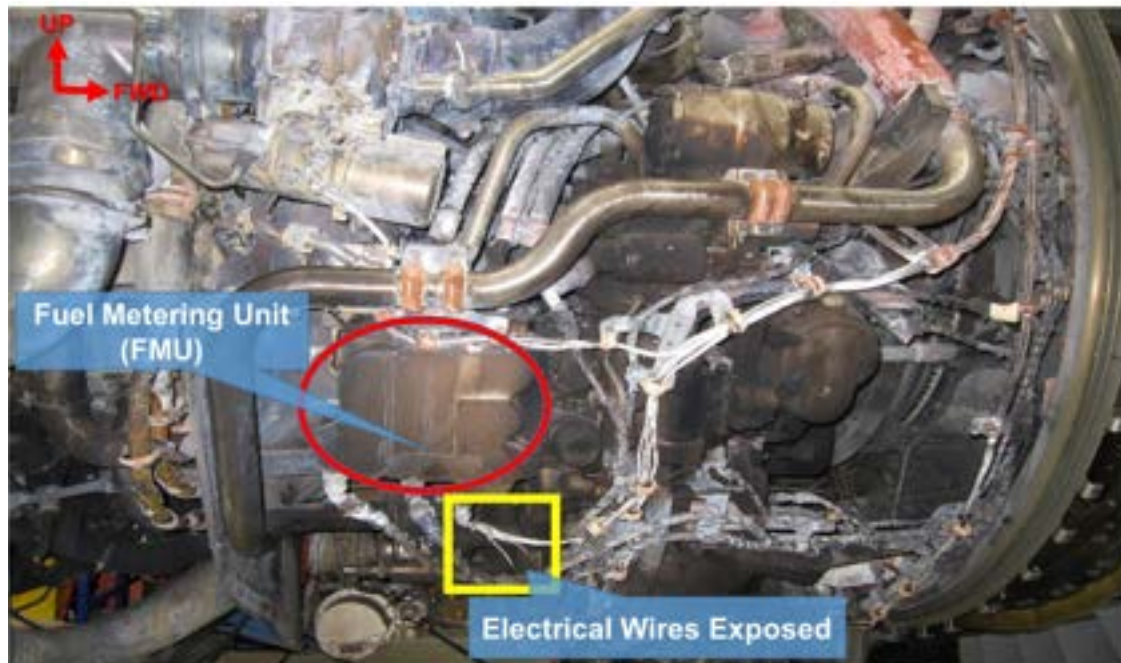
- (4) All the fire loops, overheat detectors, and responders appear to be continuous and intact. Below the FMU at about the 5 o'clock position, the conductors of the electrical wires appeared to be exposed.

Figure 17: Electrical Wires Exposed below FMU

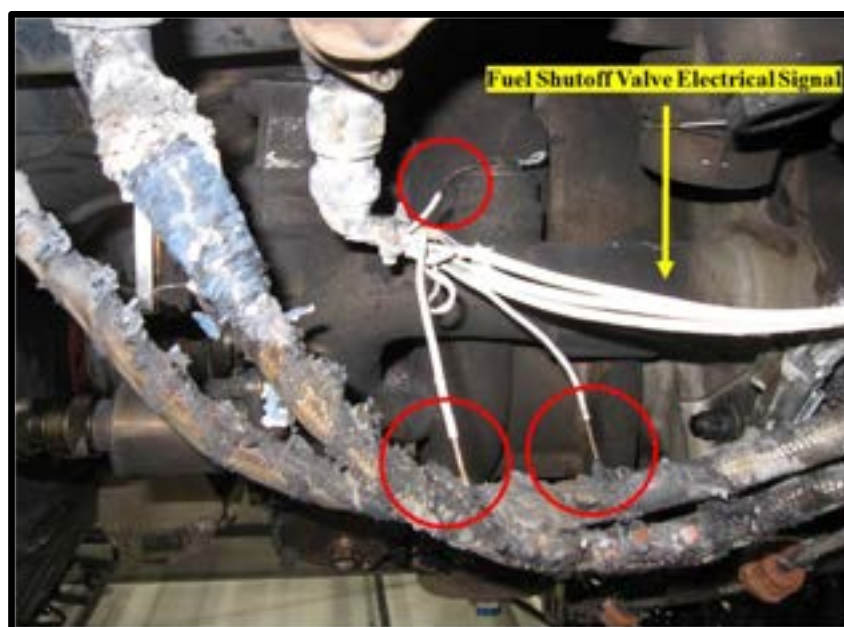
- (5) A detailed inspection revealed that the electrical wires exposed were from the fuel shutoff valve electrical connector, which was still installed and connected to the FMU.

Figure 18: Fuel Shutoff Valve Electrical Signal Wires Exposed

- (8) The end caps of the electrical wires likely melted as a result of thermal damage. Thus, the electrical wires became exposed.
- (9) The top of the engine, from about 9 o'clock to 3 o'clock position, was covered in a bluish powder residue, and yellowish powder residue at about the 1 o'clock position on the environmental cooling manifold.

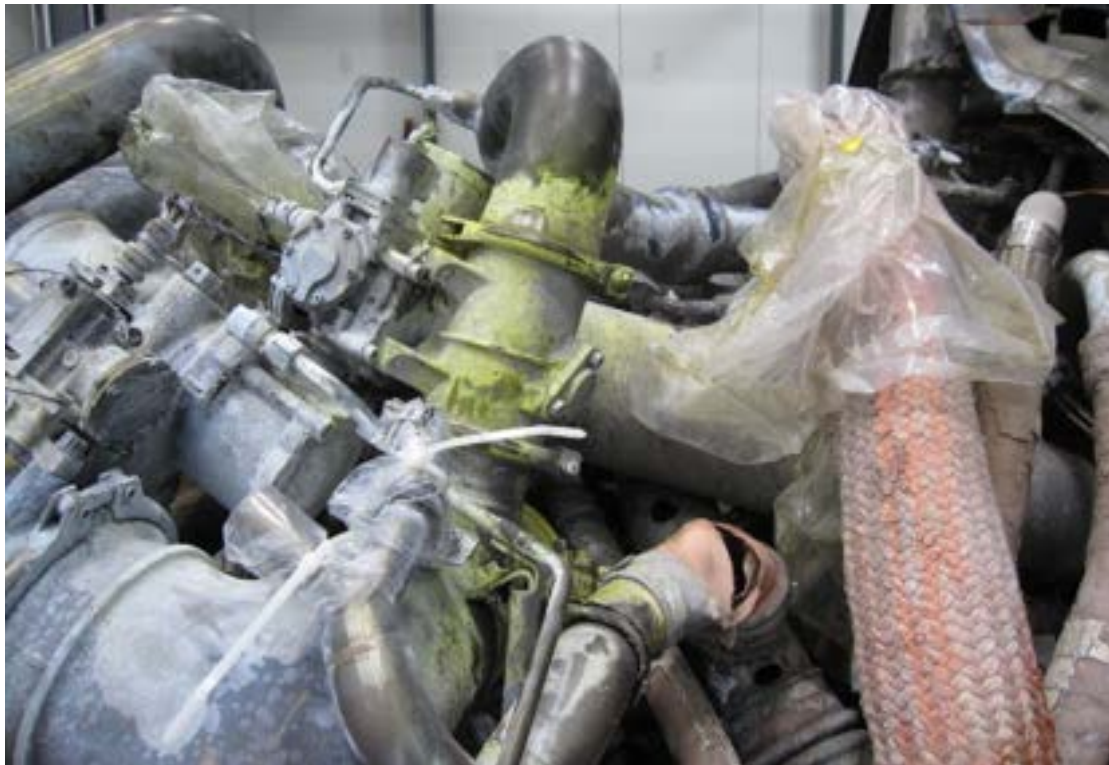
Figure 20: Yellowish Residue Near Top

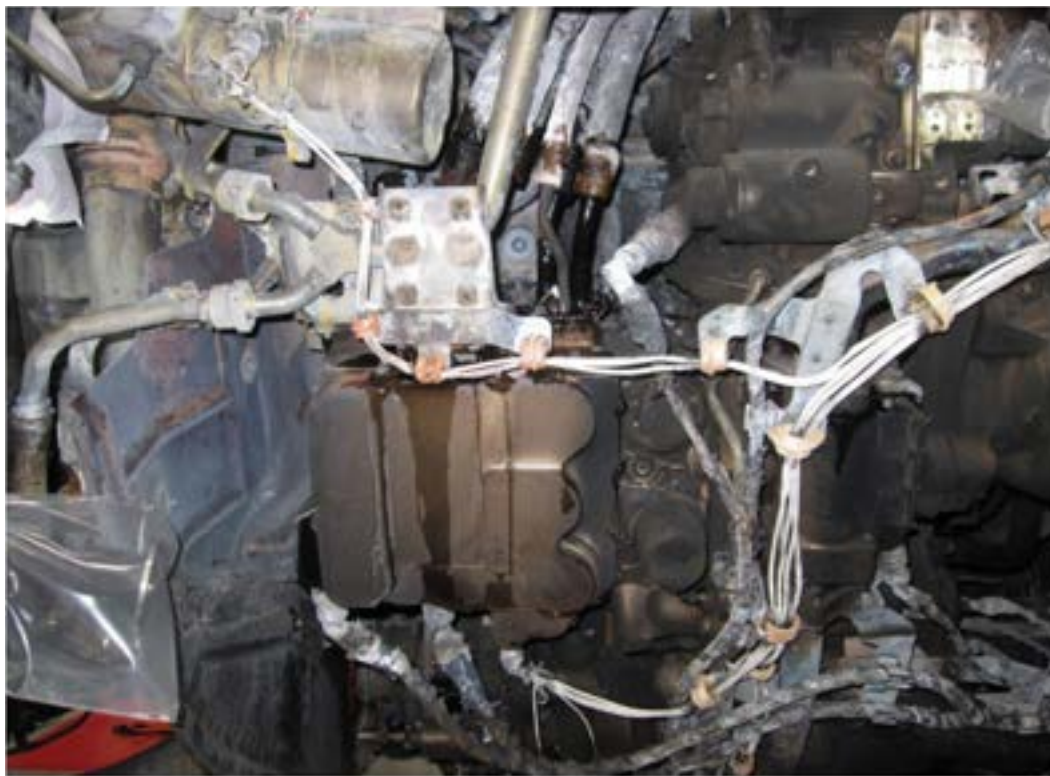
Figure 23: Fuel Leaking from Multiple Locations of FMU

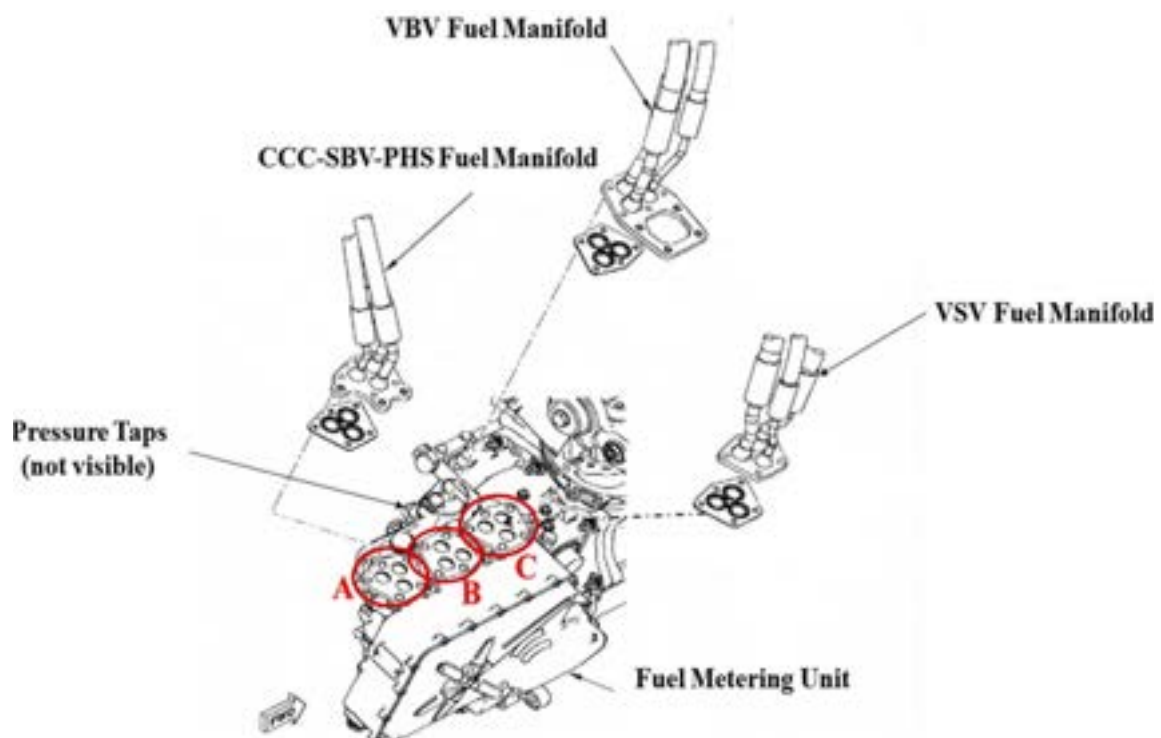
- (6) The leaks were observed coming from:
- the variable bleed valve (VBV) fuel manifold
 - the variable stator vane (VSV) fuel manifold
 - the core compartment cooling (CCC)-start bleed valve (SBV)-heated servo pressure (PHS) fuel manifold
 - two pressure taps on the back side of the FMU.
- (7) Due to multiple fuel leaks from the FMU, it was decided to isolate the FMU by installing cover plates on the manifold ports labelled A, B, and C in the figure below.

Figure 24: Leak locations of Fuel Metering Unit

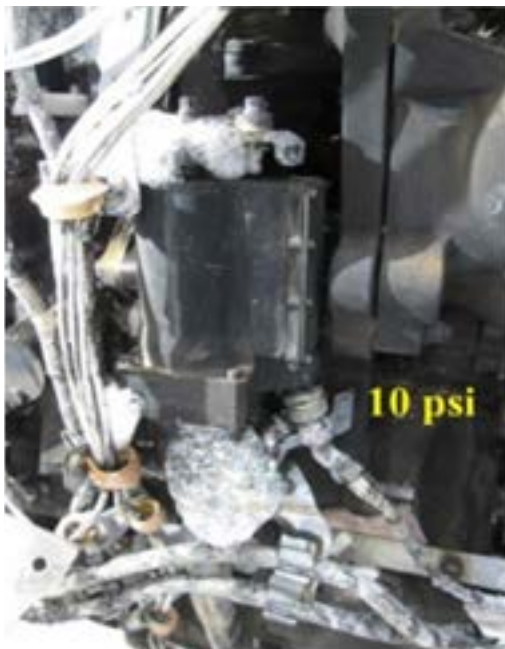
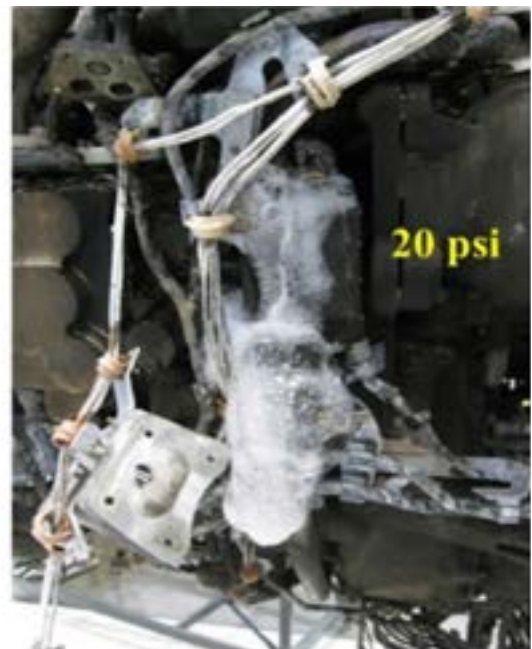
- (11) Using Leak-Tek fluid, nitrogen was seen leaking from the top and bottom of the fuel flow transmitter (FFT). No other leaks were noted. The nitrogen pressure was increased in 10 psi increments up to 30 psi. No additional leaks were observed other than what was observed coming from the FFT.

Figure 26: Leaking from Top and Bottom of FFT

- (12) These flexible portions of the fuel lines have a plastic inner core that during the testing was found to have melted due to fire, so fuel leaked through the metal outer braid.

- (13) The fire damage to the fuel lines did affect the integrity of the tube and would definitely leak during the leak check. These interface leaks were considered to be a result of the fire, not the cause.
- (14) The results of the engine leak check are shown in the table below.

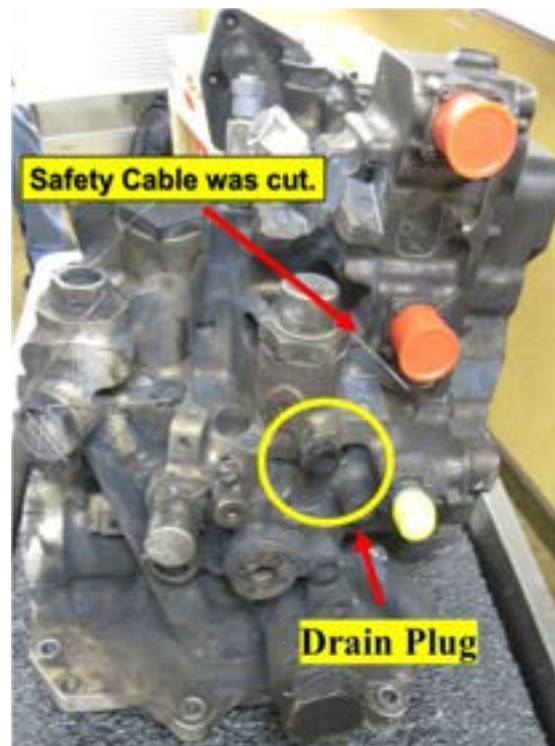
- (2) The FMU was completely sooted, but there were no signs of thermal distress to the housing.
- (3) Visual inspection of the FMU revealed that the safety wire from one of the drain plugs was found broken; it appeared to be a clean cut.
- (4) According to GE Field Support, the FMU was drained in Hong Kong for engine shipment; thus, the safety wire was cut to drain the unit. This was confirmed and photographed at the engine.

Figure 28: Cut Drain Plug Safety Cable

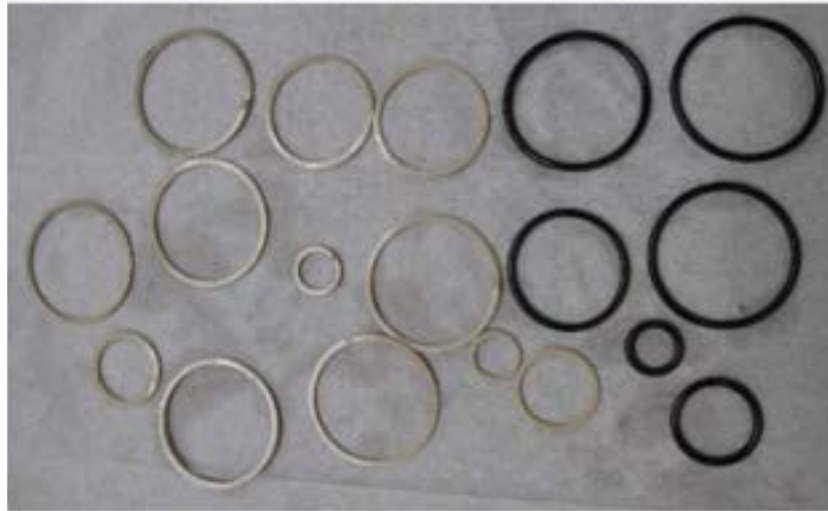
- (6) Each fuel port has a primary black packing (O-ring) with a whitish flat backup split ring on either side of the primary packing. The O-rings and the backup split rings were all intact, in good condition, and did not exhibit thermal or heat distress.

Figure 31: Condition of Packing & Back-up Split Rings

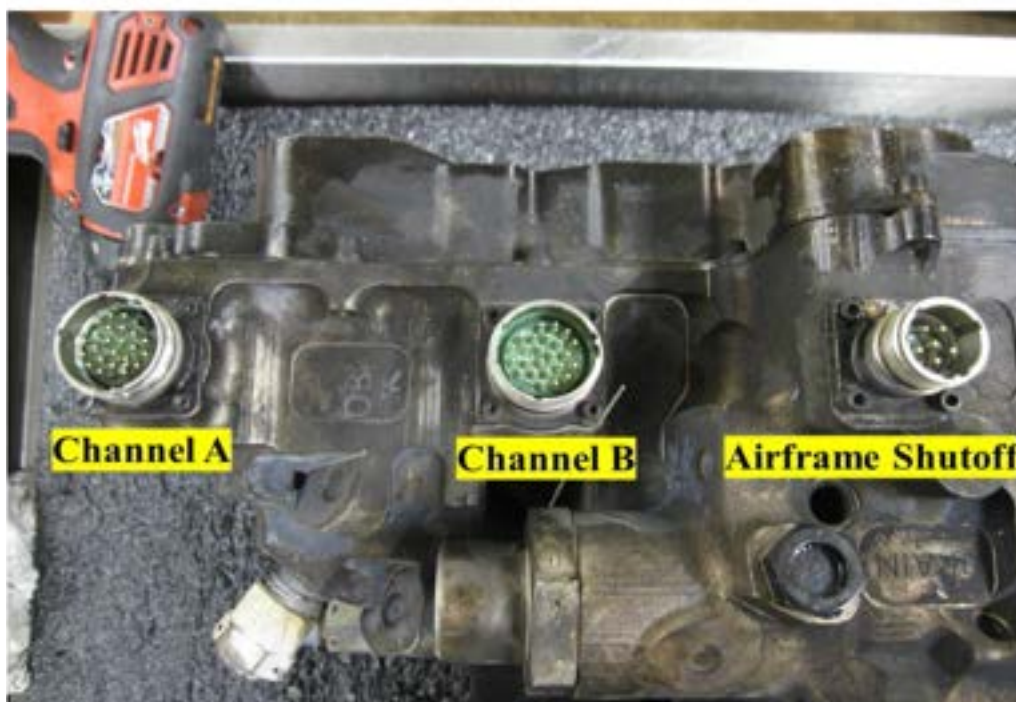
- (7) Visual examination of the electric connector plugs (Channel A, Channel B, and Airframe Shutoff (AFSO)) revealed that all the pins were present and intact, and no thermal distress was noted; the Channel A and AFSO green rubber grommet exhibited some minor thermal damage.

Figure 32: FMU Electrical Connectors

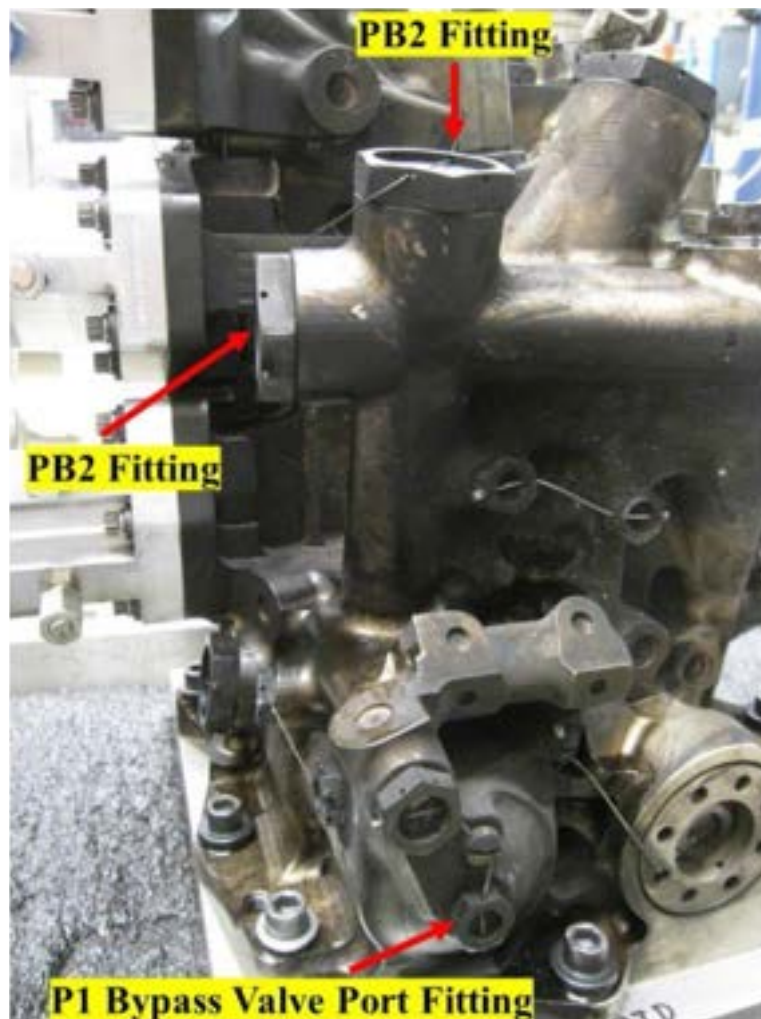
- (4) Leaks were observed coming from two PB2 bypass fittings³ and the P1 bypass valve port fitting. At all three leak locations, the fittings were loose. No other leak locations were identified.

Figure 36: Nitrogen Leak Locations

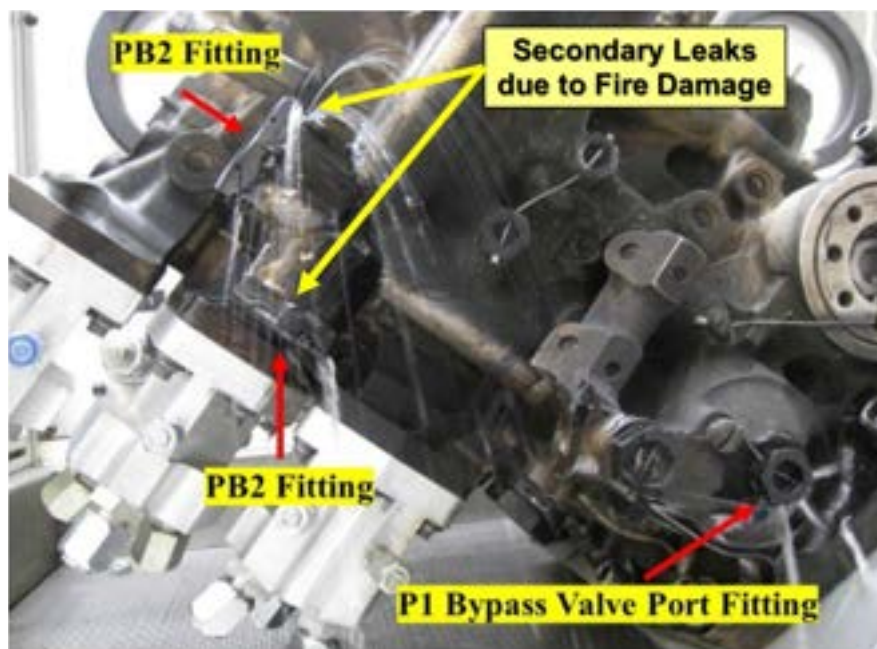
- (3) Calibration fluid at about 12 psi was introduced and leaks were observed from the same two PB2 bypass fittings and the P1 bypass valve port fitting that was observed in during the nitrogen leak check. No new leaks were observed.

Figure 38: Calibration Fluid Leak Locations

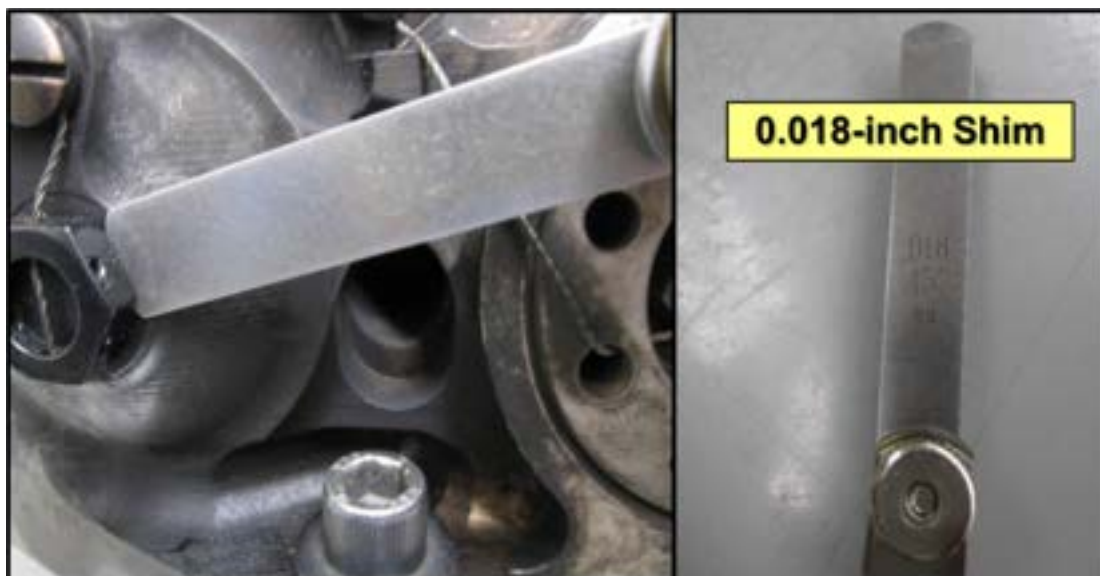
Figure 41: Feeler Gage Between FMU and P1 Bypass Valve Port Fitting

- (3) For a normal installation, there should be no gap. Since the fitting thread is 0.4375-20, i.e. 0.050" per turn, the 0.018-inch gap would equal to 1/3 turn loosen. To torque the fitting to specification, an additional 1/3 turn is required.
- (4) There was no noticeable gap between the PB2 bypass fittings and the FMU housing. Thus, no measurements were taken.

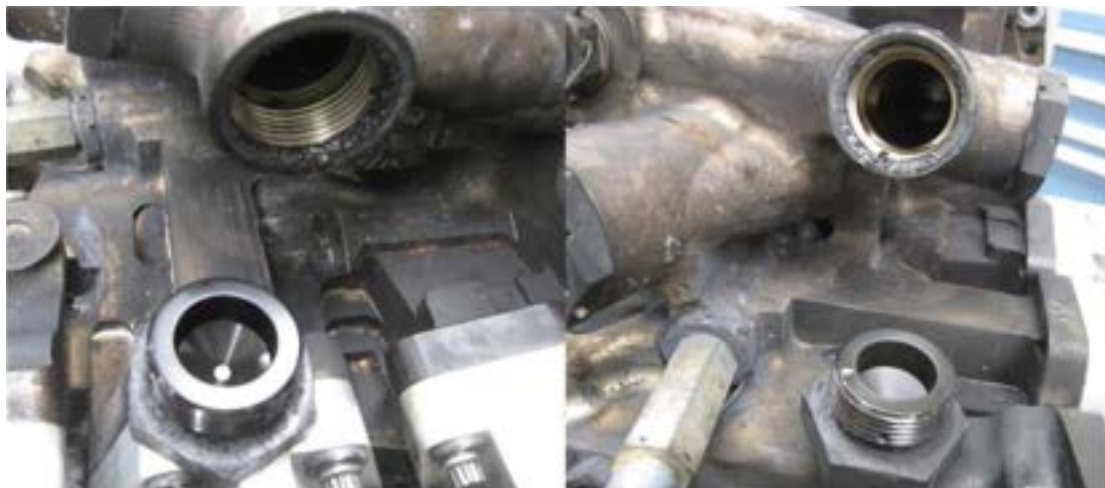
- (1) The PB2 bypass and two P1 bypass valve port fittings were removed to access the condition of the packings; these were the locations that leaked during the nitrogen and the calibration fluid leak tests.
- (2) Before removing the fittings, all three were marked to document their "original" position prior to removal. i.e. how "tight" they could get with the as-installed lockwire.
- (3) Due to fire damage, the packings were entirely consumed at both PB2 bypass fitting locations. All that remained was the residue of the packings were noted.

Figure 42: PB2 Bypass Packings Consumed

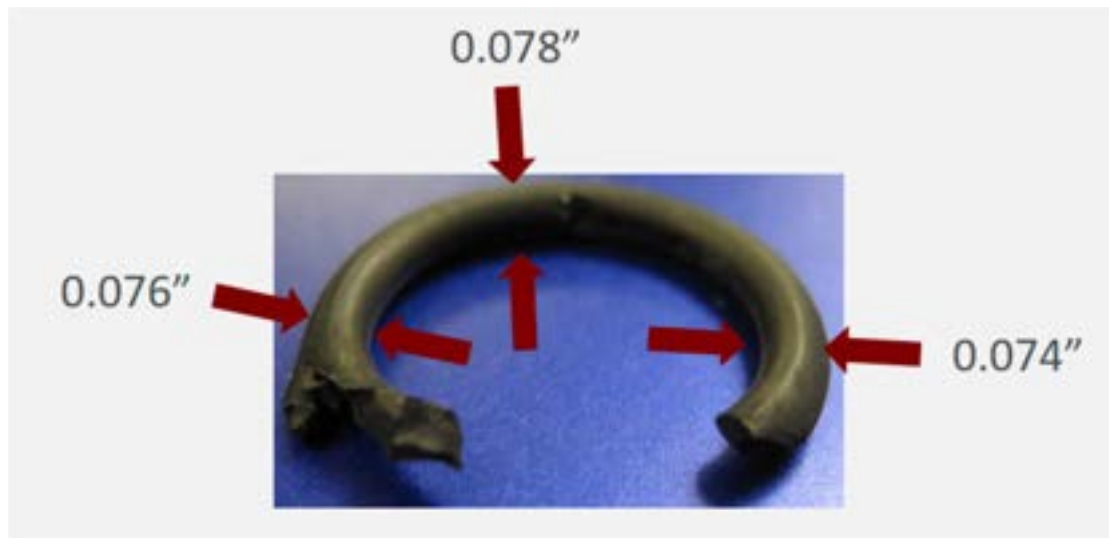
- (4) The packing for the P1 bypass valve port fitting was present and still had a reasonably round cross-section. However, a section of the packing, less than 1/4, of the circumference, was missing. Signs consistent with nibbling and extrusion damage at the broken edges of the packing were noted.

Figure 43: Damaged P1 Bypass Valve Port Fitting Packing

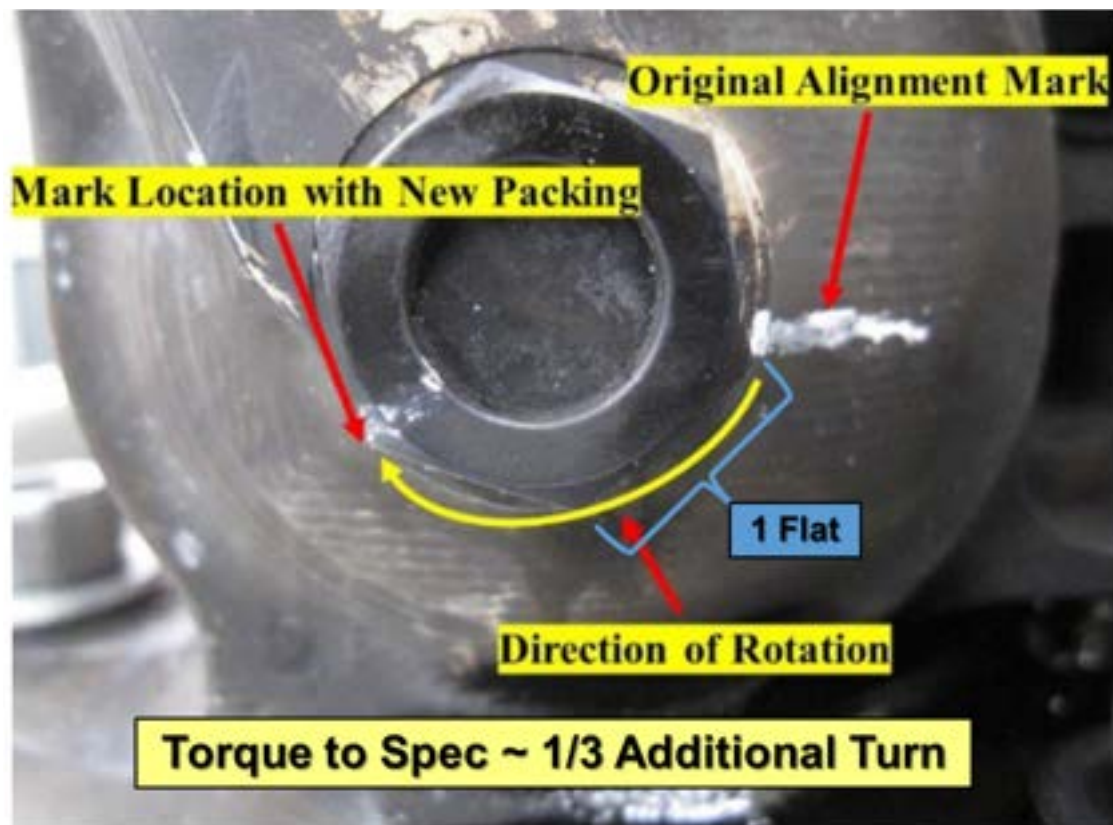
- (7) With a new packing installed on the P1 bypass valve port fitting and the fitting reinstalled to the specified torque, the new position of the alignment mark on the fitting was about two flats from the original "tight" position in the tightening direction.
- (8) Installing and torquing the fitting with new packing eliminated the 0.018-inch gap observed previously. Two flats of additional rotation corresponds to 0.018-inch gap based on the thread pitch, as noted in Section 1.16.2.4.

Figure 45: P1 Bypass Valve Port Fitting Alignment Mark With New Packing Installed
