Serious incident between the Cessna Citation 525 CJ
registered **F-HGPG**
operated by Valljet
and the Embraer 170
registered **F-HBXG**
operated by HOP!
on 12 January 2022
en route south of Auxerre (Yonne)

Safety investigations

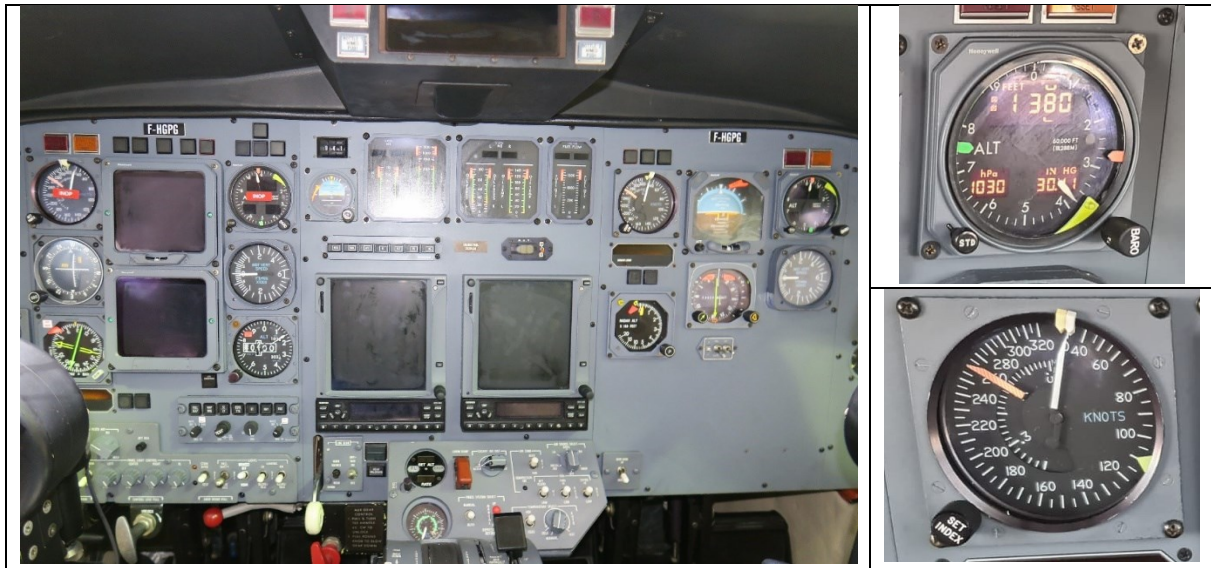
Figure 1: photo of instrument panel of F-HGPG/altimeter and airspeed indicator (source: BEA)

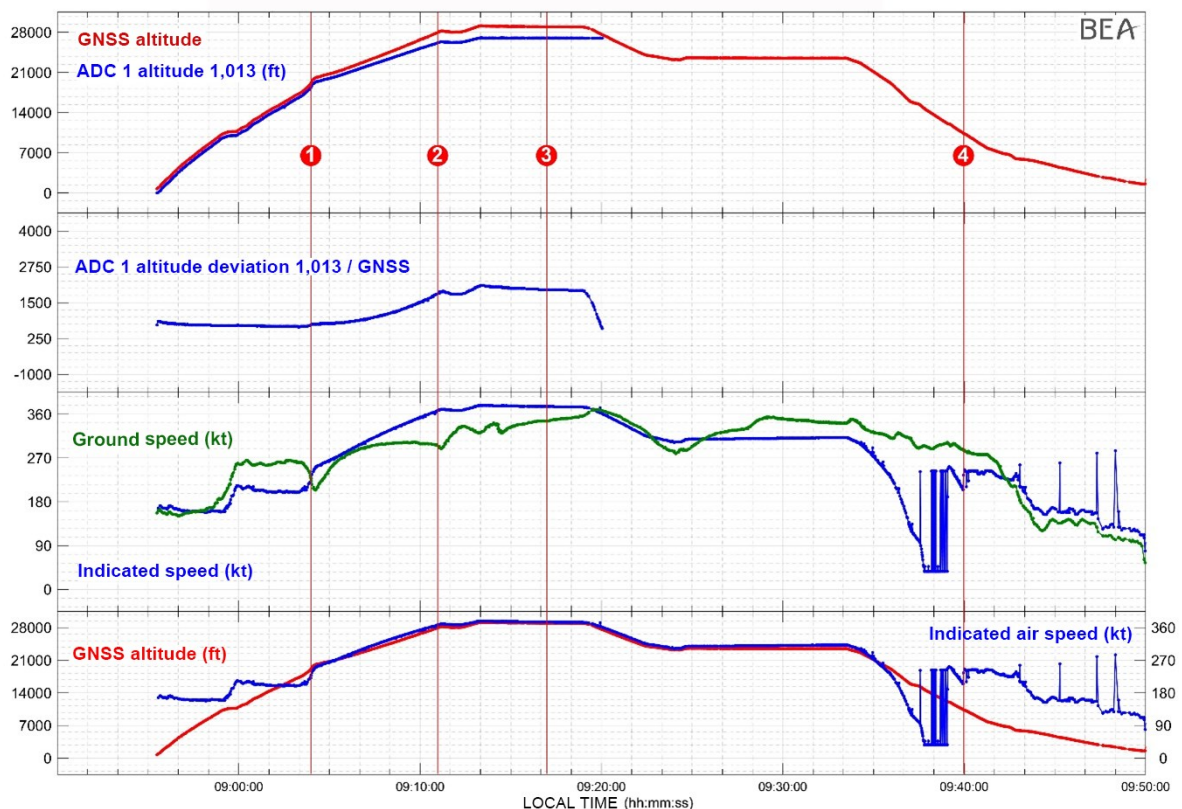
At 09:04 (see *Figure 3*, point ①), on flying through FL 185, the crew observed that the aeroplane's pitch attitude was around 20° nose up after having felt a load factor. The PF (captain) read at this point, an indicated airspeed of around 250 kt on his airspeed indicator (system 1) while the PM read an indicated airspeed of around 150 kt on his indicator (system 2). The PF disconnected the autopilot and continued the climb by selecting a customary pitch attitude of approximately 10°. He then engaged the autopilot in the vertical speed hold mode (V/S mode) to continue the climb.

- in the first part of the flight, in climb up to FL 170, there was a stabilized difference between the pressure altitude of system 1 and the GNSS altitude of around 700 ft (difference close to the QNH correction);
- from FL 180 in climb, during the en-route phase and down to FL 105 in descent, the changes in the indicated airspeed of system 1 exactly followed the actual changes in altitude (GNSS altitude) which was consistent with a blocked Pitot tube;
- the difference between the system 1 pressure altitude and the GNSS altitude reached 2,075 ft.

Figure 3: curve diagram (source of data: ADS-B)
