Incident

AAIS Case N° AIFN/0011/2021

In-flight Engine Shutdown

| Make and Model: | Boeing 777-300ER |

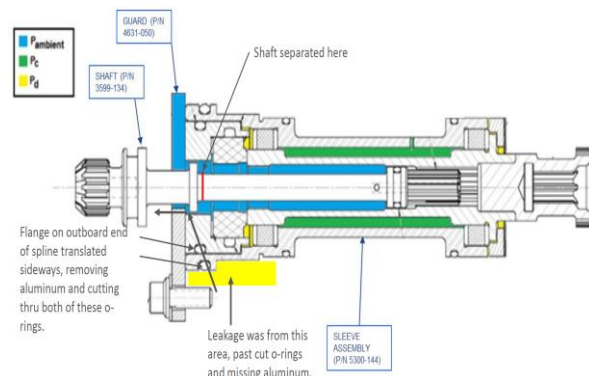
Figure 1. Description of the failure

- Accessory gearbox (AGB) hydro-mechanical unit (HMU) ball bearing damage
- The HMU quill shaft had sheared and consequently the HMU guard, sleeve, seal, housing and O-ring were damaged causing fuel leak into oil from the shaft out of HMU line of the AGB
- Fuel leak was confirmed during the HMU test (0.33 to 1.33 gallons per minute was measured). This was consistent with what happened during the flight from VGHS to OMAA. (Figure.1)

- "
- "Hard particles contamination, which were found in silver plating of the bearing cage
 - Signs of handling damage which was evident from the deformation of outer ring raceway
 - Assembly damage as the inner ring found migrated and misaligned."

According to the engine manufacture's root cause report, the handling damage was related to the AGB HMU ball bearing installation.

The analysis of the engine at the manufacturer premises indicated that both the stall/in-flight shutdown and fuel-in-oil root causes are traced to the ball bearing failure in the HMU line of the AGB. The engine manufacturer analysis of the engine revealed that the root cause of the engine failure is related to:

- Hard particles contamination, which were found in silver plating of the bearing cage
- Signs of handling damage which was evident from the deformation of outer ring raceway

- Assembly damage as the inner ring found migrated and misaligned.

The engine manufacturer subsequently revised the *FIM* to call up the correct maintenance task, to more reliably detect the imminent failure and prevent dispatch in cases where similar failures occur.
