# AIRCRAFT ACCIDENT REPORT 2/2023

Report on the accident to  
**Sikorsky S-92A, G-MCGY**  
at Derriford Hospital, Plymouth, Devon  
on 4 March 2022

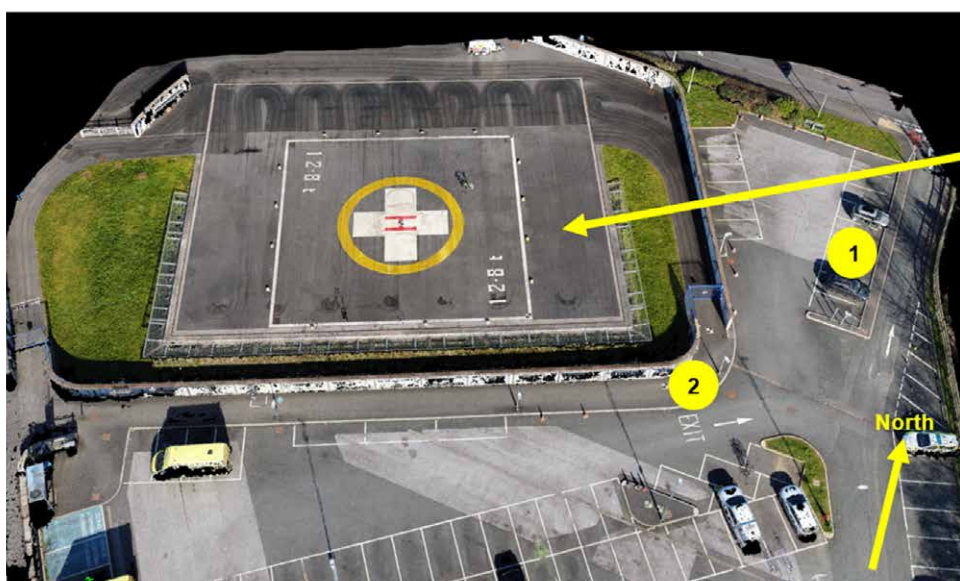
**Figure 1**

At about 200 ft agl, the winch operator was looking out the right door and told the copilot to be aware of a person in the undershoot, in the car park by some cars, that he could see (Figure 1). The co-pilot reported that he was also visual with that person. The co-pilot thought it was a man, who he believed was in the latter stages of getting into the car but assessed him as not a factor because he believed the car door would be shut before they landed. The co-pilot also believed he saw two people (one of whom he noted "had long hair"), at the south-western end of the HLS wall, walking in an easterly direction along the footpath. During this time the aircraft had about 45% twin-torque and flew with about 10° nose-up pitch attitude. This reduced to about 5° noseup as the helicopter came over the HLS.

Approximate locations of the injured persons and the direction of approach of the helicopter

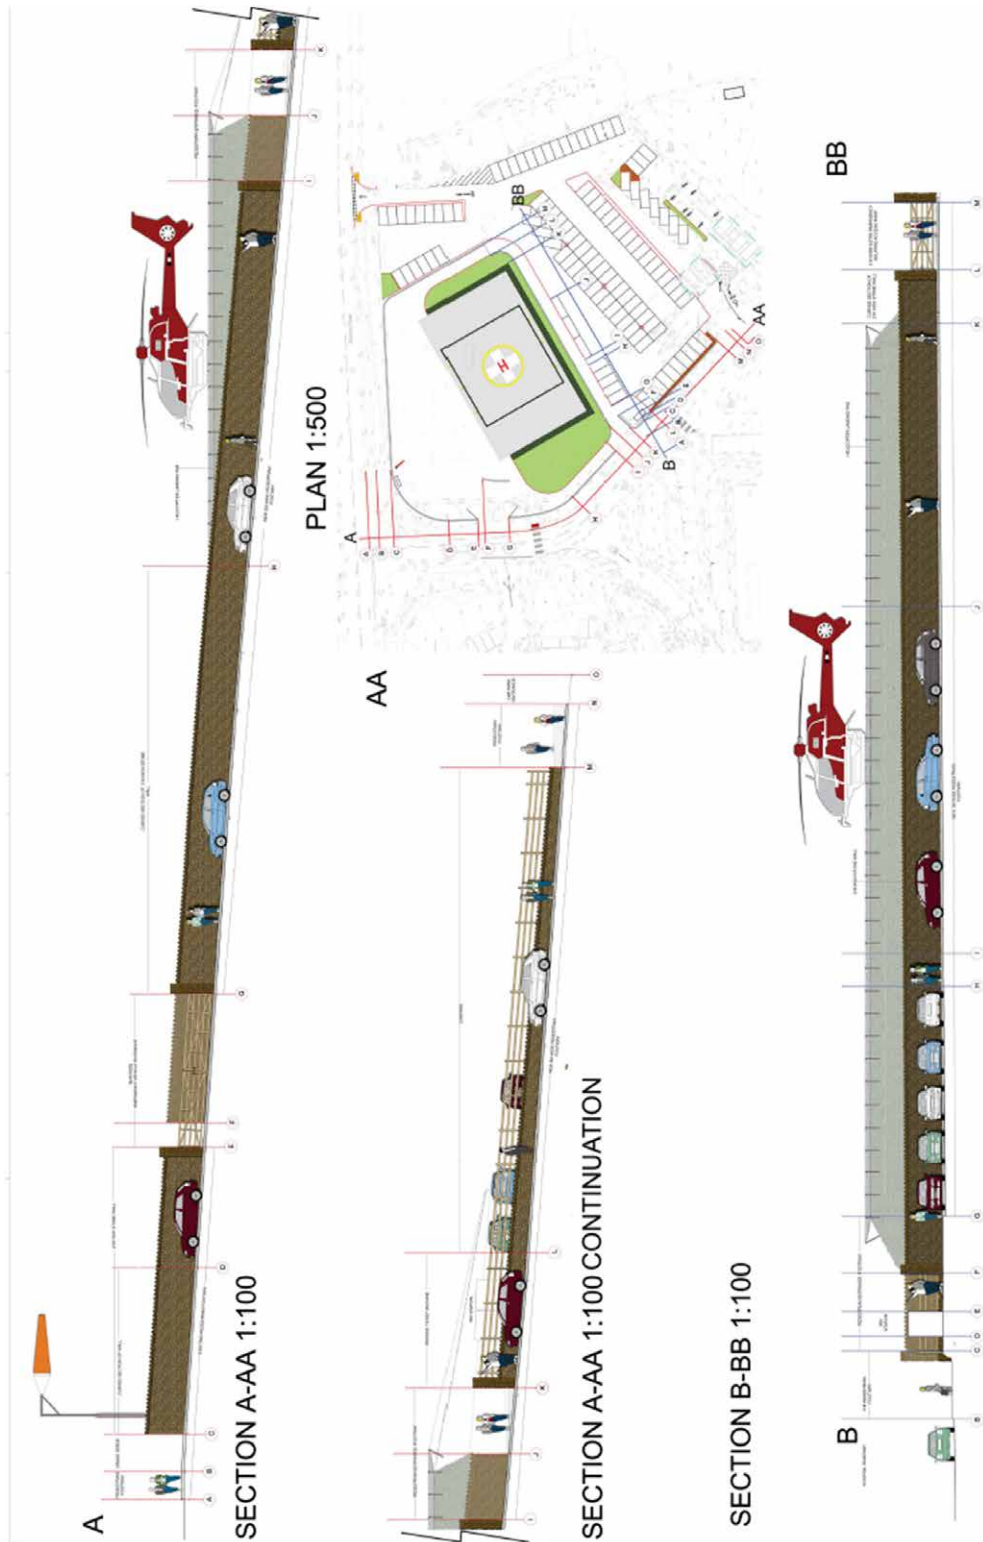
**Figure 4**

The HLS is a partially raised structure (on a mound) that was specified to be able to accept helicopters with a maximum weight of 12,800 kg or a maximum Dvalue of 21 m. This is sufficient for HEMS and SAR type helicopters including the S92 and AW189. The HLS is separated from the car park by a perimeter wall and access for hospital staff is through one of two lockable gates in the southwest and southeast corners of this wall. If required, road vehicles can access the HLS through a lockable gate in the west side of the wall. Figure 4 shows plan and elevation views of the HLS.

Plan and side elevations showing the adjacent footpath in Car Park B and the locations of the HLS access gates. (Used with permission)

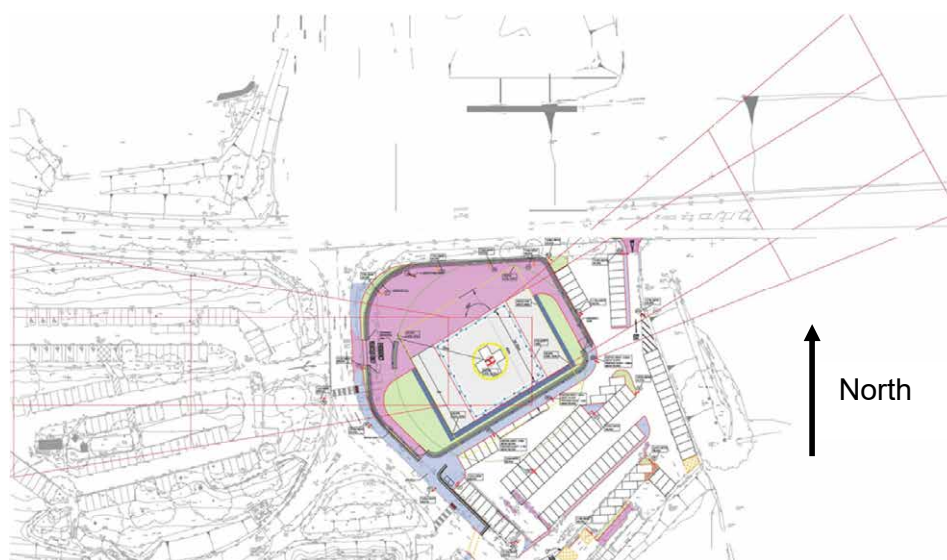
**Figure 5**

International guidance<sup>16</sup> indicated that elevated heliports should have at least two approach and departure flight paths separated by no less than 150°. The designated flight paths for the DH HLS have tracks of about 090° and 240° and are shown in Figure 5. They both pass over hospital car parks.

Approach and departure flight paths designated by DH in its guidance to operators

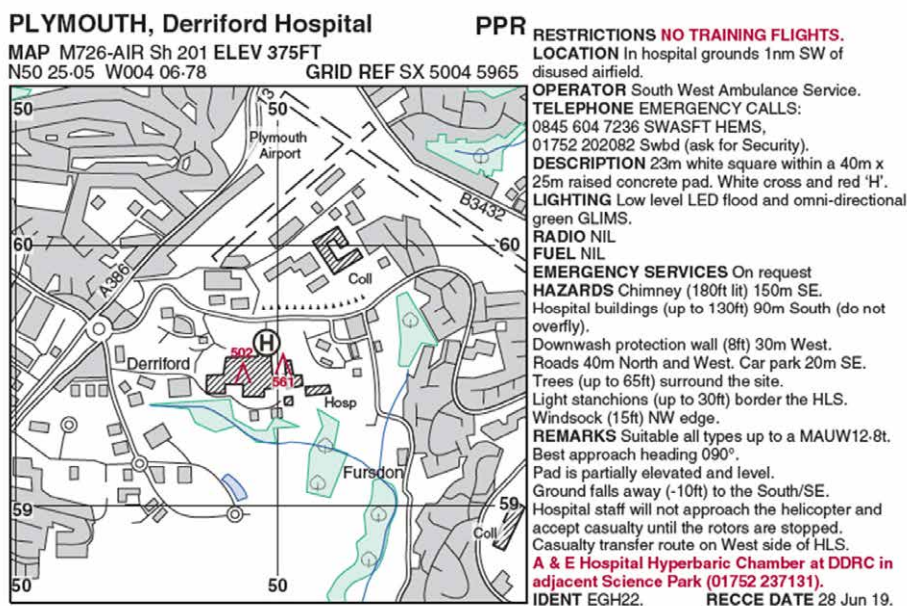
Figure 6

Among the hazards listed in the entry for DH were; '*Downwash protection wall (8ft) 30m West. Roads 40m North and West. Car park 20m SE*'.

While it stated, '*Best approach heading 090*', there was no reference to the south-westerly flight path as shown on Figure 5.

No 1 AIDU *Helicopter Landing Sites - Hospitals United Kingdom* entry for DH

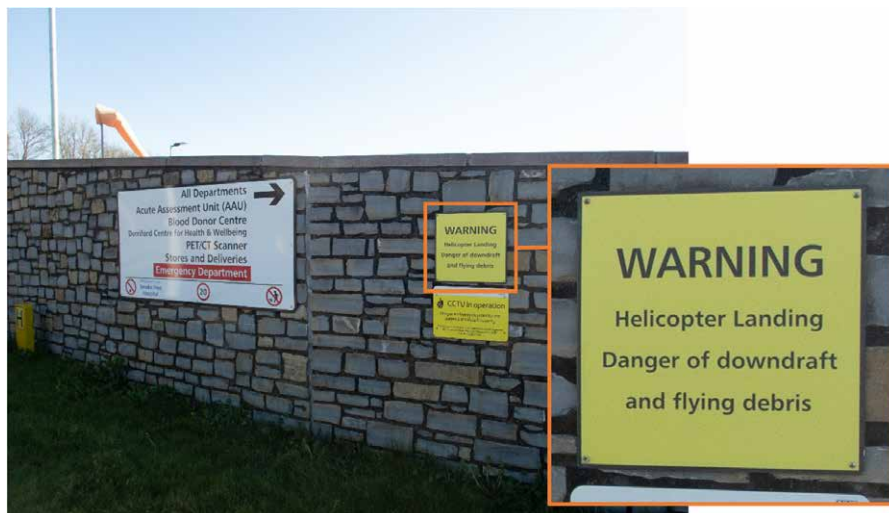
**Figure 8**

Warning sign on the perimeter of the HLS

These safety signs were not installed when the helipad opened. DH reported they were installed at a later date as part of the action taken in response to downwash complaints and incidents. The timeline and decision process were not documented in the risk assessment or post-incident investigation documentation that were provided to the AAIB.

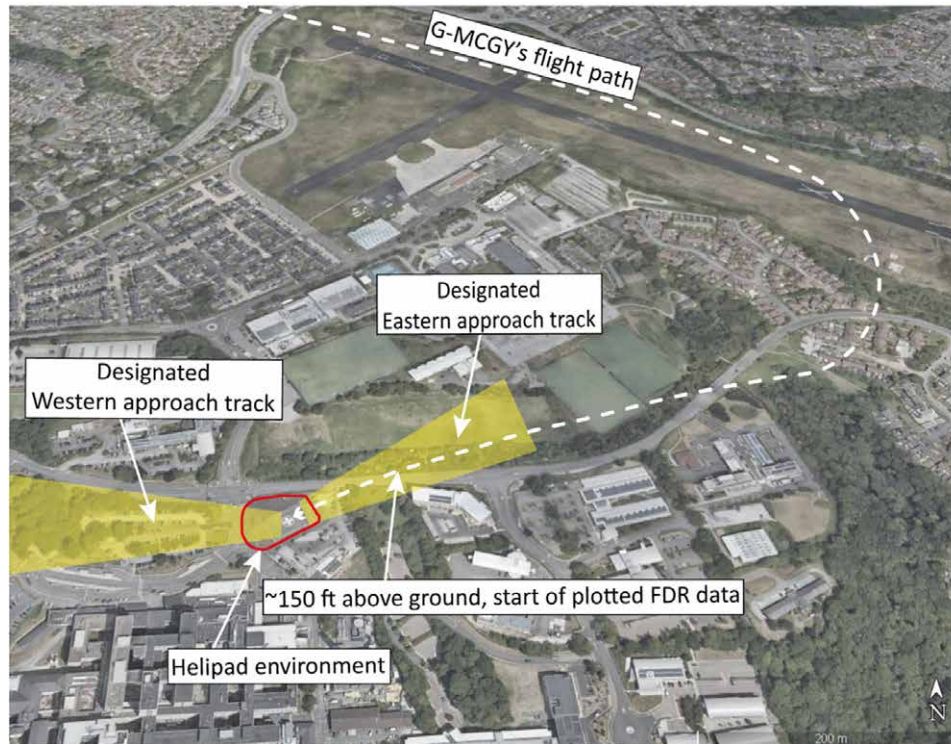
**Figure 11**

The flight data for this period showed that, as the helicopter passed over Pedestrian 1 (Figure 1), G-MCGY was approximately 50 ft agl with a groundspeed of 10 kt. G-MCGY subsequently passed abeam Pedestrian 2 at approximately 45 ft agl, with a groundspeed of 9 kt.

G-MCGY's flight path during the approach to DH

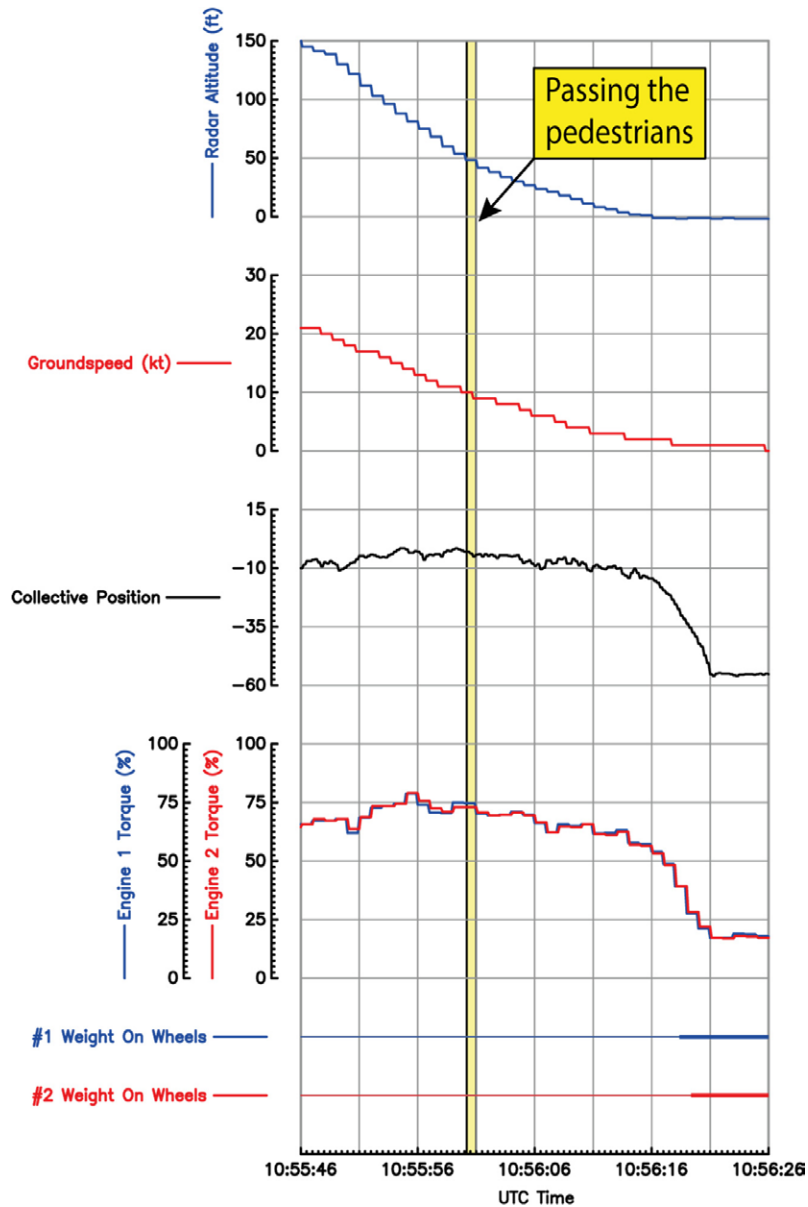
**Figure 12**

Flight data for G-MCGY's final approach and landing

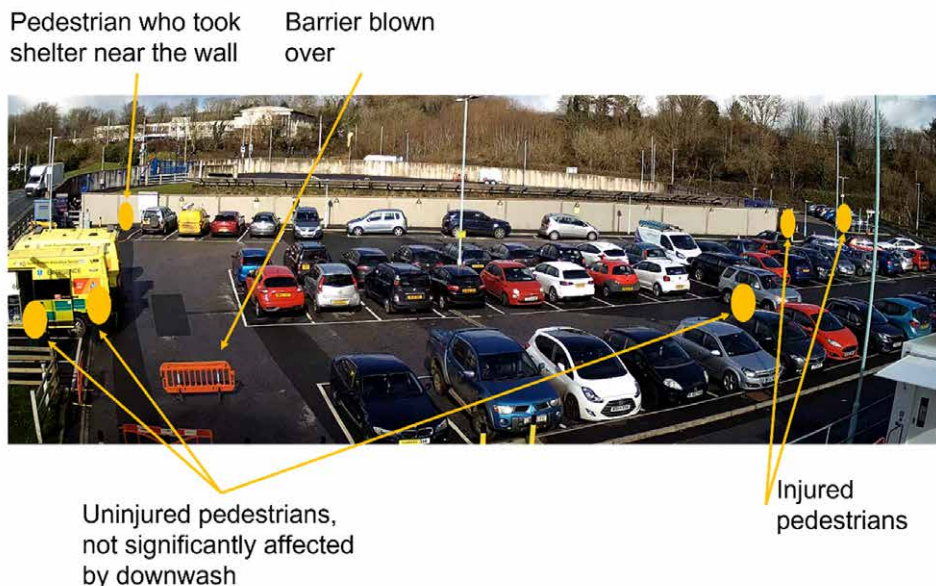
**Figure 13**

In a five-minute sample of CCTV containing the accident arrival, 27 people were observed walking in Car Park B. In this sample, several people stopped and watched the helicopter. A long-haired lady, walking on the footpath on the south side of the HLS, appeared to take shelter from the wind near the wall before running to assist those who had been blown over. Litter and a barrier in the car park were disturbed. Figure 13 shows the positions of people in Car Park B a few seconds before the injured people were blown over.

CCTV image showing positions of people in Car Park B a few seconds before the helicopter landed (looking north)

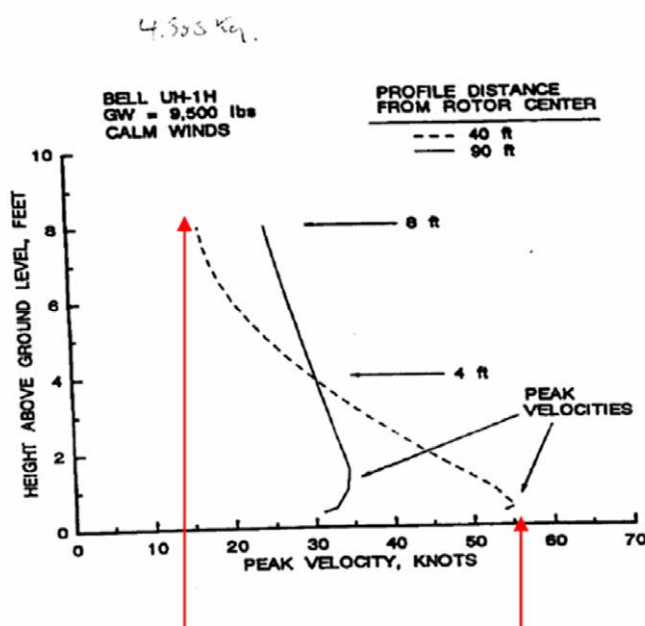
Figure 15

the ground would create downwash with a peak velocity of 55 kt (28.3 m/s) at a distance of 40 ft (12.2 m) from the centre of the main rotor. The report stated that this would reduce to 15 kt (7.7 m/s) if the helicopter hovered approximately 8 ft (2.4 m) above the ground. The report did not mention that the same graph indicated that at this height, the peak wind speed would be greater (approximately 13 m/s) at a distance of 90 ft (27.4 m) from the centre of the rotor.

Extract from the feasibility report  
(red arrows highlighted specific wind velocities in the report)

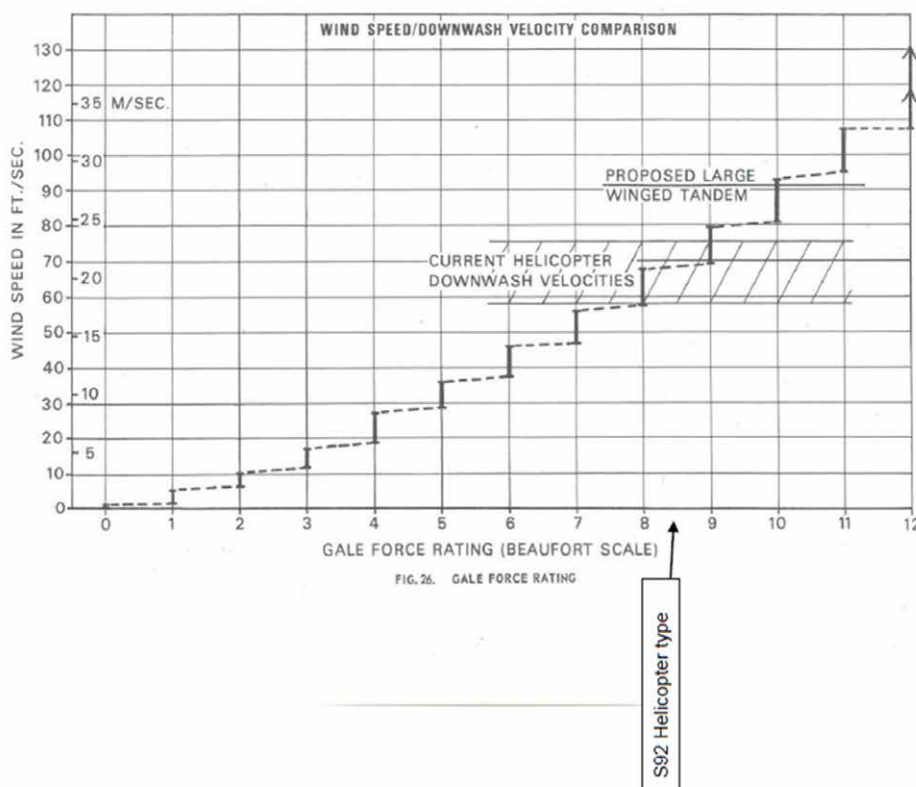
**Figure 16**

The report stated that military and coastguard type helicopters up to 12,800 kg would generate larger downwash velocities and another scanned and annotated graph (Figure 16) indicated that the S92 could cause wind speeds of 42.8 kt (22 m/s) which is equivalent to gale force 8 to 9 on the Beaufort wind force scale.

The report concluded that the effects of downwash '*on persons or property underneath the flight path will be little more than the effects normally experienced on a gusty, very windy day.*' It stated that approach and departure profiles are designed so that the helicopter can land on the HLS in the event of an engine failure, which entails a steeper than usual approach or a vertical takeoff to a decision point between 120 ft and 200 ft above the HLS. It also stated that '*the most significant effects of down wash will be confined to the helipad itself.*'

Extract from the feasibility report highlighting S92 downwash

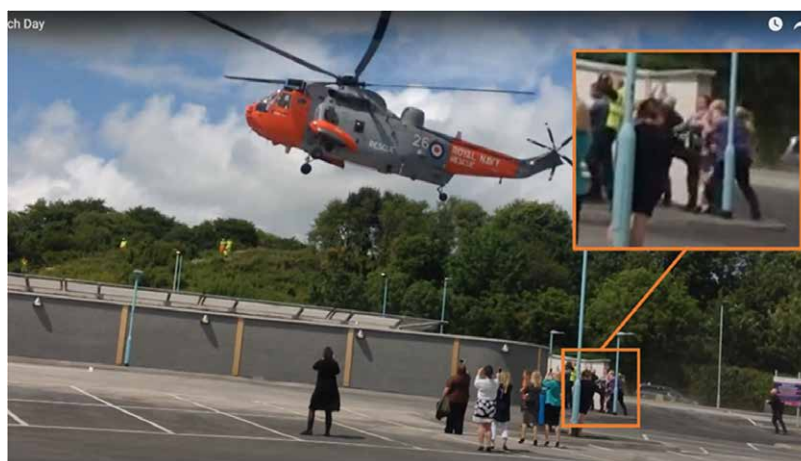
**Figure 17**

A video<sup>24</sup> of the first landing on the new HLS shows people standing close to the place where the fatal injury occurred who were affected by the downwash to the extent that they had to hold on to each other for support (Figure 17). This first landing was a Sea King helicopter, which is lighter than G-MCGY was on the day of the accident.<sup>25</sup>

Still from internet video showing people affected by downwash on the opening day of the HLS

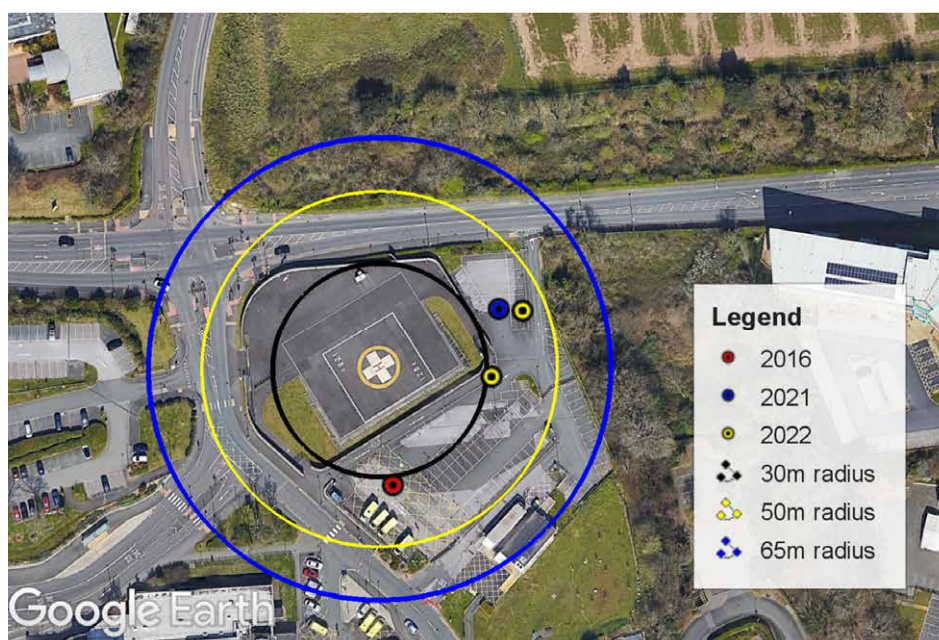
**Figure 23**

In 2016 a pedestrian was injured when she was blown over in Car Park B as a S92 helicopter was landing. Another was blown over in 2021 when a HEMS type helicopter was landing. These occurrences also indicate that the risk from downwash applies to all helicopter types and, whilst most landings at Derriford are uneventful, it is possible that other occurrences and near misses have not been reported.

Figure 23 shows an aerial view of the Derriford HLS. It shows the approximate positions of all the pedestrians that are known to have been blown over and the three circles show the extent of downwash zones with radii of 30, 50 and 65 m. Most of Car Park B is inside the downwash zone for a large helicopter, as described in CAP 1264. All the pedestrians were inside this zone when they were blown over.

Approximate pedestrian positions and downwash zones defined in CAP 1264  
© 2022 Google
