Serious incident to the BOEING - 737 - 800 registered 7T-VJM

on 6 December 2019

at Paris-Orly (94)

Loss of altitude during go-around

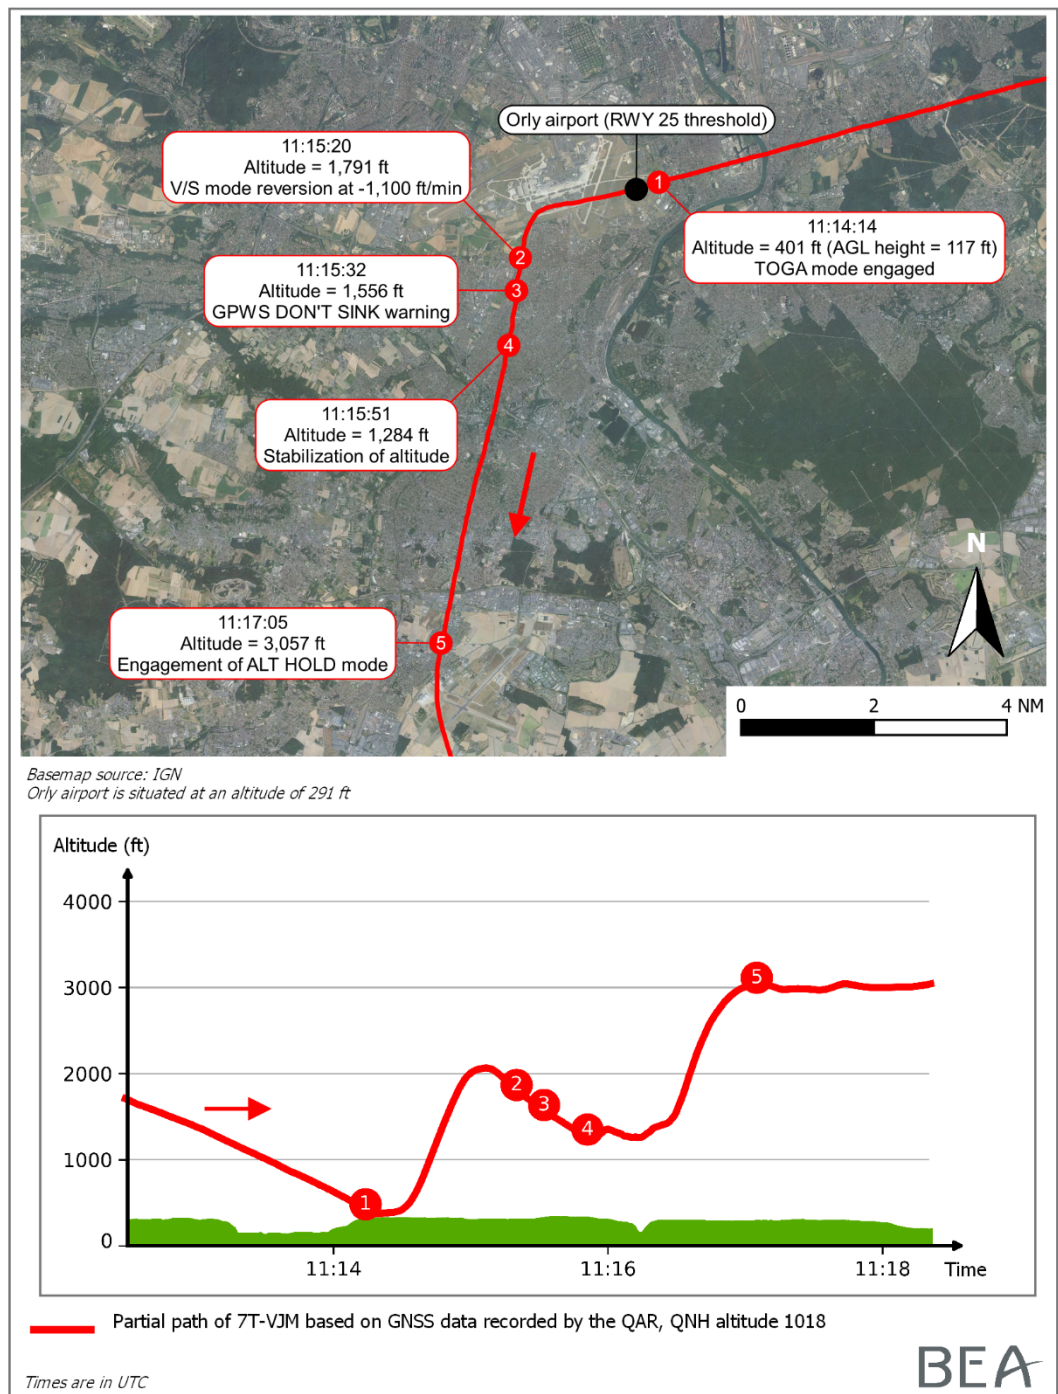
At 11:14:14, at an altitude of 401 ft and a height of 117 ft, the crew engaged the TO/GA mode by pressing the TO/GA button on the power levers (point ❶ in [figure 1](#) below) and set a nose-up attitude. As the A/T was not manually armed after being disengaged, it did not engage itself and the crew manually pushed forward the power levers to a position corresponding to around 90 % of N1. The aeroplane reached a minimum radio altimeter height of 73 ft before regaining altitude. The MASTER CAUTION light came on for twelve seconds⁽³⁾. The engine thrust and the automatic increase in the nose-up trim, despite the nose-down inputs on the control column⁽⁴⁾, increased the pitch to 18°, slightly above the Flight Director (F/D) horizontal bar (15°). The vertical speed quickly increased up to 4,000 ft/min.

With a nose-up attitude of 4.0° and around 65 % of N1, the altitude started to decrease and the speed to increase. At 11:15:15, the horizontal command bar of the F/D gave a nose-up cue to reach around 10° pitch. The pitch attitude remained below 5° and the plane came out of the turn on a heading of 200°. The altitude was around 1,900 ft and the vertical speed in descent was more than 1,500 ft/min. At the same time, the controller asked the crew to climb to 3,000 ft and to turn to heading 160°. The crew modified the altitude selection on the MCP which resulted in the transition from the ALT ACQ vertical mode to the Vertical Speed (V/S) hold mode, the target vertical speed being the speed when the mode changed, i.e. 1,100 ft/min in descent (point ❷). After this mode reversion, the crew followed the F/D command bar cues which kept the plane in descent. The engines were at 45 % of N1 and still decreasing.

At 11:15:34, the crew read back the altitude of 3,000 ft again at the controller's request. The crew disengaged the A/T and progressively increased the thrust to 50 % of N1. At the same time, the "DON'T SINK"⁽⁶⁾ alert was activated. The aeroplane was at an altitude of 1,556 ft, a height of 1,260 ft with a vertical speed in descent of 1,200 ft/min (point ③). At 11:15:37, the crew engaged the A/T in MCP SPD mode again with a target speed of 175 kt. A few seconds later, the controller told the crew that he could see the plane descending on the radar and asked them to climb to 3,000 ft. From 11:15:49, at an altitude of around 1,300 ft, the crew fully retracted the flaps, progressively increased the pitch up to 11° and thrust up to 70 % of N1 by disengaging the A/T (point ④). At 11:15:56, the stick shaker was momentarily activated and at 11:15:57, the crew reduced the pitch. The horizontal command bar of the F/D still gave a cue to take a pitch to hold a vertical speed in descent of 1,100 ft/min in V/S mode. The "DON'T SINK" alert was activated again.

Figure 1: Horizontal and vertical paths of 7T-VJM based on QAR data

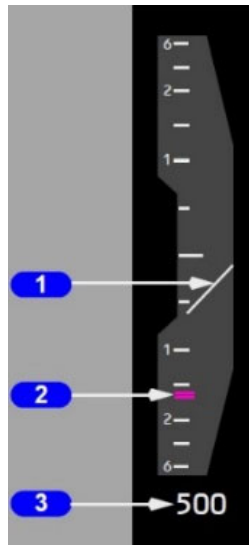
Figure 2: Vertical speed bar on B737 PFD.

- 1: actual vertical speed indicator.
- 2: target vertical speed indicator (here around -1,600 ft/min).
- 3: value of actual vertical speed.

- ☐ The display of the vertical speed target value on the PFD which may require a verification on the MCP. This may have contributed to the crew not detecting that the target value was not consistent with the desired path.
