الهيئة العامة للطيران المدني
GENERAL CIVIL AVIATION AUTHORITY

Serious Incident

AAIS Case N° AIFN/0004/2021

Smoke/Fire from Windshield Window

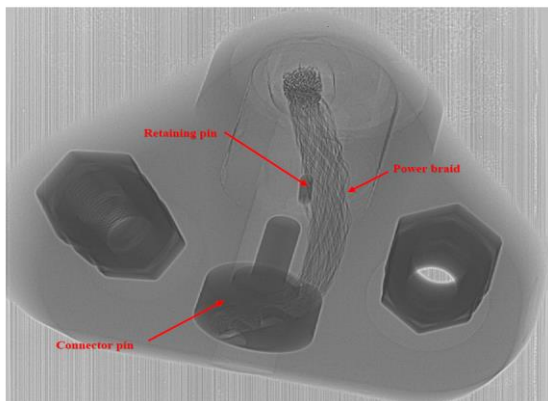
Figure 9. DR image of the terminal (J)

The X-ray digital radiography (DR) examinations were performed on windshield terminal (J) and (A) block assemblies as shown in figures 9 and 10. Parts inside the terminal (J) are the power braid wire, connector pin and retaining pin.

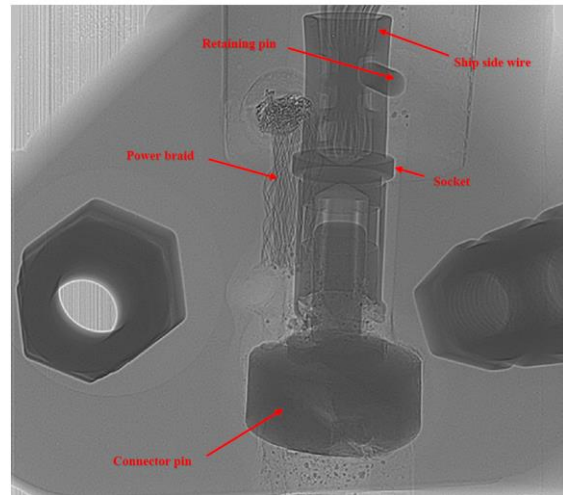
Figure 10. DR image of the terminal (A)

The part in the image of the terminal (A) shown in figure 10 are the power braid wire, connector pin, ship side wire and socket

The electrical arcing originated from the integrated power braid wire joint crimped at the connector base leading to degraded electrical conductivity within this terminal. The results from the CT scan images revealed that fractures of wire strands at a crimp point within the pin base caused the electrical resistance and heat buildup which generated electrical sparks and smoke.

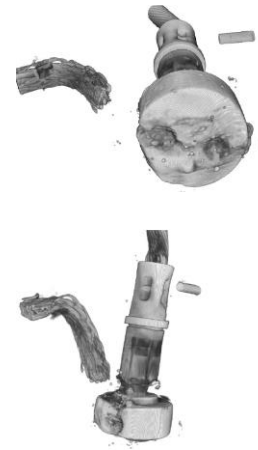
Figure 12. terminal (A) CT cross-section

The Air Accident Investigation Sector determines that the cause of the smoke and fire in the R1 window terminal block was the defective windshield thermal (anti-ice) heating electrical pin/socket terminal block consisting of a power braid wire crimped at the base pin.
