# Aviation Investigation Final Report

| <b>Location:</b> | Broomfield, Colorado | <b>Incident Number:</b> | DCA21FA085 |
| <b>Date &amp; Time:</b> | February 20, 2021, 13:09 Local | <b>Registration:</b> | N772UA |
| <b>Aircraft:</b> | Boeing 777-222 | <b>Aircraft Damage:</b> | Minor |

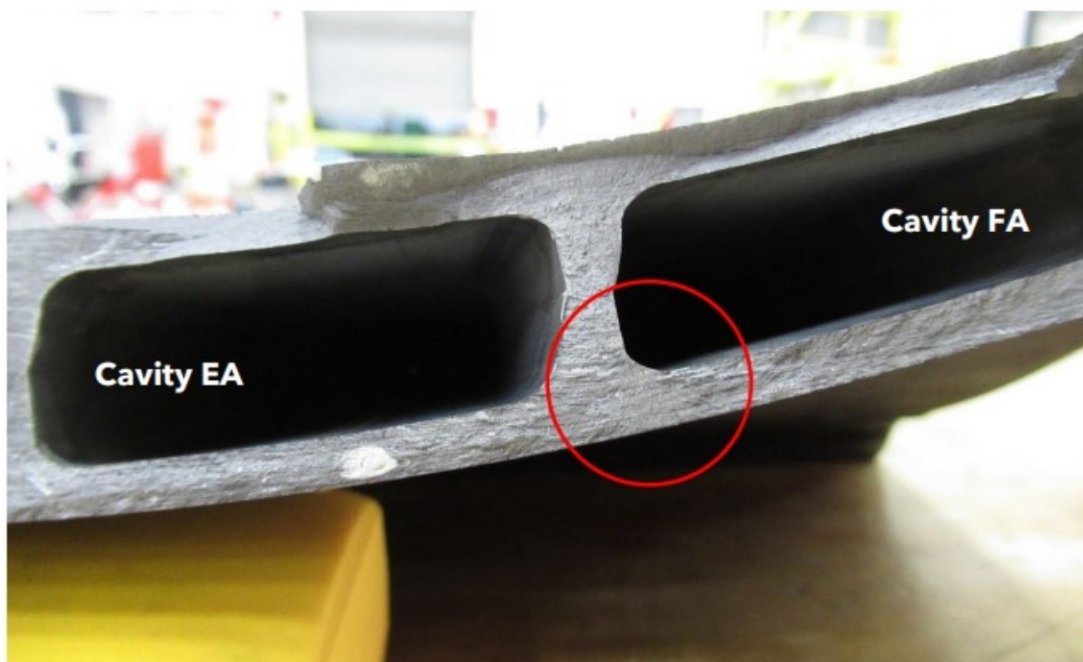
Metallurgical examination of the fractured blade was performed at the P&W Materials Laboratory under NTSB supervision. The examination revealed a fatigue crack that initiated internally about 6.6 inches above the root on the surface of an internal radius in a cavity of the hollow core fan blade. (see figure 6.) The fracture surface showed evidence of an estimated 3,150 cycles of stable low-cycle fatigue growth between 0.063 inch to 0.199 inch from the fatigue origin.

In addition to the primary fracture, multiple fatigue cracks were identified in the flowpath and midspan of the fractured blade. These secondary fatigue cracks had origins at the internal cavity surfaces, and many of the cracks exhibited multiple origins, consistent with the primary fracture. The largest of the secondary cracks had a maximum crack depth of 0.065 inch.

**Figure 6.** Closeup of fan blade No. 19 fracture surface and fatigue evidence.

Examination of the crack that led to the failure of the blade revealed a discontinuity in a local tight radius in the internal blade geometry that had been introduced during the machining and manufacturing process. A P&W technical review of the discontinuity estimated a local steady stress increase of 30% at the location, reducing the fatigue life by 50%.

Metallurgical and chemical characterization revealed that the surfaces of the internal cavities were contaminated with carbon that had diffused into the parent material. According to P&W engineers, carbon contamination of titanium can cause decreased fatigue resistance capability. It was observed that the carbon surface contamination was not present in the cavities of the blade that are sealed off during the diffusion bonding process, indicating that the contamination was introduced after the diffusion bonding process.

Following this event, Pratt & Whitney performed an immediate TAI inspection of the entire fleet before the next flight and issued a service bulletin introducing ultrasonic testing (UT) blade inspections to occur both immediately and at regular intervals. Additionally, the frequency of required TAI inspections was increased from every 6,500 cycles to every 1,000 cycles. The increased inspection interval and the immediate TAI inspection were made mandatory on April 15, 2022, when the FAA issued AD 2022-06-09. Additionally, the new UT inspection that was developed by Pratt & Whitney for the flowpath and midspan areas has shown a capability to detect small cracks that are below the threshold of detectability for the TAI inspection. The blades are now inspected by UT every 275 cycles.
