Centro de Investigação e Prevenção de Acidentes Aeronáuticos

Preliminary Report

Classification:	ACCIDENT
Type of Occurrence:	#ICE - FORMAÇÃO DE GELO #LOC-I - PERDA DE CONTROLE EM VOO
Date:	9 August 2024

Date (UTC):	9 August 2024
Time:	16:22
City:	VINHEDO - SÃO PAULO - BRASIL
Aerodrome:	OUTSIDE THE AERODROME
Local:	RESIDENTIAL AREA OF THE CITY
Damage to third parties:	YES

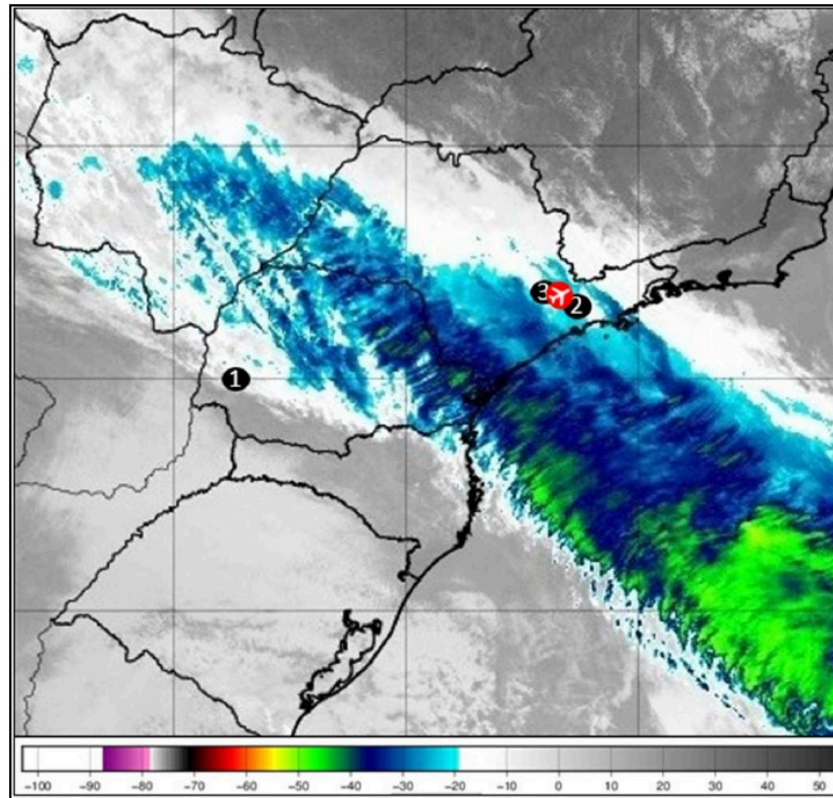
Figure 23 - GOES-16 Satellite image. Numbers show the locations of aerodromes; number "1" - SBCA; number "2" - SBGR; and number "3" - SBKP. The red circle highlights the location of the aeronautical occurrence.

Images from the Geostationary Operational Environmental Satellite (GOES) 16 on channel 13 (thermal infrared channel centered at 10.3 μm), between 14:56 UTC and 16:26 UTC on 09 August 2024, showed the presence of an extensive band of clouds over the states of *Mato Grosso do Sul* (MS), southwest of *Mato Grosso* (MT), north-central and east of *Paraná* (PR), *São Paulo* (SP) and extreme south of *Minas Gerais* (MG), as illustrated in Figure 23.

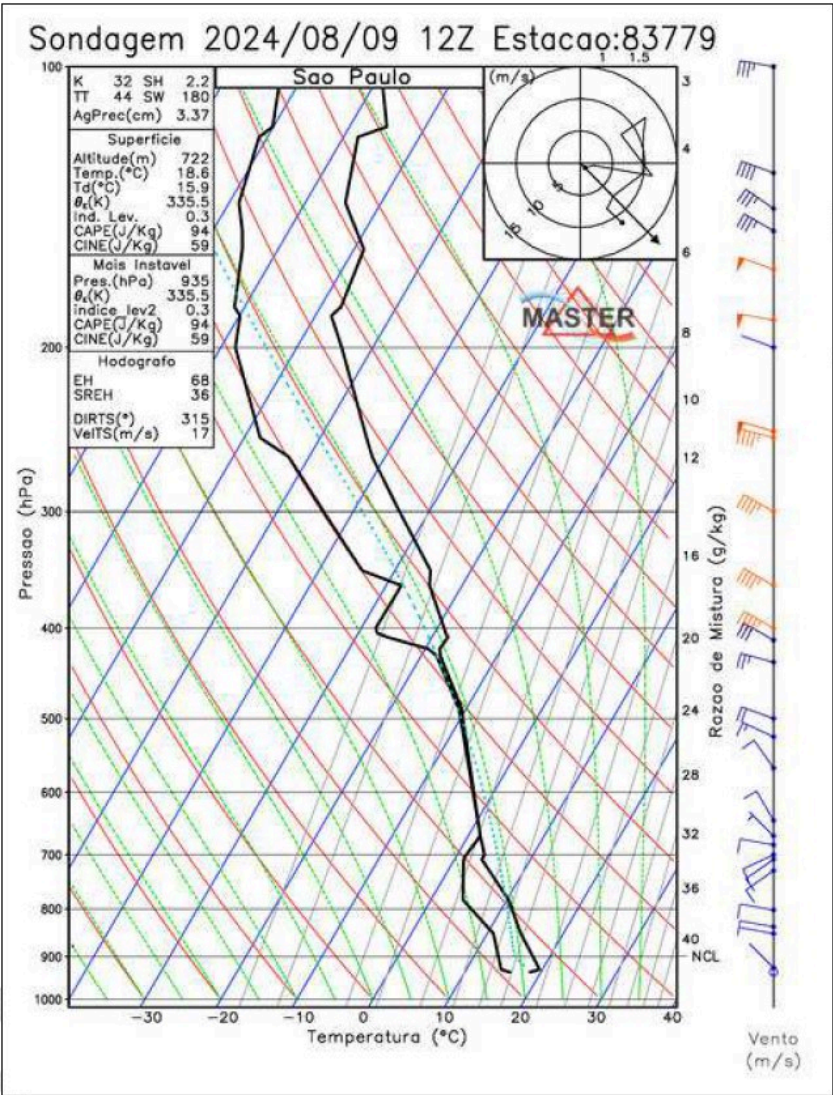
Figure 24 - Skew-T log-p diagram with winds aloft data of SBMT 12:00 UTC 09 August 2024.

From the data obtained by the SBMT EMA, it was possible to verify that the atmosphere was very humid ($T_d < 2^{\circ}\text{C}$ and the mixing ratio $> 1\text{g/kg}$) at average levels, between 670 hPa (FL110) and 420 hPa (FL230), evidencing the presence of extensive cloudiness with significant thickness.

Since the air temperature only reaches the 0°C isotherm at 650 hPa (FL120), severe High Altitude Icing (HAF) occurs between FL120 and FL230. The wind at FL170 was predominantly from the West (W) with 46 kt., and the air temperature was -9°C . A maximum wind (*jet stream*) from the West at a speed of 100 kt. was identified around 250 hPa (FL340), as shown in Figure 24.

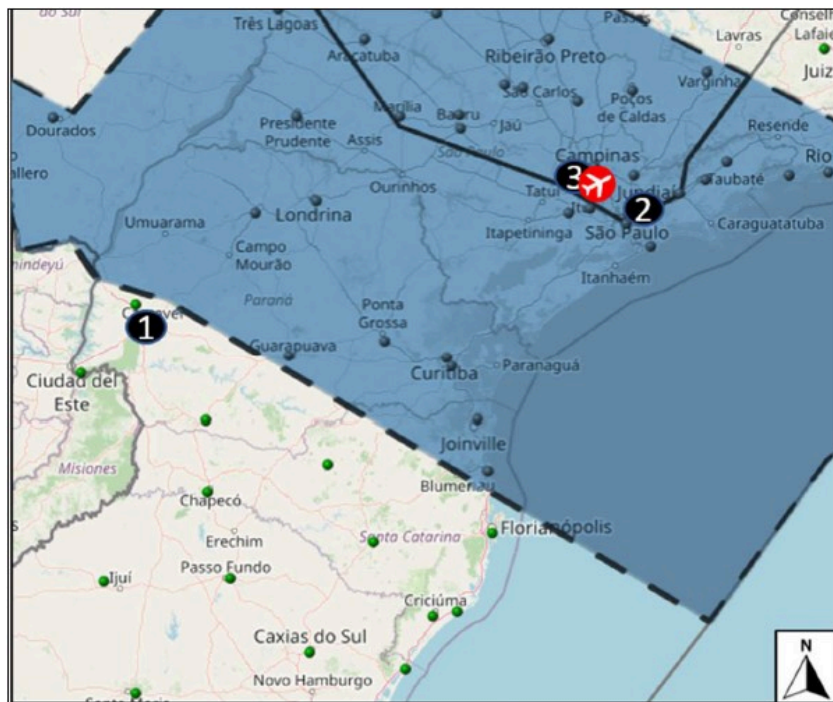
Figure 25 - Areas related to the Severe Icing SIGMET message issued for FIR-CW and FIR-BS (blue hatched highlight). Numbers show the locations of aerodromes: "1" - SBCA, "2" - SBGR, and "3" - SBKP. The red circle indicates the crash site.

SIGMET messages related to severe-icing forecast were issued on 09 August 2024 for the Flight Information Regions of *Curitiba* (CW) and *Brasília* (BS), with validity from 15:30 UTC to 19:30 UTC (respectively, SBBS SIGMET 2 and SBCW SIGMET 9), as shown in the Figure 25 below.

The referred SIGMET messages forecasted the occurrence of severe FGA (SEV ICE), with base at FL120 and top at FL210, with no apparent movement and no change in intensity, as shown below:

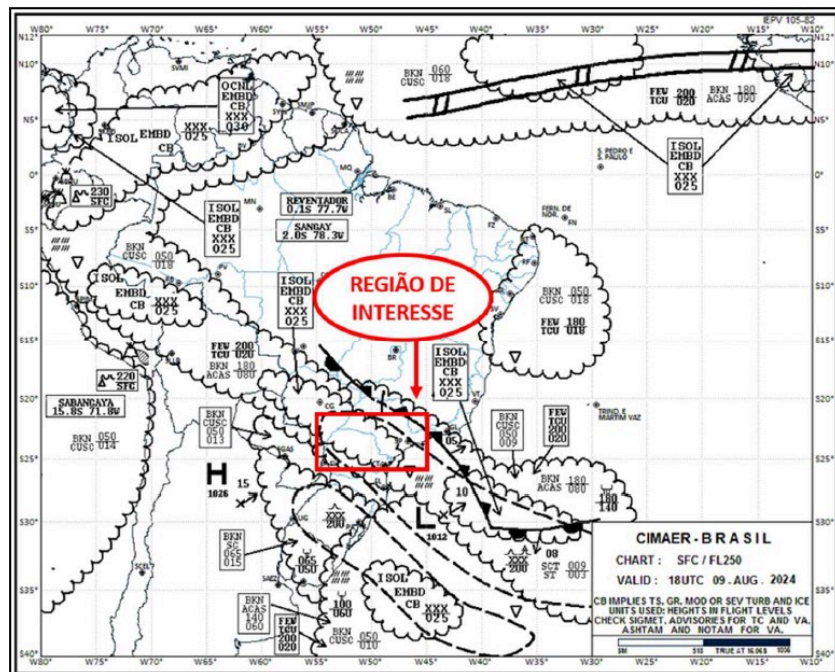
Figure 26 - 09 August 2024 18:00 UTC SIGWX from the surface to FL250. Region of interest highlighted in the red polygon.

- cold front crossing the state of São Paulo, associated with a low atmospheric pressure center of 1012 hPa located approximately at 29°S 043°W;
- TCU clouds, with base at 2,000 ft and top at 20,000 ft, covering 1 to 2 oktas sky (FEW);

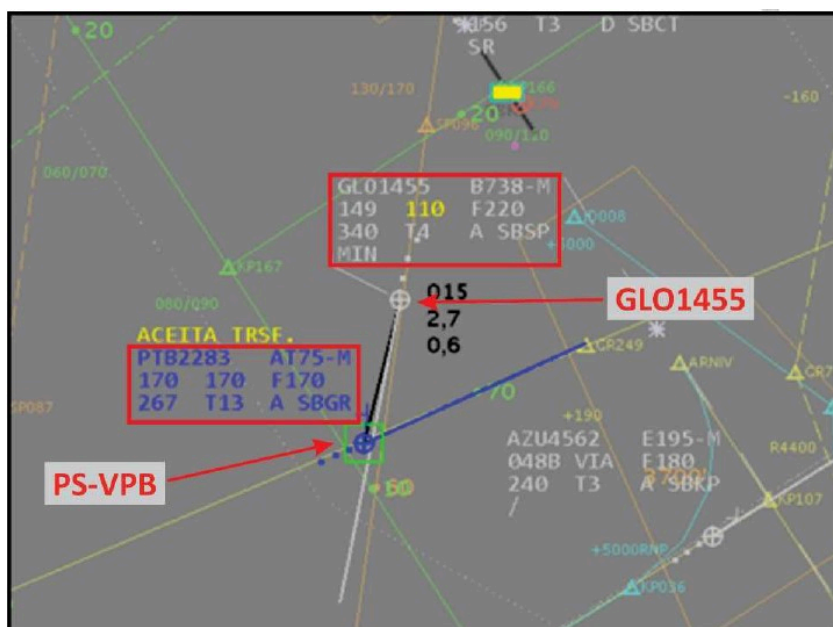
Figure 27 - RADAR rerun of the moment at which the PS-VPB had its traffic restricted by GLO 1455.

At that moment, *Passaredo 2283* was at FL170 at a distance of approximately 3 NM from the GR249 fix. There was traffic temporarily restricting their descent (GLO 1455, which was performing STAR DOSPI 1A, and was at a 10 o'clock position from *Passaredo 2283*, 2.7 NM away, heading south, and passing FL149, descending (Figure 27).

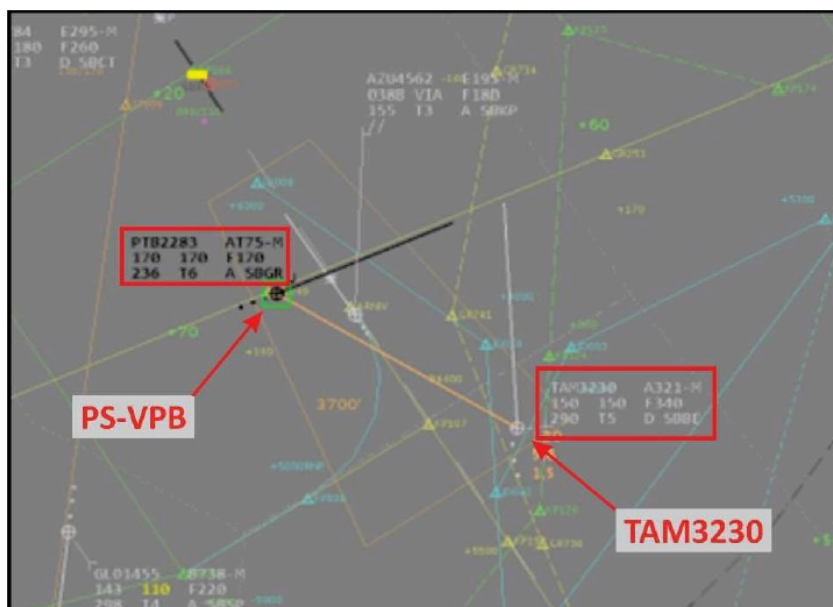
Figure 28 - RADAR rerun of the moment at which the PS-VPB had its traffic restricted by TAM 3230.

At that moment, *Passaredo 2283* was passing over the waypoint GR249, maintaining FL170, with the traffic of TAM3230 restricting its descent at the 2 o'clock relative position, distance 5.8 NM, leveled at FL150 and heading North (Figure 28).

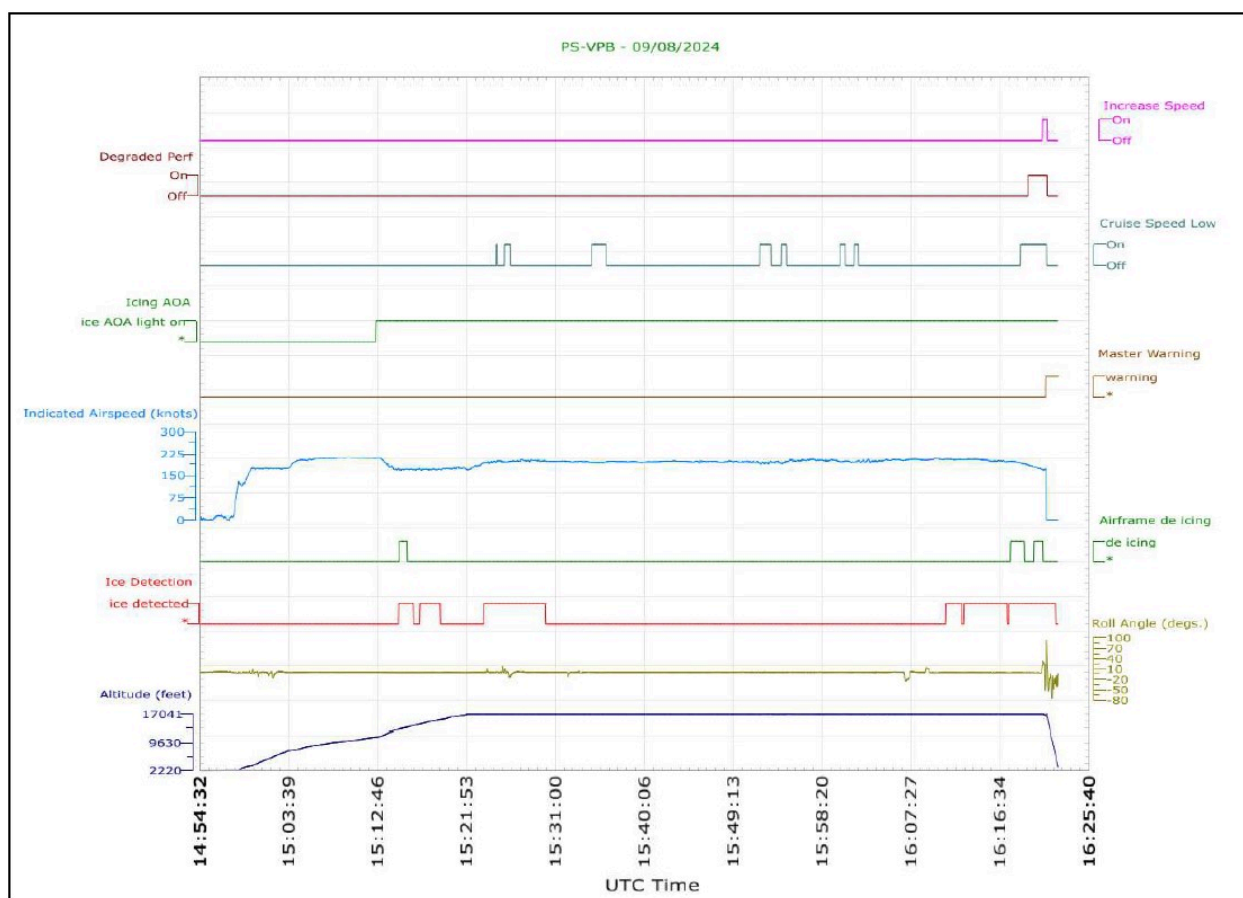
Figure 31 - Parameters collected from the FDR and analyzed by the Insight Analysis software.

Given the PS-VPB aircraft configurations, one verified that the FDAU was feeding the FDR at a rate of 128 words per second, and 313 flight hours were retrieved from the recorder.

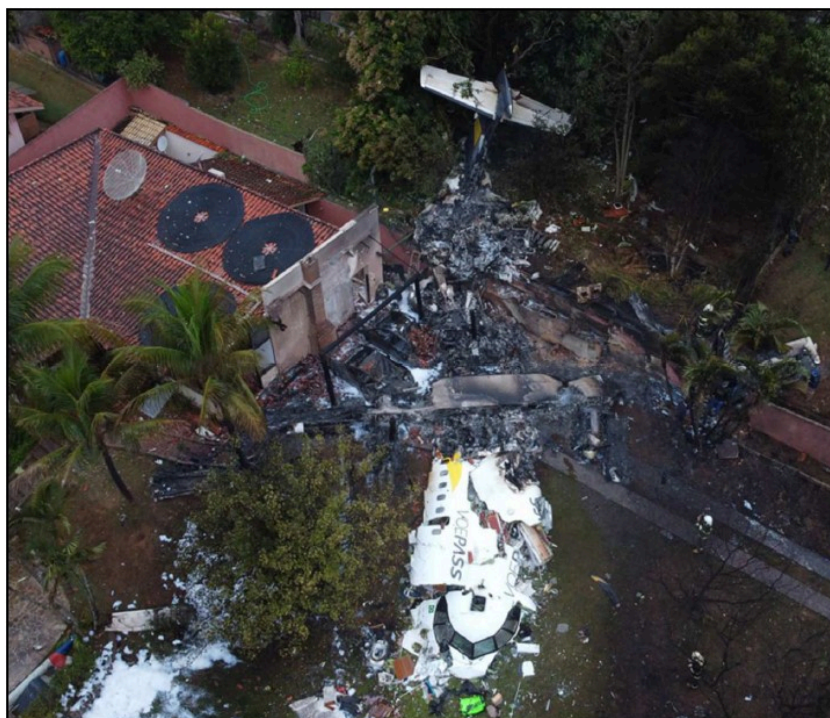
Figure 32 - Overview of the aircraft after colision with the ground and the post impact fire.

The engines remained attached to the wings, but were further affected by the post- impact fire. All the propellers were fractured due to impact with the ground. The aircraft's tail cone struck a wall and was not consumed by the fire.

The cockpit and flight instruments suffered substantial damage from the collision with the ground but were not affected by the fire.

There was no evidence of in-flight fire. The fire started immediately after impact with the ground. The burning material was the aircraft's fuel and the ignition source probably originated from the aircraft's strong friction with the ground.
