Air Accident Investigation Unit Ireland

SYNOPTIC REPORT

**Boeing 767-322ER, N670UA
Shannon Airport, Co. Clare, Ireland**

AAIU Report No: 2024-001

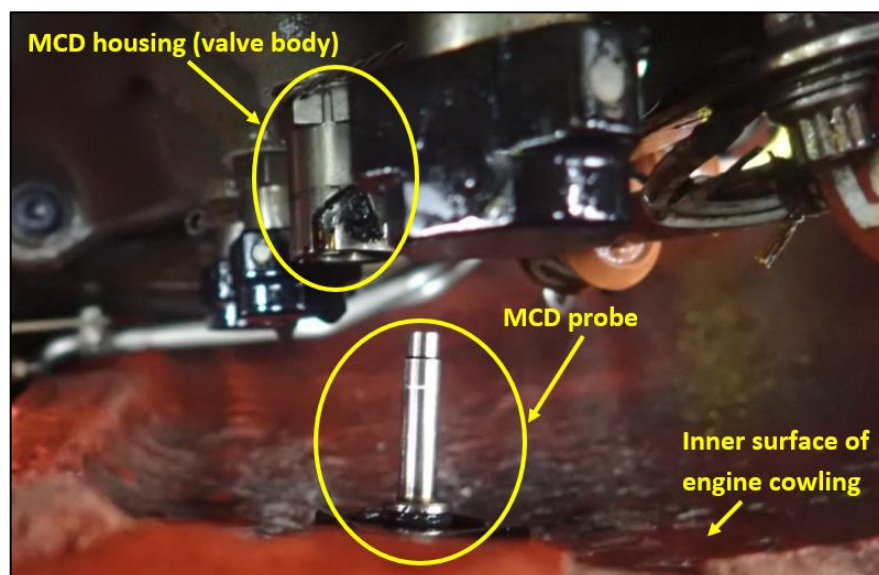
When the No. 1 engine was examined at EINN following the occurrence, the MCD probe for the engine's No. 4 main bearing scavenge line was found in an upright position in the engine cowling below its housing (valve body) (**Photo No. 1**), and there was evidence of oil in the surrounding area. The Operator informed the Engine Manufacturer of the occurrence.

Photo No. 1: MCD for No. 4 bearing on No. 1 engine as found following occurrence

9. When the No. 1 engine was inspected following the occurrence, the MCD probe for the engine's No. 4 bearing scavenge line was found in an upright position, in the engine cowling, below the MCD housing.

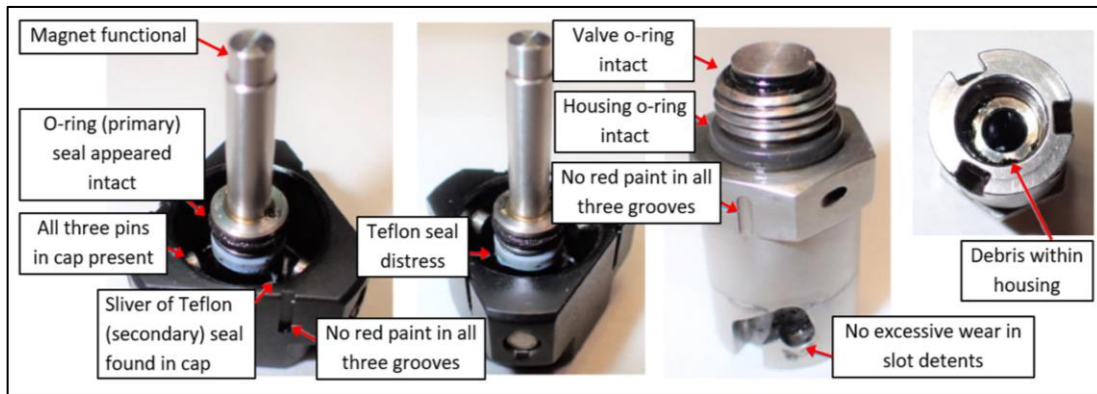
Figure No. 3: MCD probe and housing (Adapted from Engine Manufacturer's report)

The MCD housing (valve body) and probe from the No. 1 engine's No. 4 main bearing scavenge line were shipped, in the '*as found*' condition, to the Engine Manufacturer for detailed examination and testing. An '*as received*' visual review report was prepared by the Engine Manufacturer (**Figure No. 3** refers).

The report noted the following points in relation to the MCD probe:

- All three locking pins were present.
- The o-ring (primary) seal appeared intact.
- A sliver of Teflon® (secondary) seal was found within the grip of the probe.
- There was distress on the Teflon® seal on the side opposite the liberated sliver.
- There was no red paint in the three alignment grooves.
- The magnet was functional.

The following points were noted in relation to the MCD housing:

- The o-ring on the spring-loaded valve appeared intact.
- The o-ring that provides a seal between the housing and the engine appeared intact.
- There was no red paint in the three alignment grooves.
- Debris was present within the housing.

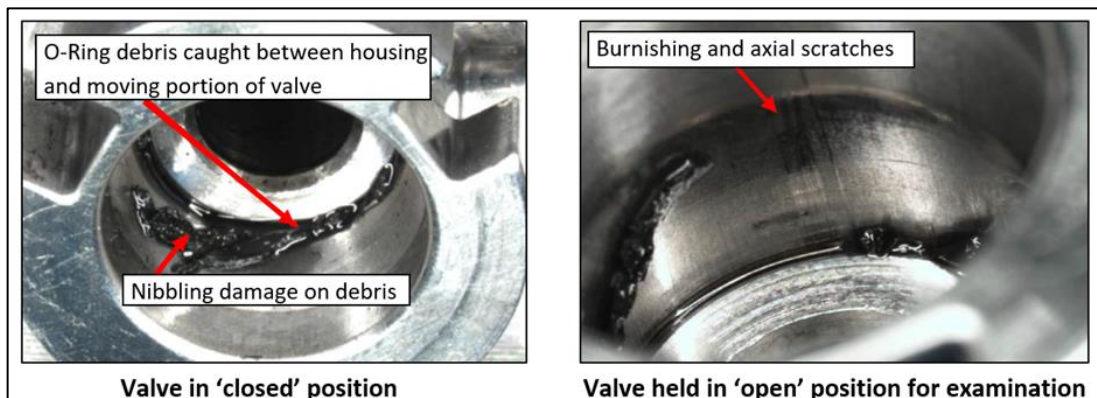
Several anomalies were identified on further examination by the Engine Manufacturer (**Figure No. 4**), including 'nibbling' damage to the o-ring (primary seal) fitted to the probe, in addition to the damage to the Teflon® seal already noted. Nibbling damage was also found on the debris within the housing. The Engine Manufacturer considered that the 'nibbling' damage on the debris in the housing 'suggests that it [the debris] was moving relative to the housing'. The debris within the housing was caught between the housing and the moving portion of the spring-loaded valve. It was noted that the amount and size of the debris recovered from the housing was 'greater than the missing material from [the] worn o-ring', and that the o-ring on the MCD probe and the debris were not the same material (probe o-rings are not all manufactured from the exact same material). When the valve was held in the open position for the purpose of the examination, 'burnishing [polishing/evidence of rubbing] and axial scratches' were identified on the housing wall in the valve operating area, which the Engine Manufacturer considered to be 'indicative of interference between the housing and the moveable valve'. In addition, scuff marks were found on the side of the shank of the probe.

Figure No. 4: Debris within the housing, and burnishing and axial scratches (Adapted from Engine Manufacturer's report)

The Engine Manufacturer's examination also noted that rubber debris that exhibited nibbling damage was observed to be caught between the housing and the moving portion of the spring-loaded valve. The Engine Manufacturer carried out an X-Ray examination of the housing and probe, with no adverse findings. The Engine Manufacturer sectioned the valve to permit disassembly. The sealing o-ring on the valve was found to be in good condition with no obvious wear observed on the spring or on the body of the valve; however, rubber debris was found on the valve spring coils.

The Engine Manufacturer's examination of the housing with the valve held in the open position for the purpose of the examination found burnishing and axial scratches on the housing wall, which the Engine Manufacturer deemed to be indicative of interference between the housing and the moveable valve. Any interference could adversely affect the closing of the valve, in the event of a migrated probe. However, the Engine Manufacturer considered the most likely scenario was that the MCD probe had been in a partially installed position due to lack of spring force from the self-closing valve as a result of debris. The Engine Manufacturer suggested that engine vibration caused the partially installed MCD probe to migrate and become liberated from the housing, while the debris in the valve caused the valve to remain partially open and permit oil leakage.

20. The amount and size of debris within the housing was greater than the missing material from the o-ring on the probe and was not of the same material which is suggestive of o-ring damage during a previous installation of the MCD probe.

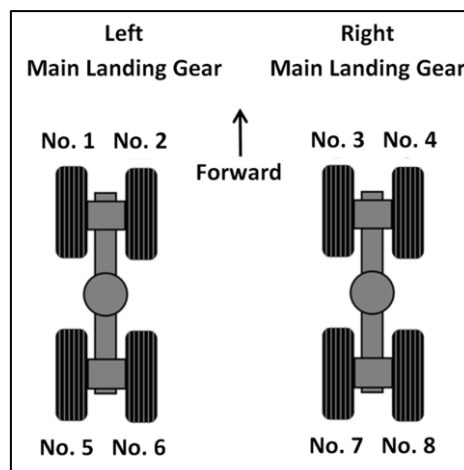
Figure No. 5: Wheel and brake unit numbering convention

The Flight Crew subsequently reported in the aircraft's technical logbook that they had received a Brake Temperature warning and that there was a brake temperature of '9' at the 'left truck/left rear wheel' (the No. 5 position as shown in **Figure No. 5**).

The left main landing gear was inspected by the Operator's maintenance personnel in the presence of the Investigation. Excess lubrication grease was evident at several of the lubrication points and brake dust was also present; however, there was no visible evidence that a fire had occurred. Based on the reported fire and the entry in the aircraft's technical logbook, maintenance personnel replaced the No. 5 wheel and brake unit. Subsequently, following clarification from the AFRS regarding the exact location of the observed fire, maintenance personnel inspected the No. 6 main wheel and brake unit, and found no defects.
