**Serious incident** between  
the AIRBUS A320  
registered **OE-INE**  
and the Robin DR400  
registered **F-GTZY**  
on 31 December 2022  
at Bordeaux-Mérignac airport

## SAFETY INVESTIGATIONS

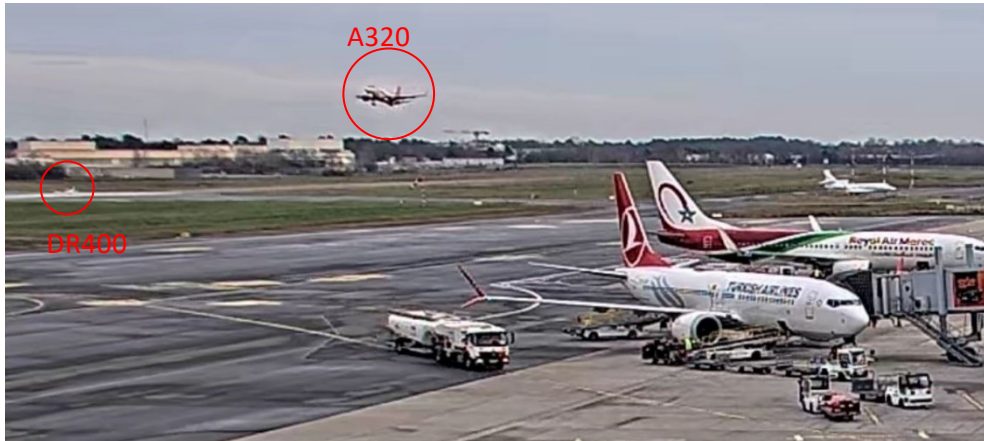
Figure 2: video footage from Bordeaux airport showing the two aeroplanes

Immediately after the end of the radio message, the crew of the A320 flew a missed approach. At this point, the aeroplane was at a height of 133 ft, at 525 m from the threshold of runway 23. Due to the inertia of the aeroplane, the height decreased to 103 ft, at around 260 m from threshold 23 (see Figure 3, point 7) and then quickly increased. The A320 flew over the DR400 at a height of 178 ft (see point 8). The pilot of the DR400 saw the A320 fly over him and observed the retraction of the landing gear.

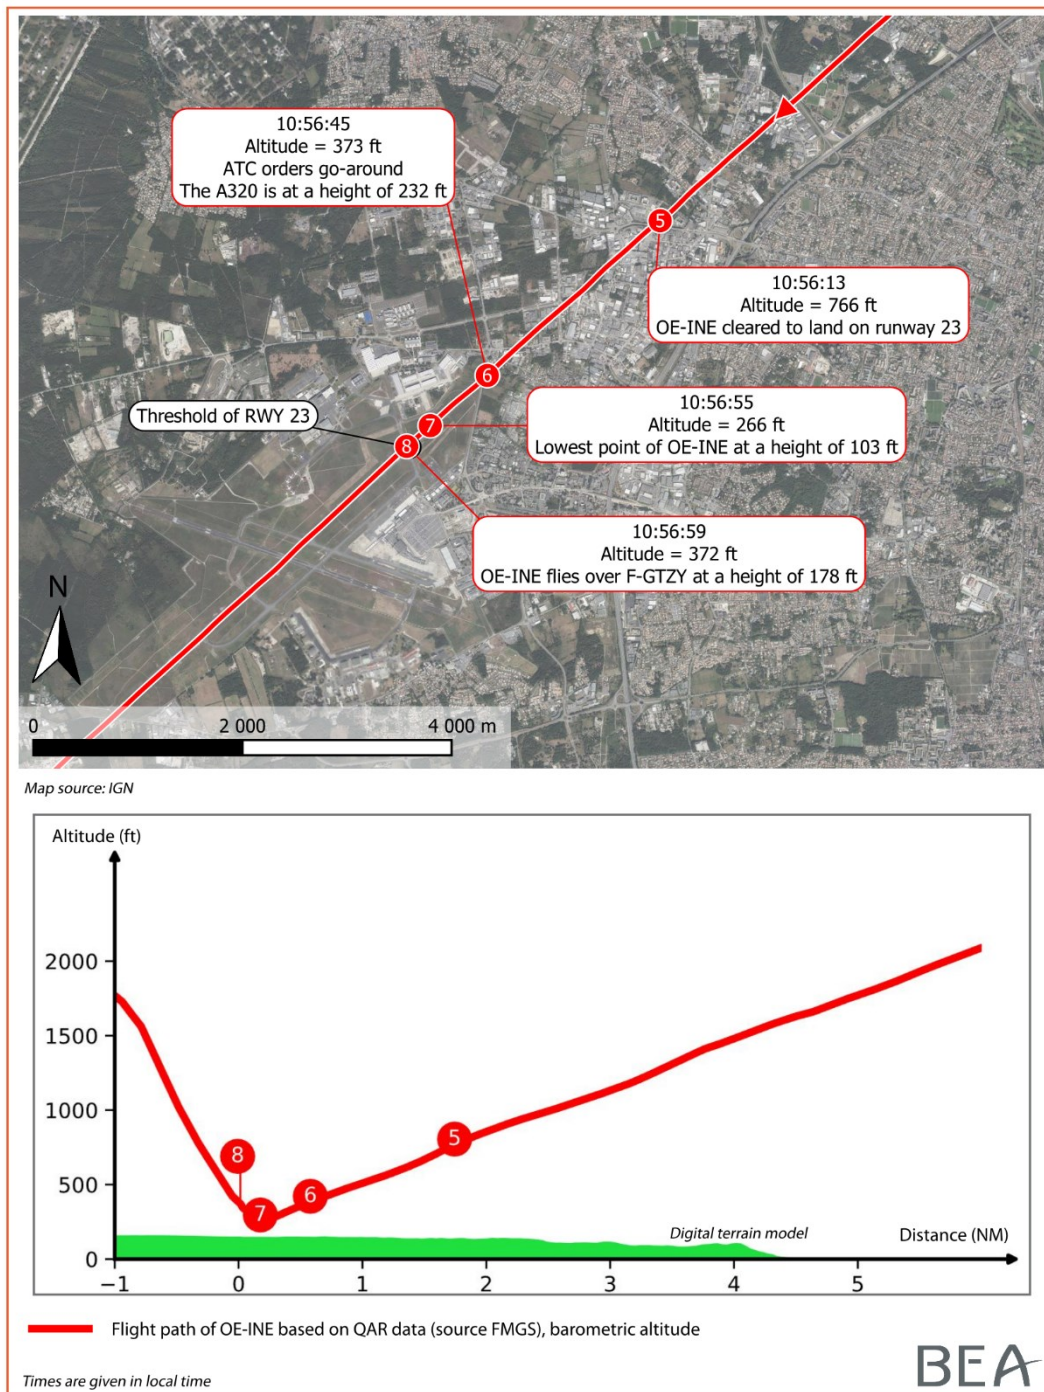
Figure 3: final flight path and go-around of A320

At 10:56:45, controller A instructed the crew of the A320 to go around, “*Remise de gaz euh Alpine 49QH immediately go around go around aircraft on runway.*” At this point, the aeroplane was at a height of 232 ft, at 1,000 m from the threshold of runway 23 (see Figure 3, point 6).

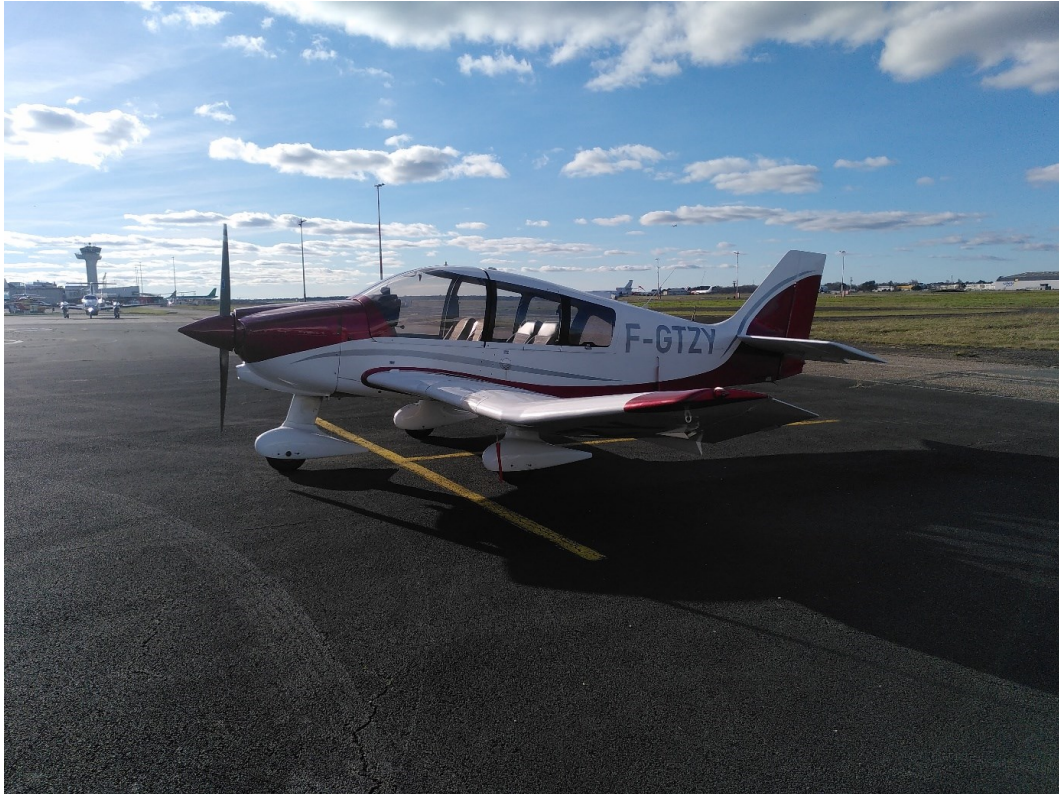
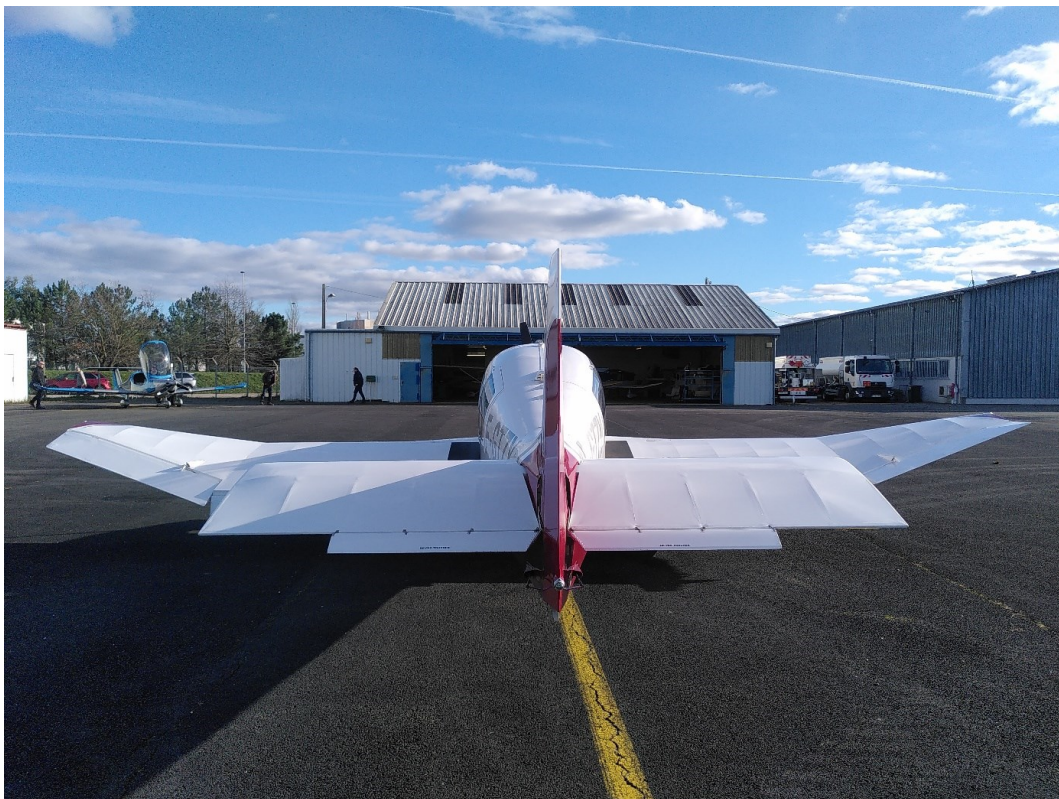
F-GTZY is a DR400-160 belonging to the flying club, CAPAM. Its colour livery is shown below. It is equipped with a transponder which does not have the "ground mode" function. Other TCAS therefore always see it as being in flight.

*Figure 4: photo of DR400 from side (source: CAPAM)*

*Figure 5: photo of DR400 looking forwards (mostly white - source: CAPAM)*

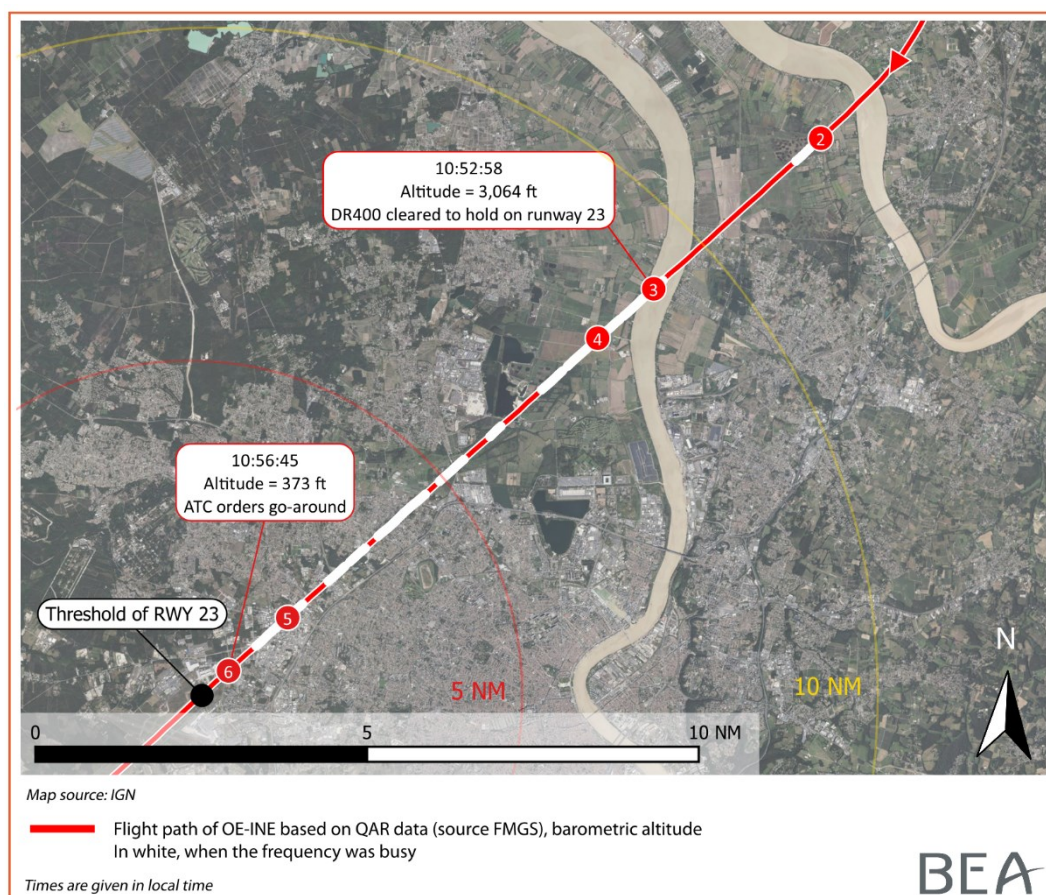
Figure 6: illustration showing when the radio frequency was busy

The examination of the radiocommunications found that the frequency was busy 60% of the time, between the clearance for the DR400 to line up at 10:52:58 and the instruction to go around given to the crew of the A320 at 10:56:46. Communications in connection with VFR flights took up 50% of the frequency (26 messages with 4 aeroplanes) and with IFR flights 10% (9 messages with 2 aeroplanes).

Figure 6 below graphically illustrates (in white) when the frequency was busy.

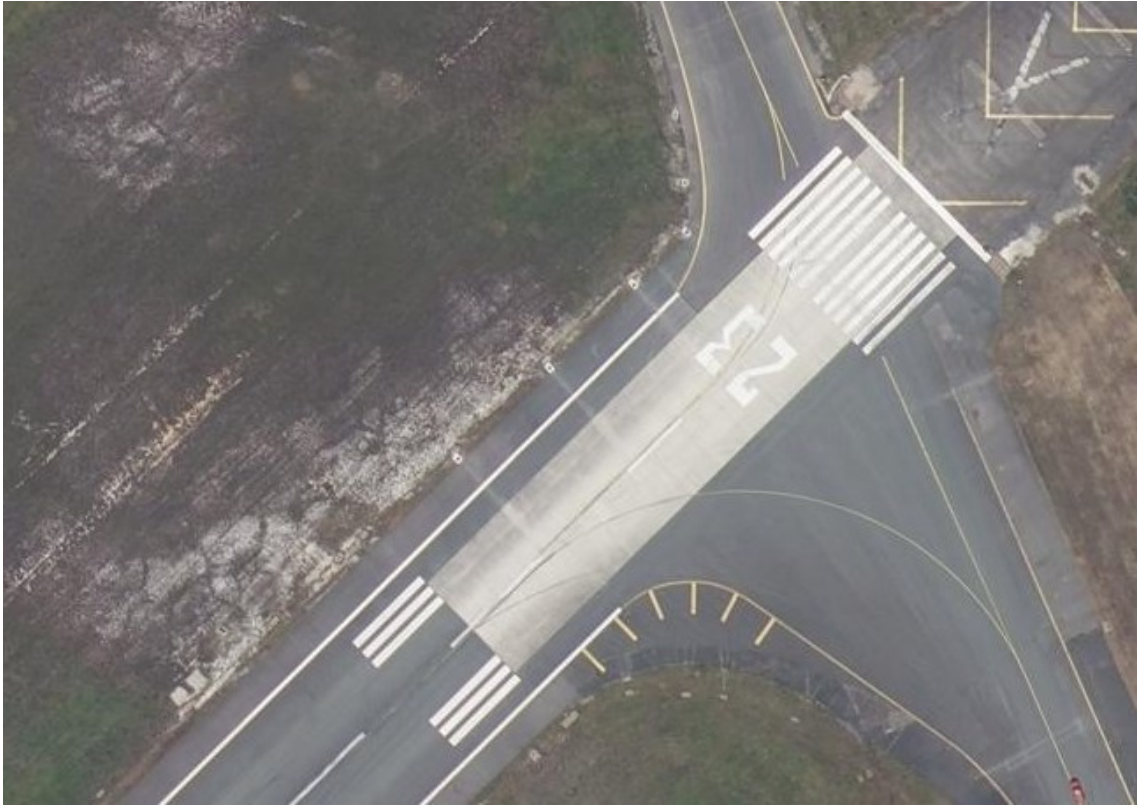
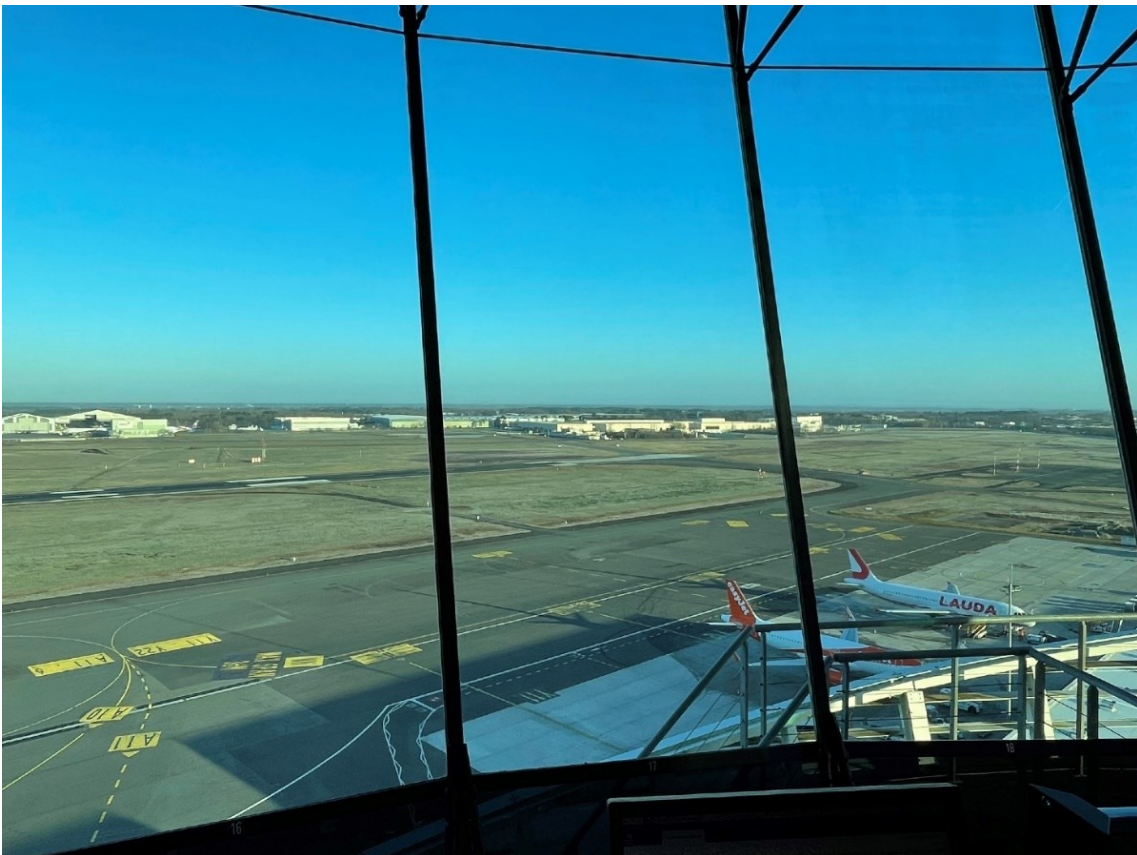
Unlike the rest of the runway and the taxiways which are dark grey, the threshold of runway 23 is light grey.

Figure 8: aerial view of runway 23 threshold (source: IGN)

Figure 9: view of runway 23 threshold from TWR controller position (source: BEA)

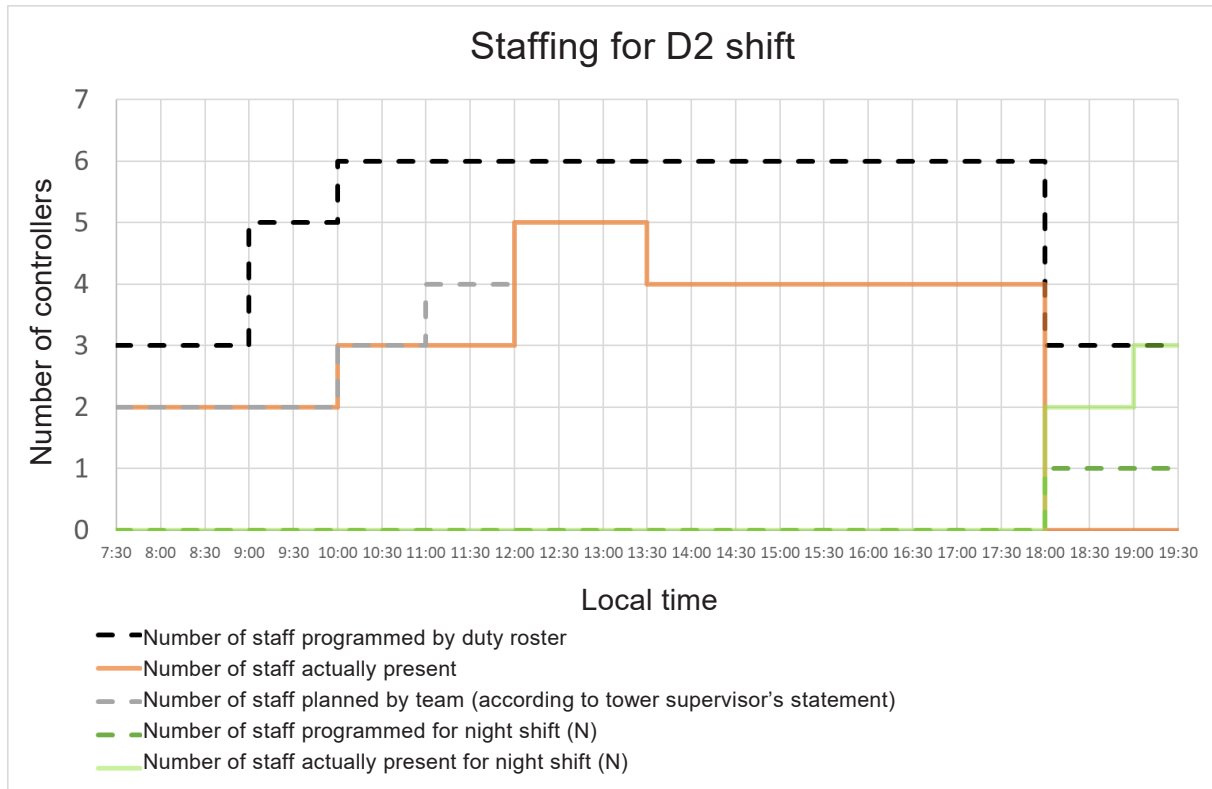
Figure 14: programmed and actual staffing levels for the D2 shift

- the number of staff for the D2 shift programmed by the duty roster (black dotted line);
- the number of staff for the D2 shift planned by the tower supervisor and indicated by him in interviews (dotted grey line);
- the number of staff for the D2 shift actually present on the day of the serious incident (solid amber line);
- the number of staff for shift N programmed by the duty roster (dotted green line);
- the number of staff for shift N actually present on the day of the serious incident (solid green line).

- at the time of the serious incident, 10:55, the actual number of staff present was two controllers and a tower supervisor, instead of five controllers and a tower supervisor;
- the number of controllers actually present remained below the number programmed by the duty roster for the entire D2 shift; this is explained by the fact that the five controllers of the D2 shift team came and stayed for less than the scheduled working time, and that the backup controller from the D1 shift team did not come to work;
- the team carrying out the D2 shift finished its shift at 18:00 and team N arrived ahead of schedule at 18:00 to man the tower. The two teams had agreed on this organisation for that day.

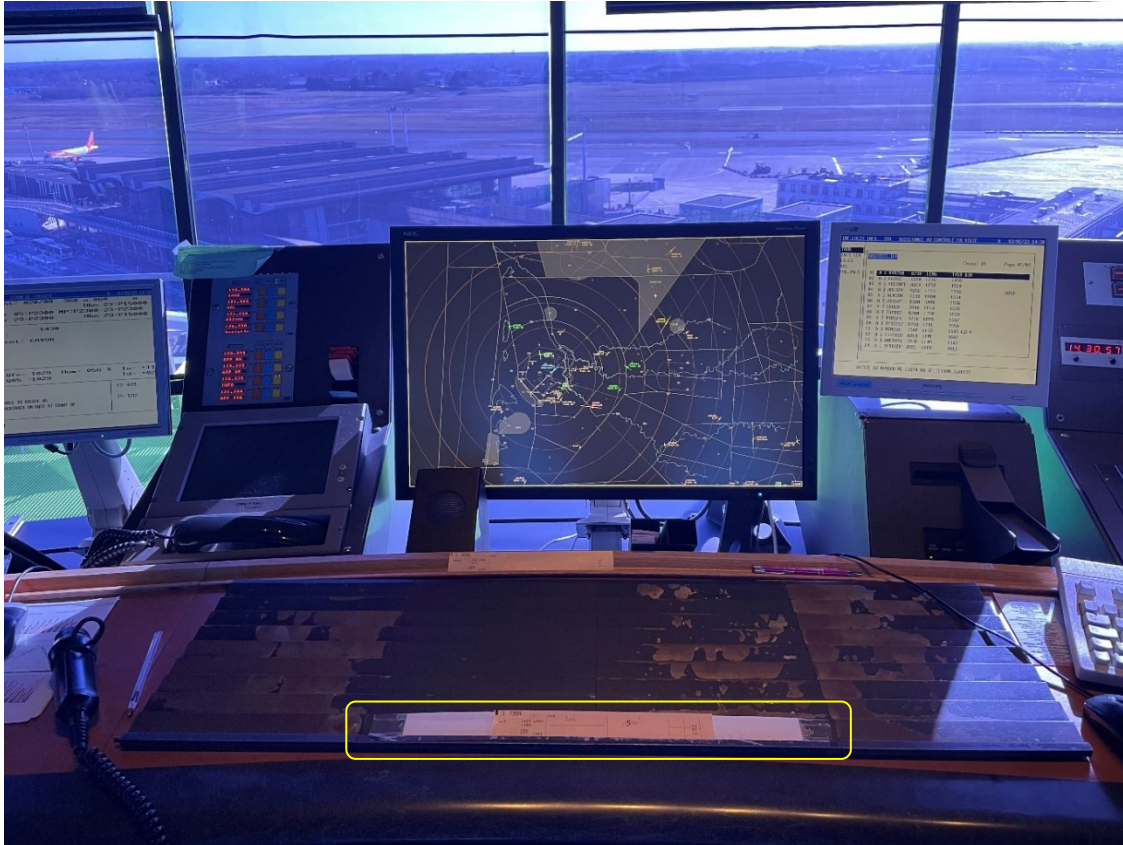
She also felt that the "runway area" on the strip board should be reviewed, and that it was in a poor state of repair, which made it difficult to use. She perceived the SIGMA tool as "archaic", to the extent that some controllers prefer to write out the strips by hand. Before the serious incident, she indicated that the tower supervisor had in fact devoted a lot of his resources to entering VFR flight information into SIGMA, which probably affected the attention he could pay to the controller's actions on the frequency.

Figure 15: photo of the strip board used on the day of the serious incident; theoretical positioning of a strip for an aeroplane at the runway threshold, represented by a white band, here covered with transparent adhesive tape.
